FINAL REPORT
IG-544/CENIPA/2015

OCCURRENCE:	SERIOUS INCIDENT
AIRCRAFT:	PR-OAF
MODEL:	F28MK0100
DATE:	21JAN2012

This is the Final Report of the 21 January 2012 serious incident involving the F28MK0100 aircraft, registration PR-OAF. The incident was classified as “in-flight fire”.

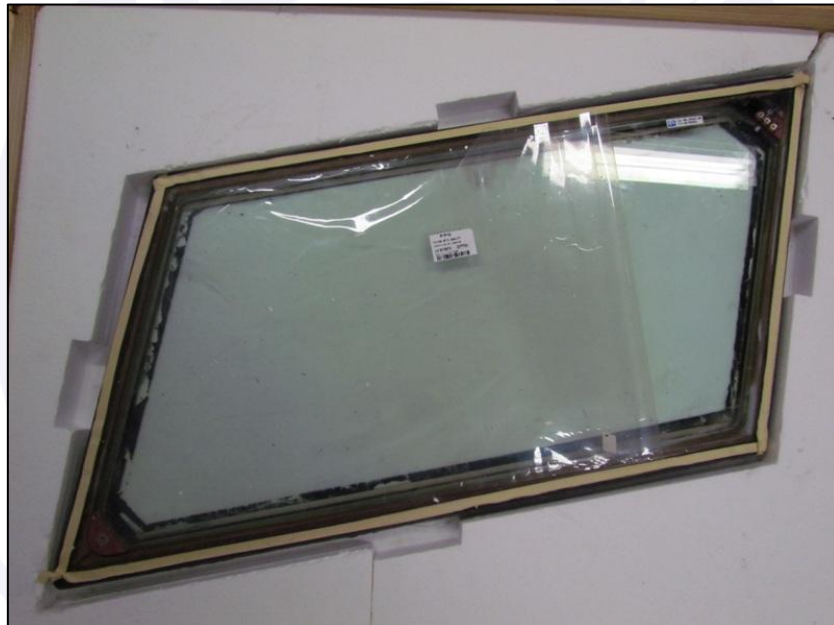
The pertinent PR-OAF windshield and its corresponding transformer were sent to the Materials Division of the Aerospace Science and Technology Department (DCTA) for analysis (Figures 2 and 3).

Figure 2 - Right-hand-side windshield.

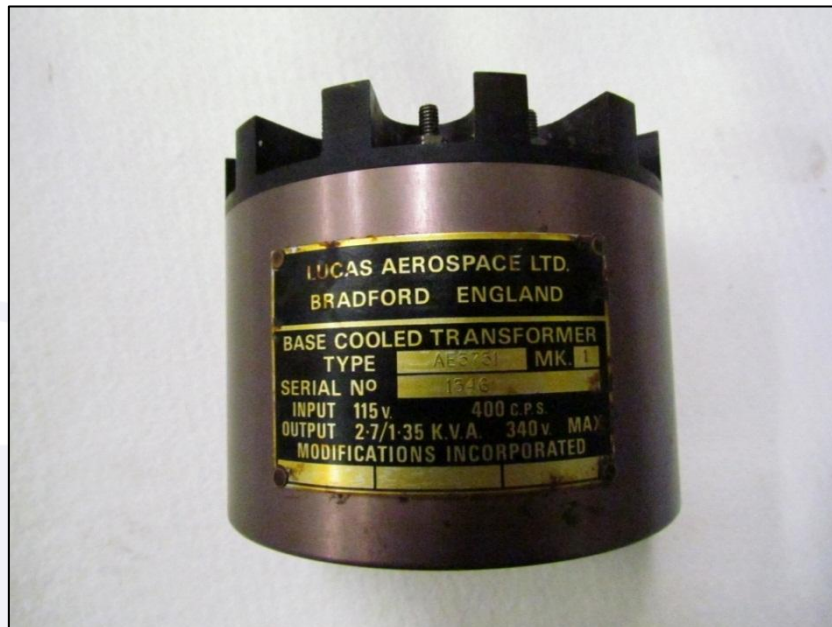
Figure 3 - Transformer.

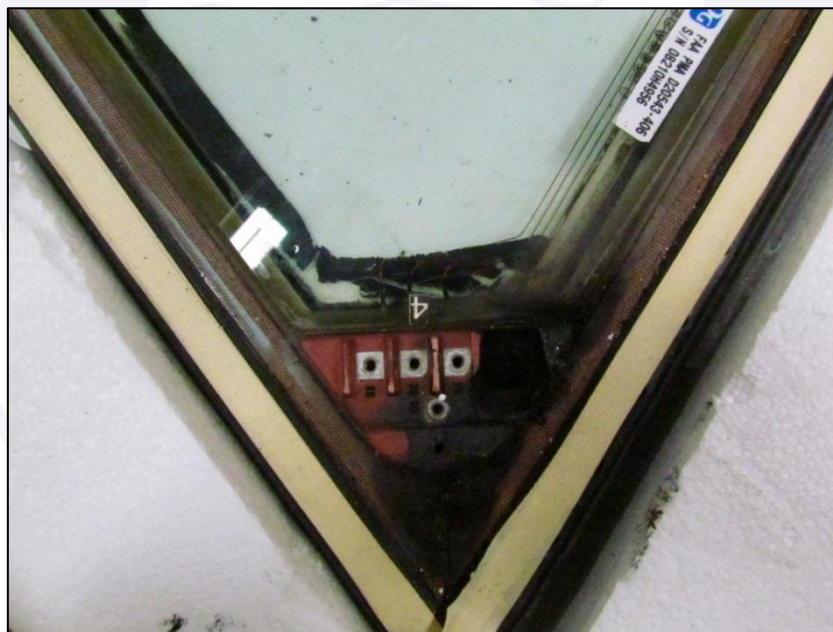
In the event in question, the terminal presented a burn resulting from short-circuit (Figure 4) The corresponding circuit-breaker did not disarm.

Figure 4 - Windshield: general aspect of the failure.

Thus, it is possible that the uncorrected increment in the resistance of the laminate, together with the wrong assembling of the terminals, may have accelerated the degradation of the windshield, expediting the process of delamination to, finally, cause the short circuit in the heating system.

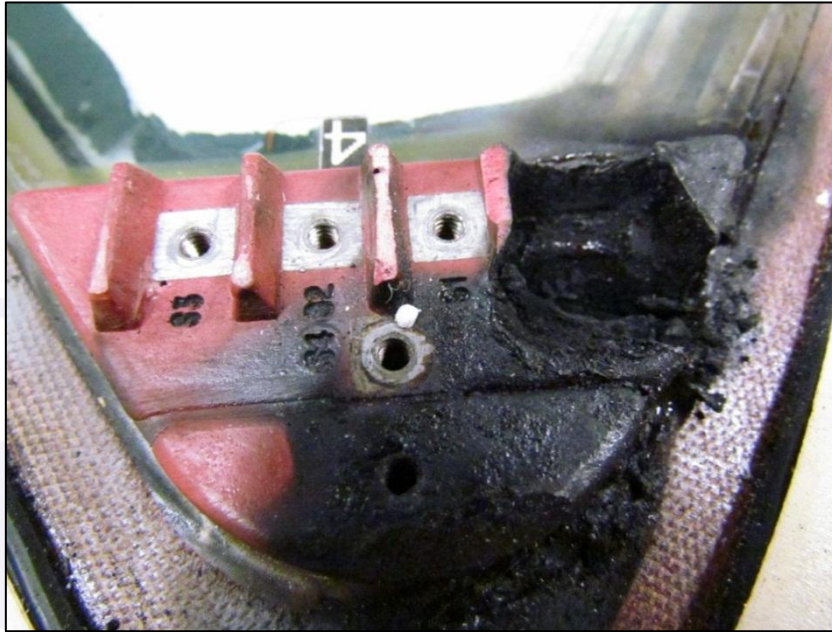
Figure 5 - Detail of the short circuit in the connecting terminals between the windshield and the transformer.

Windshield assembled with misplaced transformer terminals.

While examining the item, the investigators observed that the transformer terminals had been assembled in discordance with the specifications of the manufacturer's manual.

The misplacement of the terminals could generate an increment of 55 volts in the system, and result in overload. However, the erroneous assembly of the terminals does not explain the long period of time elapsed from the day the windshield was installed (18 September 2009) until the occurrence of the short circuit (21 January 2012), indicating that, in itself, the wrongful assembly was not the single cause of the failure.

The inadequate installation of the transformer terminals of the right hand side windshield heating system contributed to the degradation of the safety levels of the aircraft system until the occurrence of a short circuit, which was the source of the fire and smoke in the flight deck.

There was a recommendation made by the manufacturer stating that, when the resistance of the window fell within the limits of the AMM Task 56-11-00-400-814, its electric terminal should be connected to the corresponding terminal of the transformer, whereas, if the resistance of the window was out of these limits, it had to be replaced.
