**FINAL REPORT**  
**A - 173/CENIPA/2018**

| <b>AIRCRAFT:</b> | <b>PT-FPS</b> |
| <b>MODEL:</b> | <b>AW109SP</b> |
| <b>DATE:</b> | <b>24NOV2018</b> |

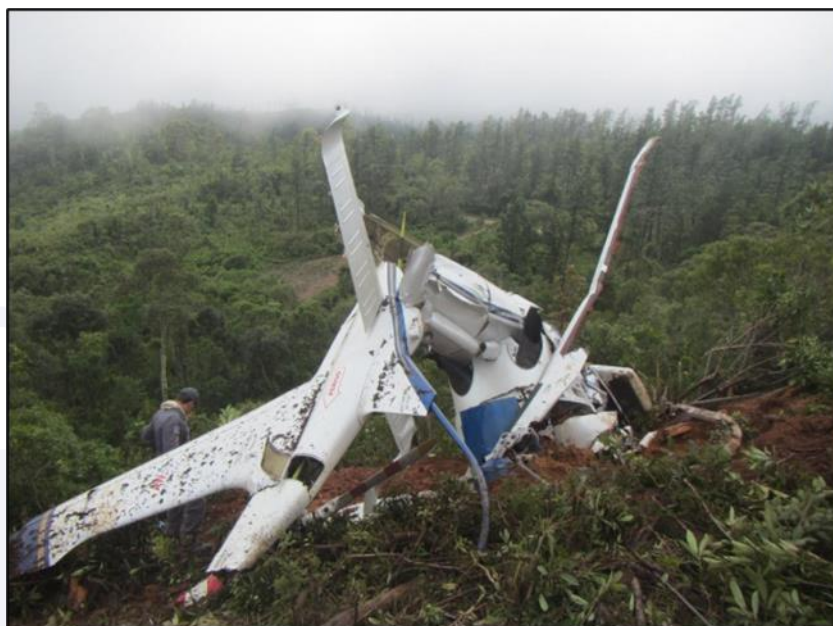
The aircraft crashed out of the Aerodrome, in a mountainous region near Campos do Jordão. The wreckage was concentrated and there was no fire in the components.

Figure 10 – General view of the aircraft at the crash site.

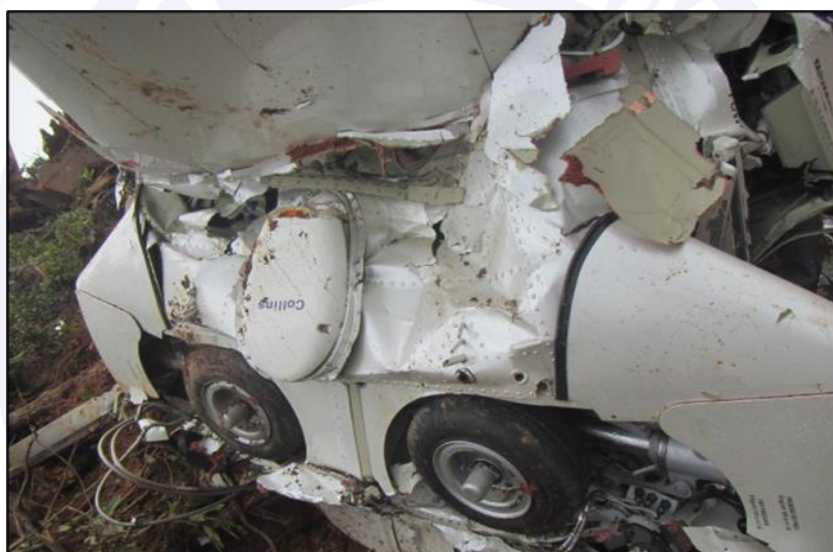
The aircraft's landing gears were found in a position compatible with that of “retracted” (Figure 11).

Figure 11 - Detail of the aircraft's landing gears.

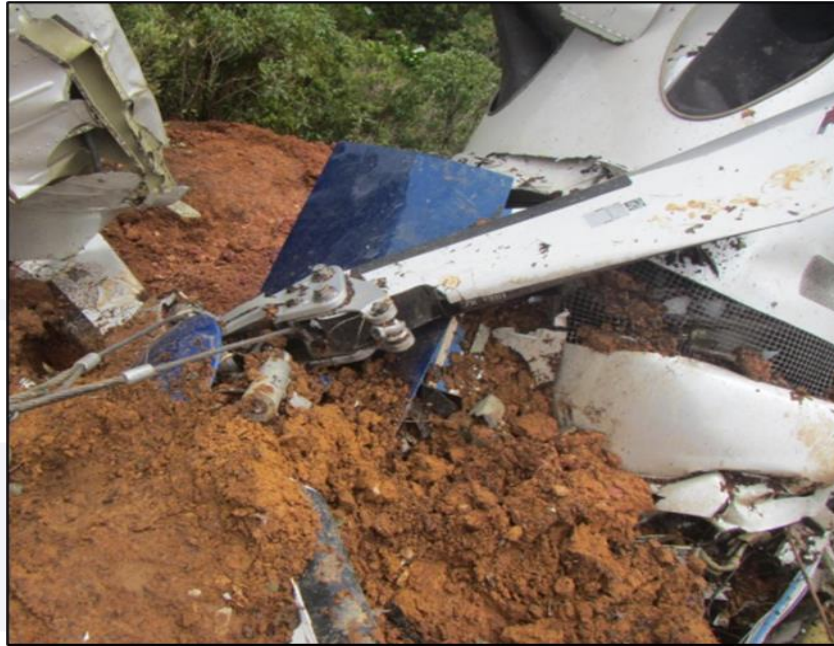
The aircraft came to rest with a considerable portion of its front and upper fuselage section buried, evidencing a collision with a large angle and high speed (Figure 12).

Figure 12 – Detail of the upper frontal section burying, highlighting one of the main rotor blades.

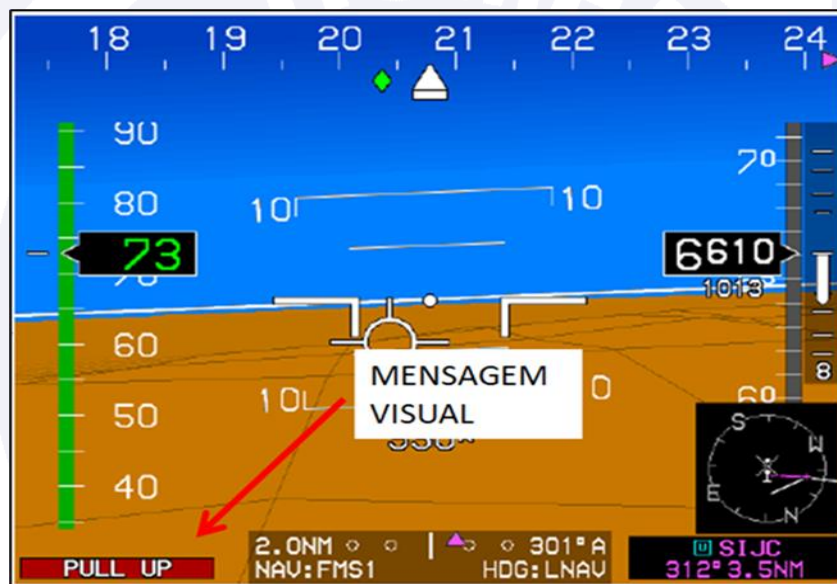
The two monitors showed indications of height reduction in relation to the terrain, with yellow and red coloring in the map view on the HSI and in the corresponding sound and text messages.

Figure 13 - Reproduction of the ADI indications during the final descent.

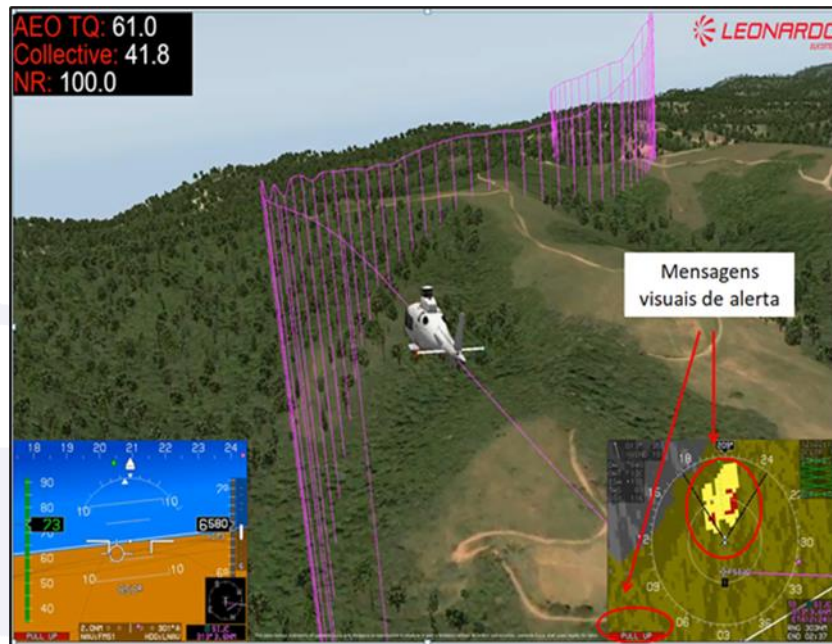
Figure 14 - Simulation of the ground approach with the visual terrain alerts.

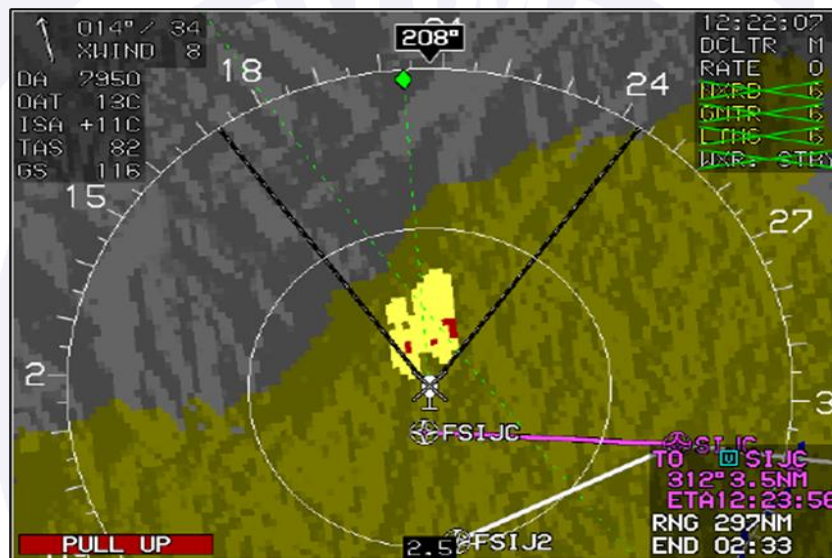
Figure 15 - Reproduction of the HSI indications (in MAP format) during the final descent.

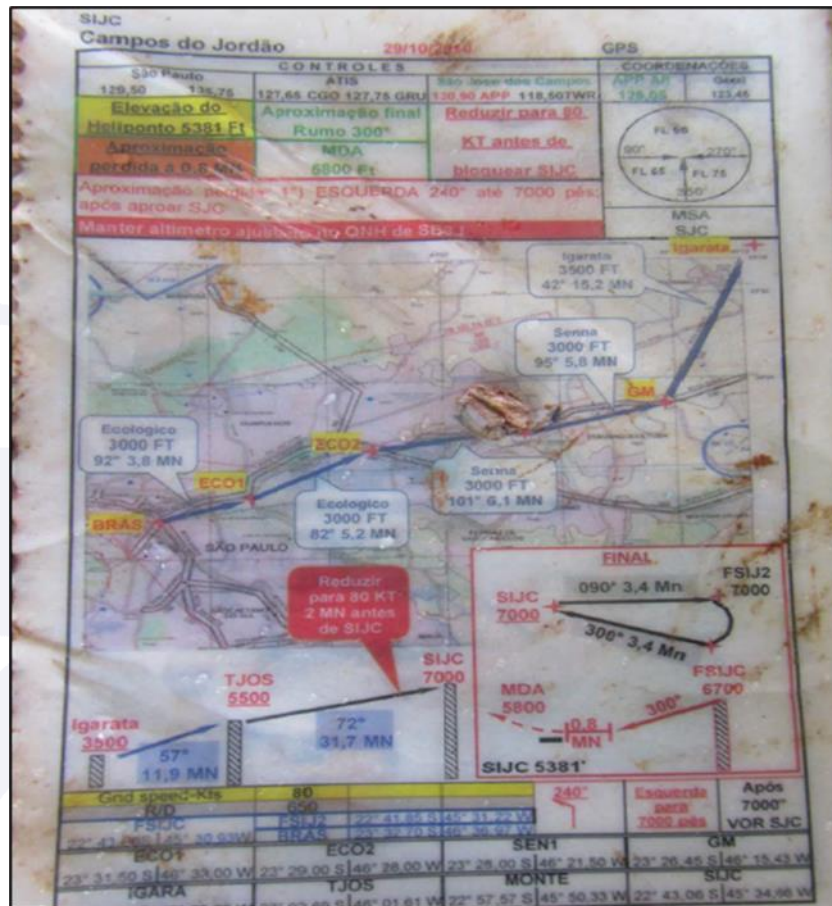
During the field investigation, a compendium of charts with uncertified procedures was found in the wreckage of the aircraft (Figure 22).

Figure 22 - Non-certified Procedure Chart.

The flight plan entered coincided with the points of a procedure called “Campos do Jordão”, which was found in the compendium of uncertified charts. SDAM was the designation of the Amarais Aerodrome, and SIJC referred, in 2010, to the Campos do Jordão Hotel Helipad and which, on the date of the occurrence, had the designation of SICH.

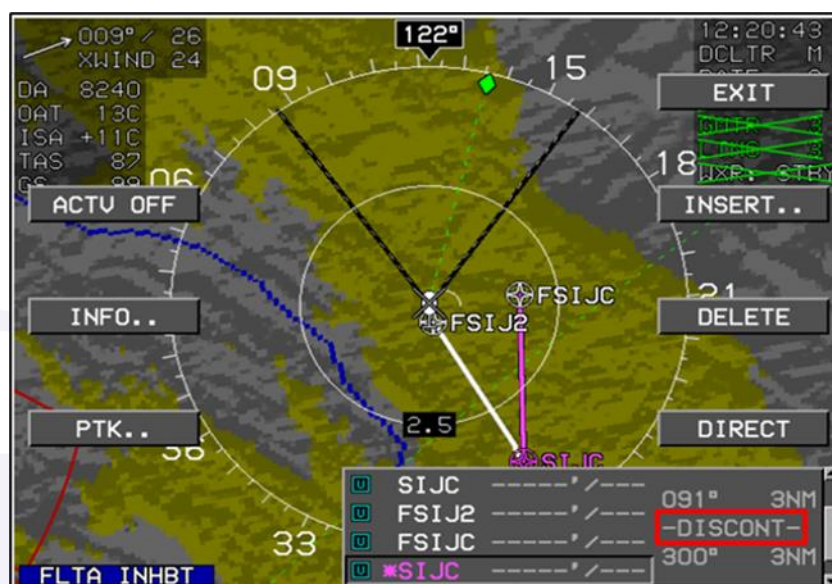
In this case, the AFCS, after passing the FSIJ2 point, would direct the aircraft to the closest intercept point of the FSIJC - SIJC leg without overflying the FSIJC, as shown in Figure 24.

Figure 24 - Simulated HSI with flight plan overlay in MAP format.

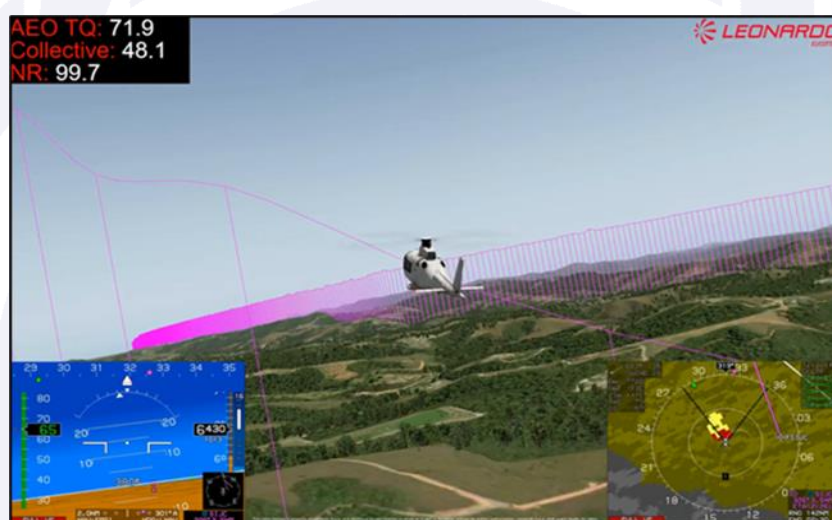
From that point, the aircraft started a steep climb, simultaneously with a constant change of course towards the right and, approximately, 40° of pitch angle.

Figure 31 - Simulation of the climb and reduction of speed.

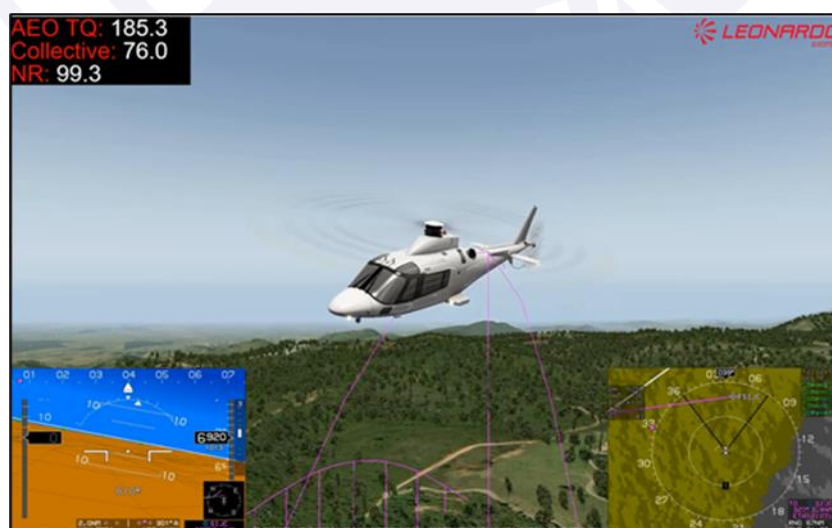
This sudden change in attitude provided a rapid reduction in speed that went from 80 to 0 KIAS when reaching the maximum recorded altitude of 6,980 ft, at 12:22:52 (UTC), followed by extreme variations of the aircraft attitude in its three axes.

Figure 32 - Simulation of the maximum altitude reached.

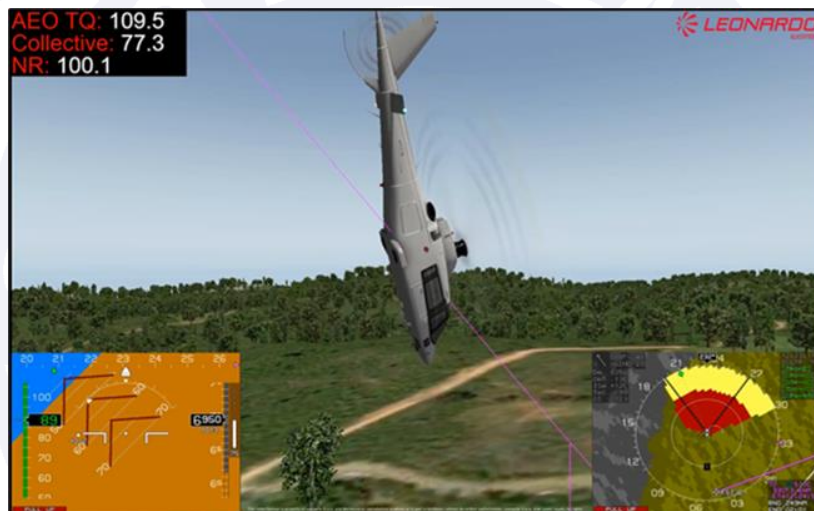
After this period, the vertical velocity of the PT-FPS suddenly and constantly decreased to negative values, until the impact against the ground at 12:23:13 (UTC), with 167 kt of ground speed and 10,000 ft/min of descent rate.

Figure 38 - Impact simulation.
