COMANDO DA AERONÁUTICA
CENTRO DE INVESTIGAÇÃO E PREVENÇÃO DE
ACIDENTES AERONÁUTICOS

FINAL REPORT
IG - 177/CENIPA/2018

OCCURRENCE:	SERIOUS INCIDENT
AIRCRAFT:	YV2937
MODEL:	B737-2Y5
DATE:	28NOV2018

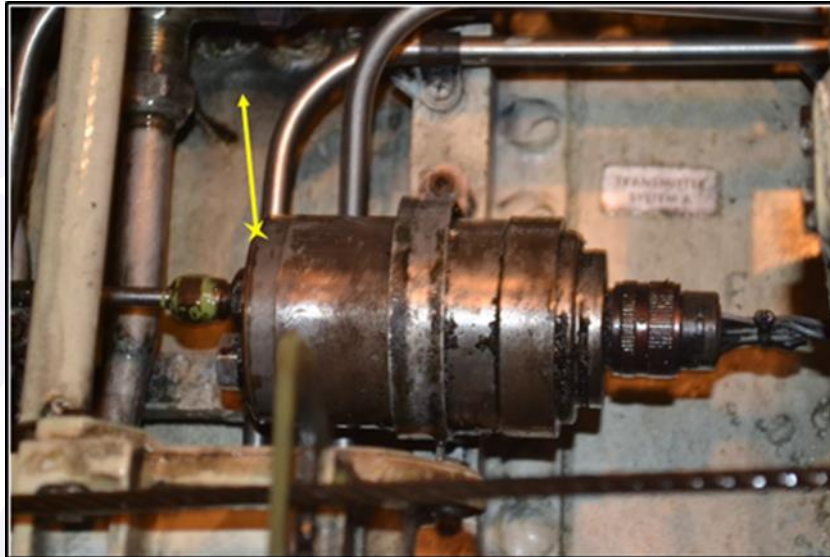
The only damage observed was the point where the leakage of the hydraulic fluid occurred in the body of the System A pressure transmitter, which occurred in flight.

The main hydraulic reservoir was refilled and pressurized, when it was observed that the hydraulic leak occurred through the body of the System A Hydraulic Pressure Transmitter, Part Number (PN) ST-107R and Serial Number (SN) 7929A.

Figure 1 - System A pressure transmitter (PN ST-107R). The yellow arrow indicates the location and direction that the hydraulic fluid leak was observed.

It was sought, together with aircraft maintenance companies certified by Boeing in Brazil, to perform examinations, tests and research, with the objective of detecting the reason that allowed the leakage of hydraulic fluid through the body of the Pressure Transmitter, however, companies with technical capacity were not found to perform such examinations.

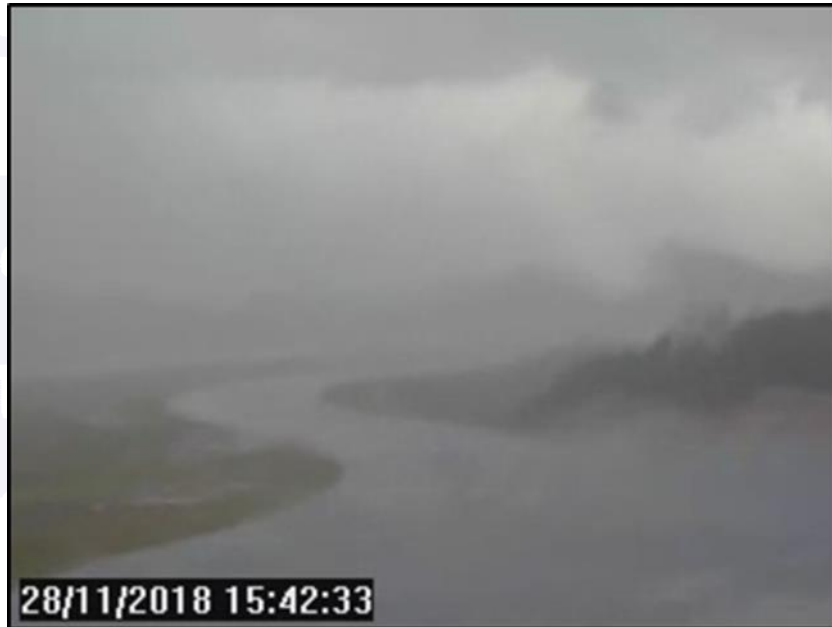
Figure 2 - Image of the CCTV of taxiway "A" and runway 11 at the time of the YV2937 landing - recording with Manaus local date and time (UTC-4).

During the investigation, it was found that this information was inaccurate, since, corroborated by the CCTV images of the airport administrator and the measurement performed by the EMS-EG rain gauge, the amount of rain that fell at that moment was not light, according to the ICA 105-15.

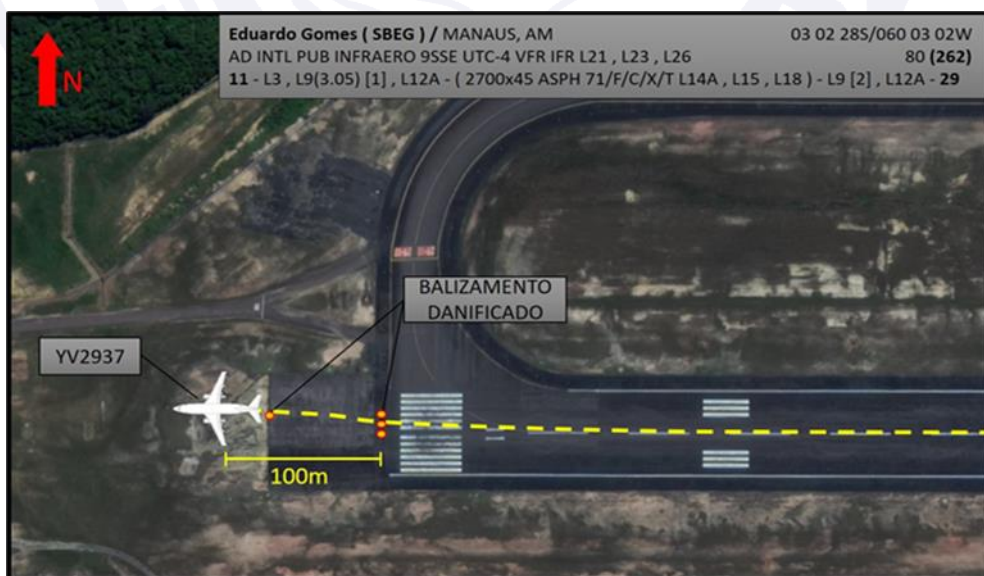
The aircraft overpassed the end of runway 29 by 100 meters, coming to a stop with the landing gear on soft ground (dirt).

During the runway excursion, the landing gear collided with three Runway End Identifier Lights (REIL) and an Approach Light System (ALS) (Figure 6).

Figure 6 - Sketch with the final position of the aircraft and damage caused to the SBEG runway marking.

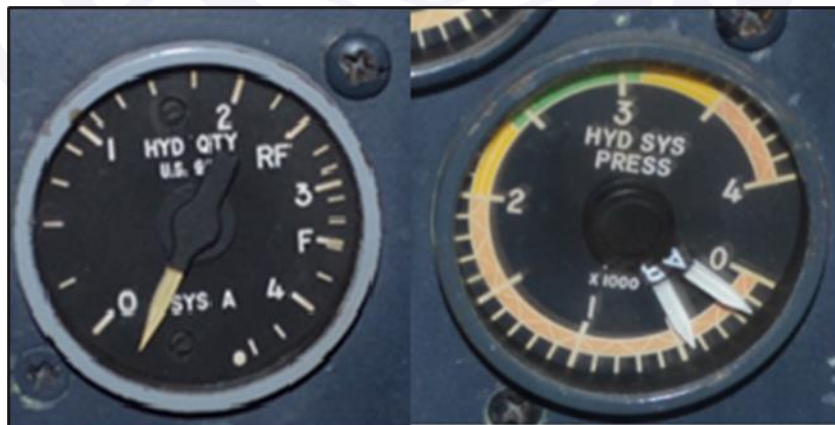
Immediately, the crew members verified, on the multiple hydraulic pressure indicator, that the pressure of System A had dropped to zero, as well as the amount of hydraulic fluid in the reservoir of that system had dropped.

Figure 7 - Indicators of the amount of hydraulic fluid in the reservoir and hydraulic pressure of the "A" and "B" systems, after landing on SBEG.

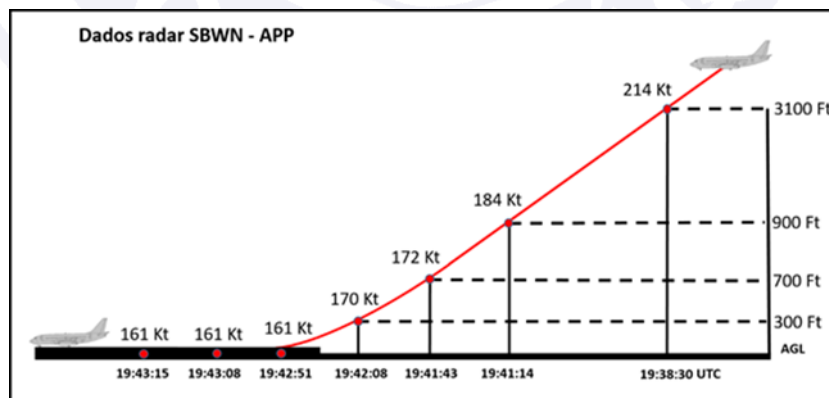
Figure 9 - Graph prepared with information recorded by the Manaus Control Approach Radar (SBWN - APP).

In the radar visualization provided by the APP-MN, it was observed that the final approach was flown with a speed on the ground of 170kt, about 20kt above the speed stipulated by the QRH. It is possible that part of that speed was caused by the wind component, which, at that time, was approximately 5kt tail.
