COMMAND OF AERONAUTICS
AERONAUTICAL ACCIDENT INVESTIGATION AND
PREVENTION CENTER

FINAL REPORT
IG - 140/CENIPA/2013

<u>OCCURRENCE:</u>	SERIOUS INCIDENT
<u>AIRCRAFT:</u>	PP-ITZ
<u>MODEL:</u>	C-208B
<u>DATE:</u>	03 OCTOBER 2012

This is the final report of the serious incident involving the C-208B aircraft, registration PP-ITZ, on 3 October 2012. The incident was classified as inflight engine failure.

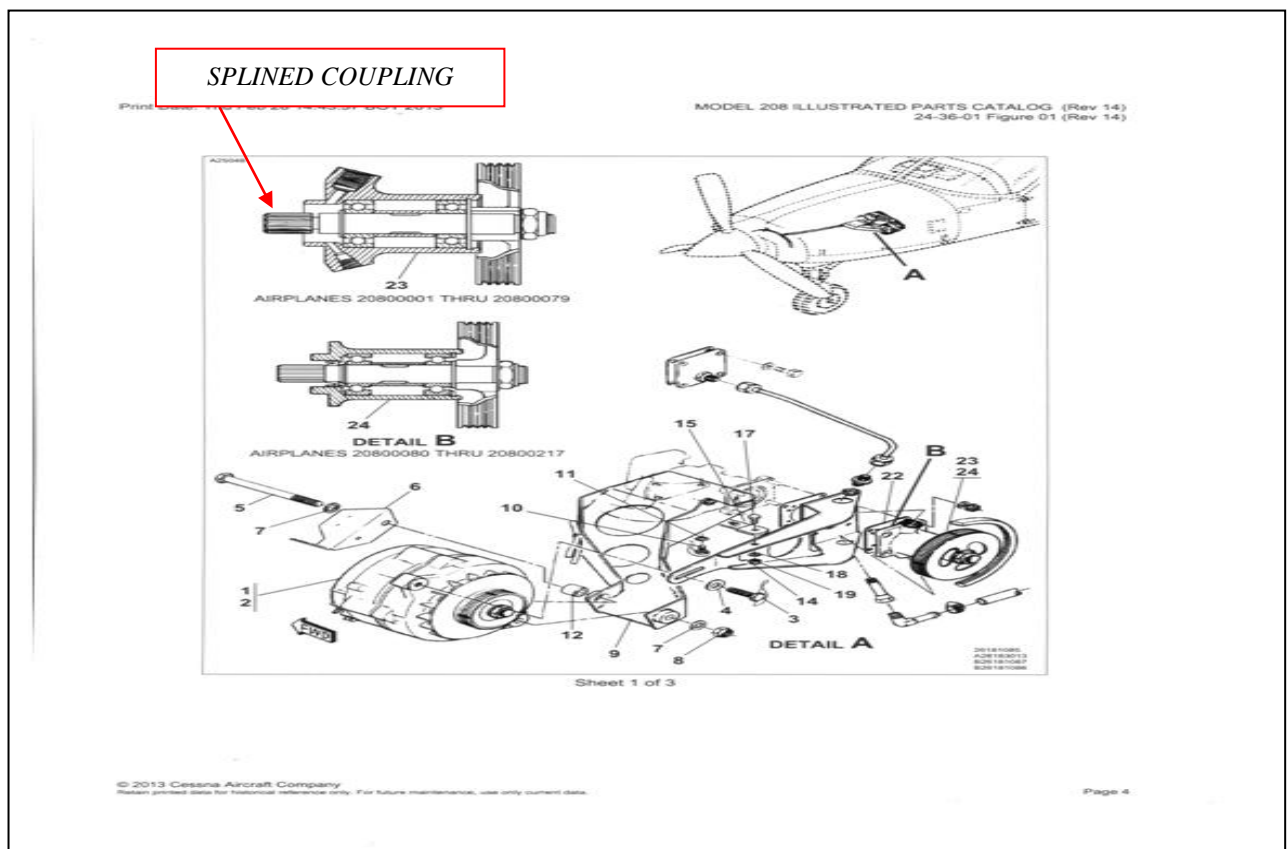
Figure 1 – Catalog of component parts.

So that the exams could be continued, the aircraft was taken to the hangar of the company in Manaus. The company was asked to remove the engine oil pump, which showed to have a fracture in the SPLINED COUPLING.

The oil pump was connected to the aircraft alternator by means of pulleys and a belt, maintaining the operation of the system.

During the investigation, it was possible to observe a fracture in the item known as *SPLINED COUPLING*, a type of cover of the engine oil pump axle, which was connected to the *STBY ALTERNATOR* by means of pulleys and a belt.

After research and analyses done in conjunction with a representative of the engine manufacturer, the investigation commission concluded that one of the possible contributing factors for the occurrence of this fracture was the application of a belt tension higher than the one recommended in the Manual of Maintenance of the aircraft.

The excessive tension of the belt may have forced the oil pump axle, which transferred the effort to the *SPLINED COUPLING*, resulting in the fracture of this component.

With the fracture of the component, in addition to the application of power and time of repetitive effort over the pump axle, the oil leak worsened, resulting in total loss of the fluid and, consequently, loss of power and feathering of the propeller.

It is possible that the performing of Task 243622 without utilization of the appropriate tools contributed to the incorrect application of tension on the STBY ALTERNATOR belt, therefore causing an effort in the oil pump shaft with the functioning of the engine and, consequently, a fracture in the SPLINED COUPLING. Such fracture gave origin to the oil leak and loss of pressure, resulting in the inflight engine failure.

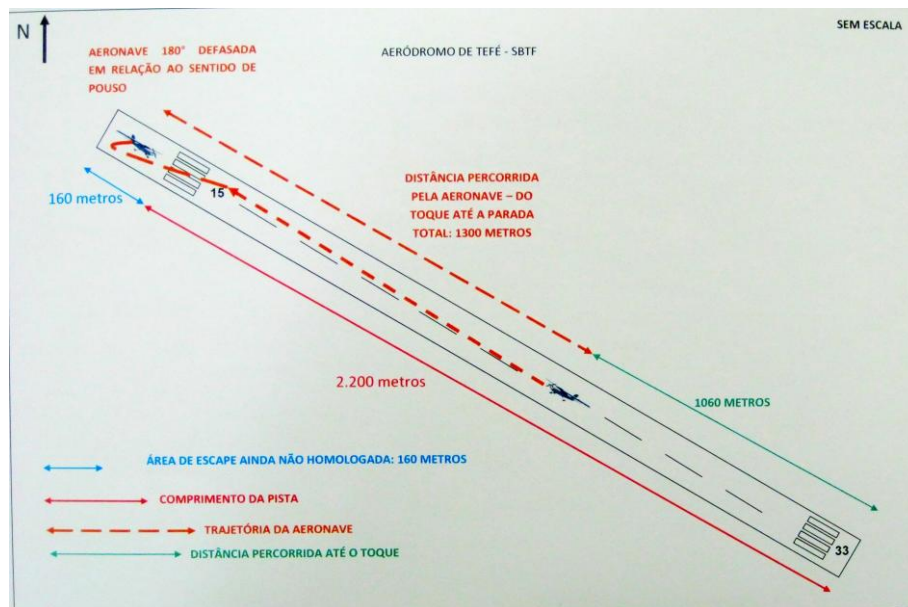
Figure 2 - Croquis of the aircraft landing path.

After passing over the threshold, the aircraft traveled over the runway for approximately 1,060 meters before touching down, and had about 1,300 meters of runway available for completion of landing.

However, even after depressing the brakes at maximum amplitude, it was necessary to make a 180-degree turn (already in the stopway) so that the aircraft did not go beyond the runway limits.

The application of maximum braking capacity by the crew resulted in an onset of fire in the aircraft brake assembly and, since the pilot had moved the yoke to produce a pitch-up attitude, the tail cone of the aircraft impacted the ground.

The pilot did not maintain the speed and configuration recommended by the manufacturer, and made the aircraft touch down at a distance of 1,060 meters from the threshold of runway 33, at a well higher speed than the one prescribed, making it impossible to stop normally within the runway limits.
