COMMAND OF AERONAUTICS
AERONAUTICAL ACCIDENT INVESTIGATION AND
PREVENTION CENTER

FINAL REPORT
A - 003/CENIPA/2014

<u>OCCURRENCE:</u>	ACCIDENT
<u>AIRCRAFT:</u>	PT-OQR
<u>MODEL:</u>	C208
<u>DATE:</u>	09 JULY 2012

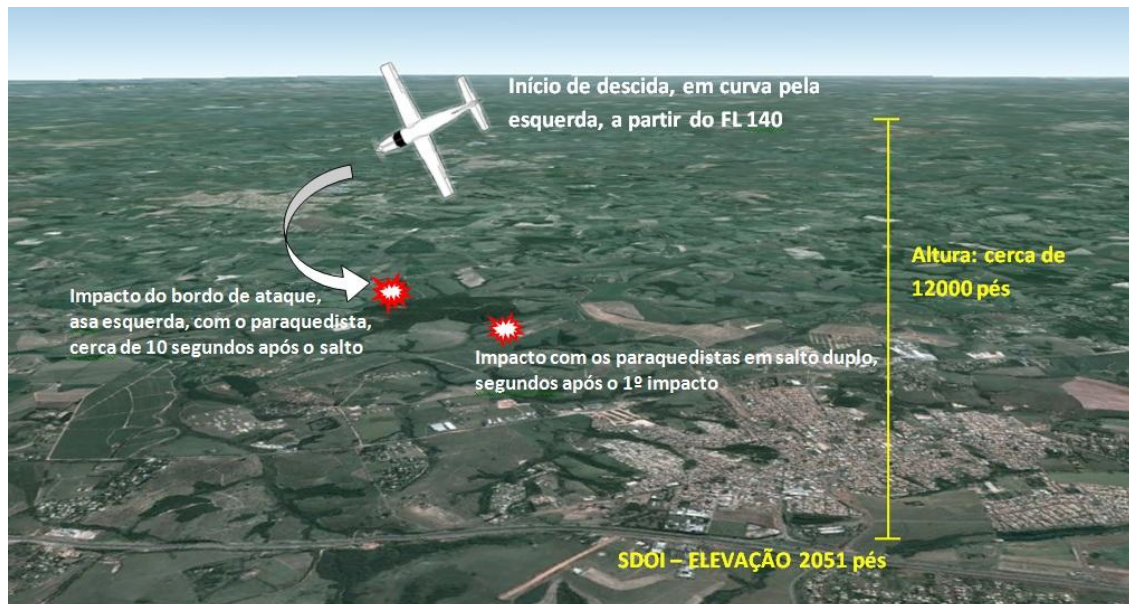
Another witness reported having become surprised by the aircraft passing very close to the skydivers. From the video that was made, the investigation commission considered that the aircraft may have collided with the tandem jump skydivers, soon after it hit the solo skydiver.

Figure 1 - Croquis of the moment of collision.

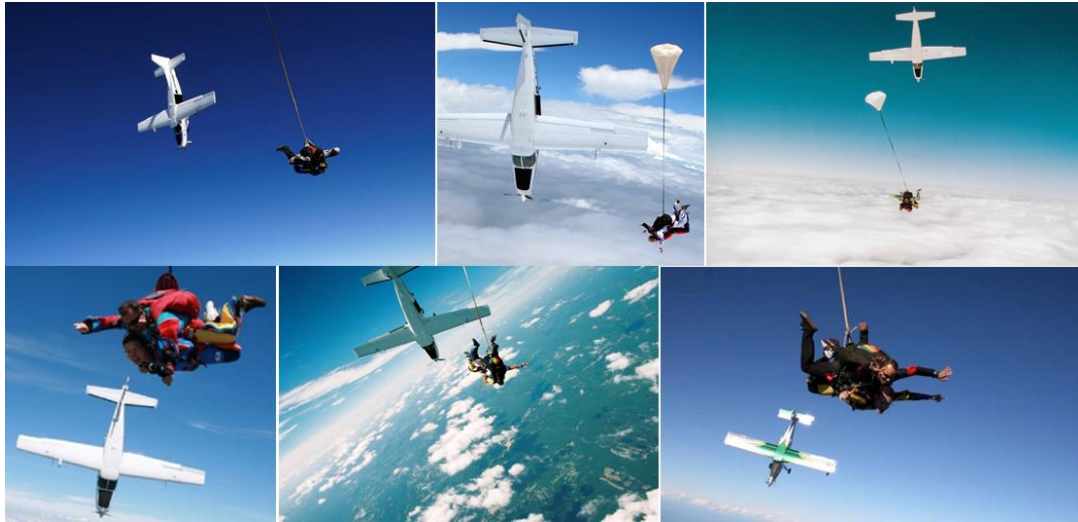
The airplane/skydiver proximity was encouraged, since, in addition to the emotion of the proximity by itself, one could possibly take a photograph or make a video of a moment considered as the “trade mark” of the activity: an aircraft diving alongside skydivers, a scene that translated the “plasticity” of this type of sport.

Figure 2 – Images obtained on the internet (Brazil and abroad) and from skydive schools, showing the culture of taking photographs of “a diving plane *versus* skydivers”.

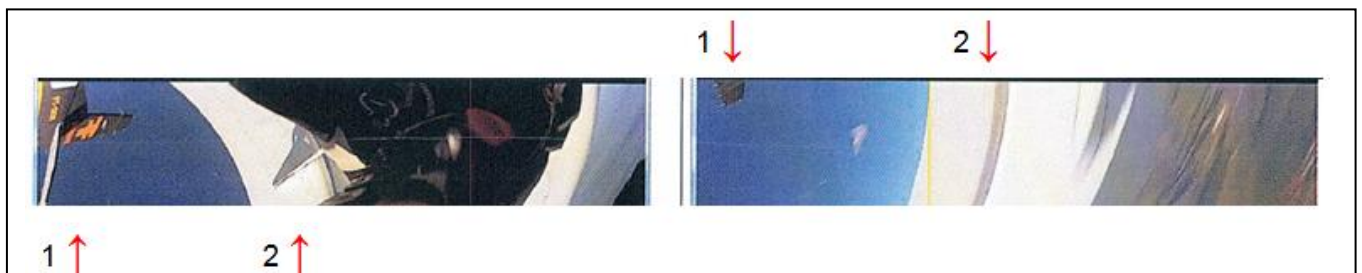
Figure 3 – In the two pictures, obtained from the development* of the video made by the fatally injured solo skydiver (*Forensic Institute, State of São Paulo Civil Police), it is possible to observe the wide angle effect of the camera objective.

RMK: 1 (empennage) and 2 (left wing intrados) appear at different angles, as if they did not belong to the same airplane.

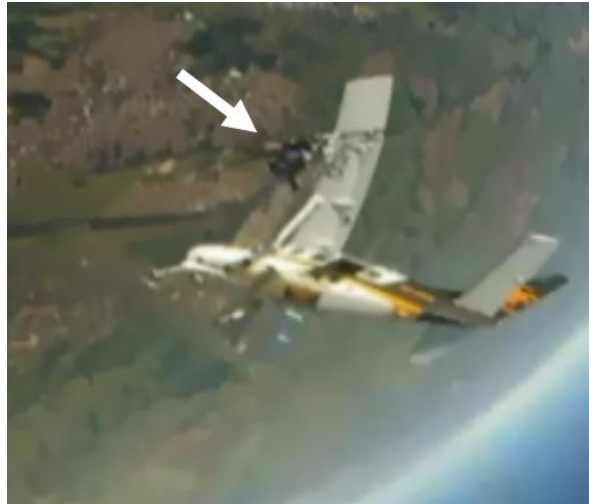
Figure 4 – “Frame” obtained approximately 13 seconds after the skydivers jumped from the aircraft, when it was passing close to the tandem jump skydivers (shown by the arrow).

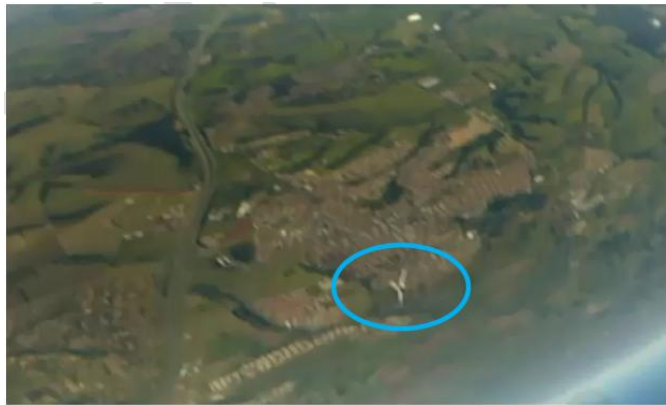
Figure 5 – “Frame” obtained approximately 3 seconds after the one shown in the previous figure, depicting the aircraft still in a turn. The horizon is in the bottom right corner.

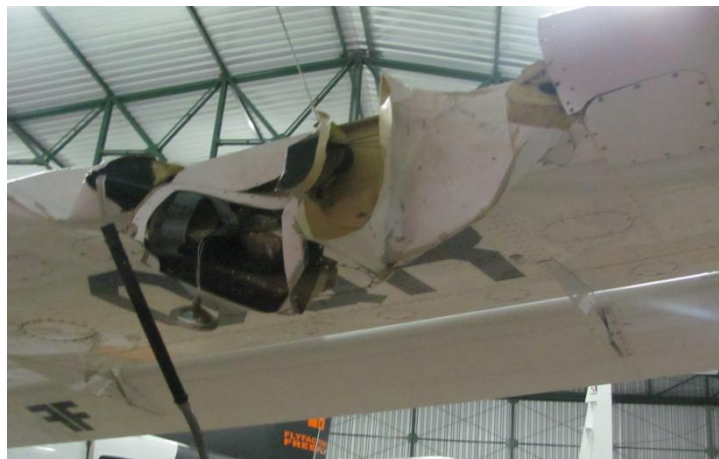
The left wing of the aircraft hit the solo skydiver. There was damage to the left wing leading edge (ripping and denting), landing light and Pitot tube.

Figure 6 – Wing damage, as observed during the initial action.
