FINAL REPORT A – 120/CENIPA/2017

OCCURRENCE: AIRCRAFT: MODEL: DATE: ACCIDENT PP-FGQ AB-115 26SEPT2017

This is the Final Report of the 26SEPT2017 accident with the AB-115 aircraft, registration PP-FGQ. The accident was classified as "[LOC-G] Loss of Control - Ground".

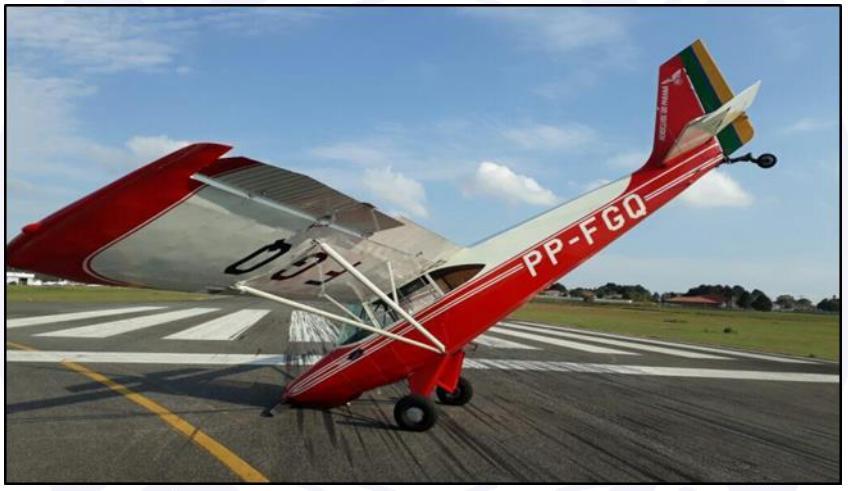
Figure 1 - Position of the aircraft after full stop.

The aircraft had substantial engine and propeller damage and minor damage to the spinner and exhaust.

There was the impact of the propeller, sudden stop of the engine and the aircraft stopped with the nose leaning on the ground.
