**COMANDO DA AERONÁUTICA**  
**CENTRO DE INVESTIGAÇÃO E PREVENÇÃO DE**  
**ACIDENTES AERONÁUTICOS**

**FINAL REPORT**  
**A - 028/CENIPA/2017**

<b>OCCURRENCE:</b>	<b>ACCIDENT</b>
<b>AIRCRAFT:</b>	<b>PR-MER</b>
<b>MODEL:</b>	<b>BO-105S</b>
<b>DATE:</b>	<b>16FEB2017</b>

This is the Final Report of the 16FEB2017 accident with the BO-105S aircraft, registration PR-MER. The accident was classified as “[F-NI] Fire/Smoke (Non-Impact) – Fire on the Ground”.

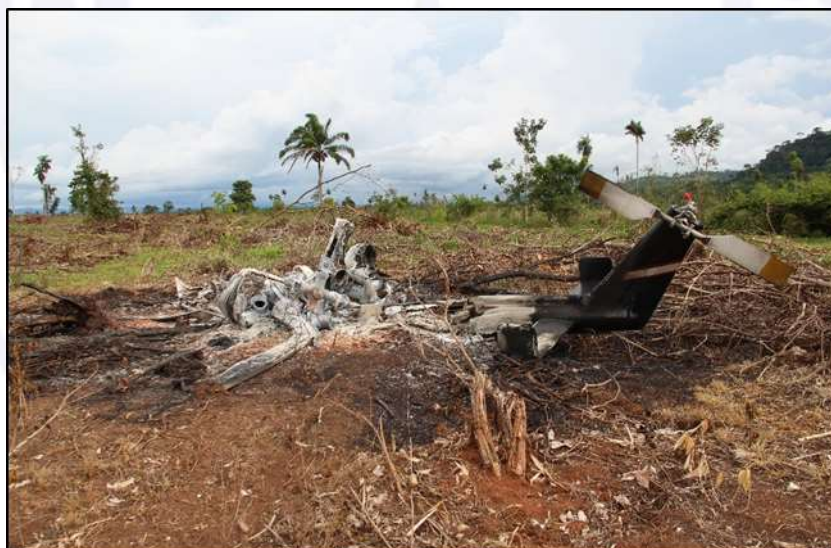
Figure 1 - Aircraft after being consumed by fire.

After abandonment, at a safe distance, the occupants considered returning and using the manual fire extinguisher, but the fire had already started in the engine compartment on the right side of the aircraft.

The fire was intense due to the existence of 440 liters of fuel remaining and to the material of the aircraft itself.

The fire consumed much of the aircraft, leaving only part of the vertical empennage and the tail rotor.

The origin of the fire could not be identified.
