FINAL REPORT A - 188/CENIPA/2013

OCCURRENCE: AIRCRAFT: MODEL: DATE: ACCIDENT PT-NKO EMB-711C 190CT2013

This is the Final Report of the 19 October 2013 accident with the EMB-711C aircraft, registration PT-NKO. The accident was classified as inflight collision with obstacle.

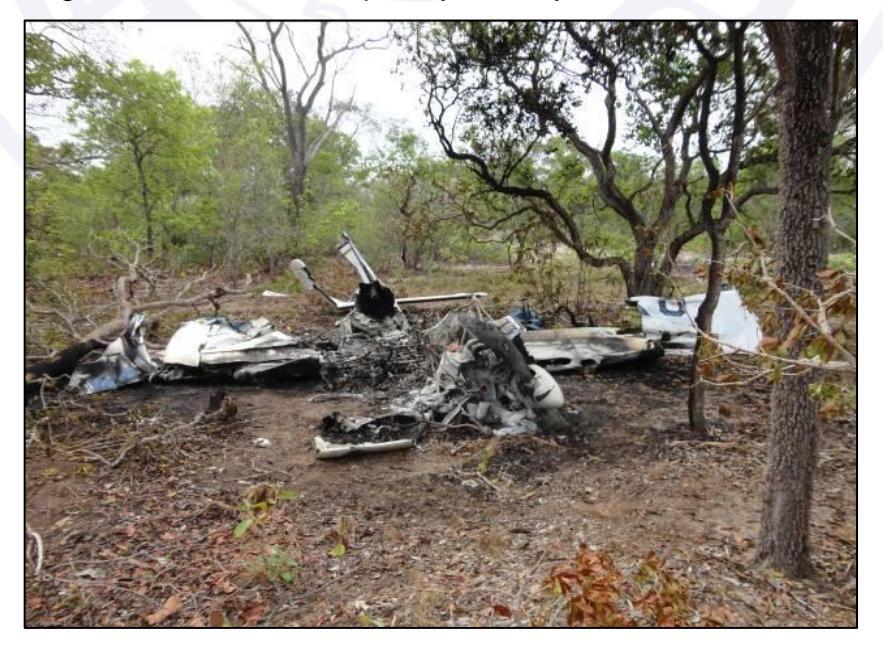
The aircraft caught fire, and was completely destroyed.

Figure 1 – View of the aircraft after the accident.

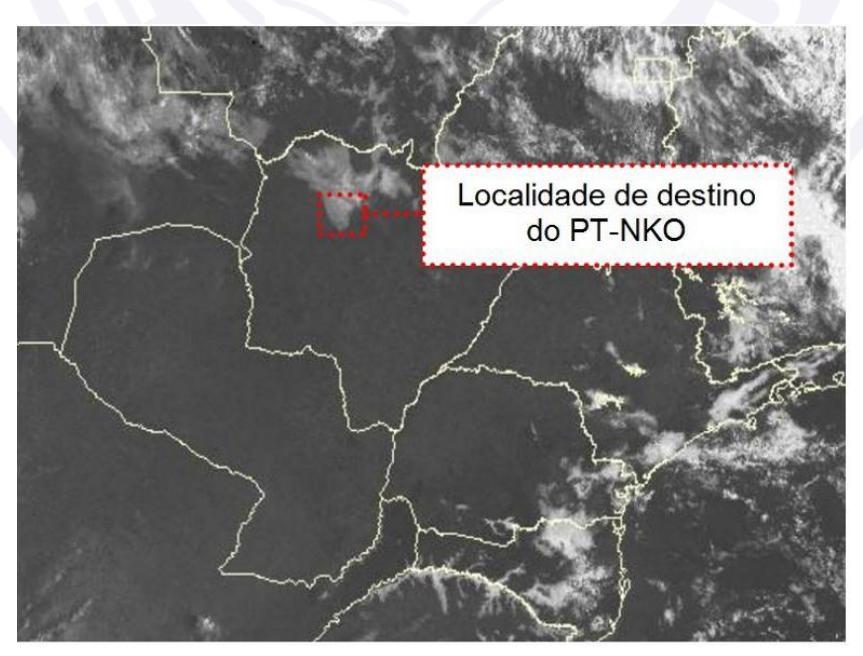
Nevertheless, despite the lack of weather reports relative to the destination aerodrome, the satellite imagery (available on <u>www.redemet.aer.mil.br</u>) showed, at the time of the flight, the presence of concentrated nebulosity exactly over the area where the pilot intended to land (Figure 3).

Figure 3 - Presence of nebulosity (11:00 UTC) over the intended destination of the PT-NKO aircraft around the time of the accident.

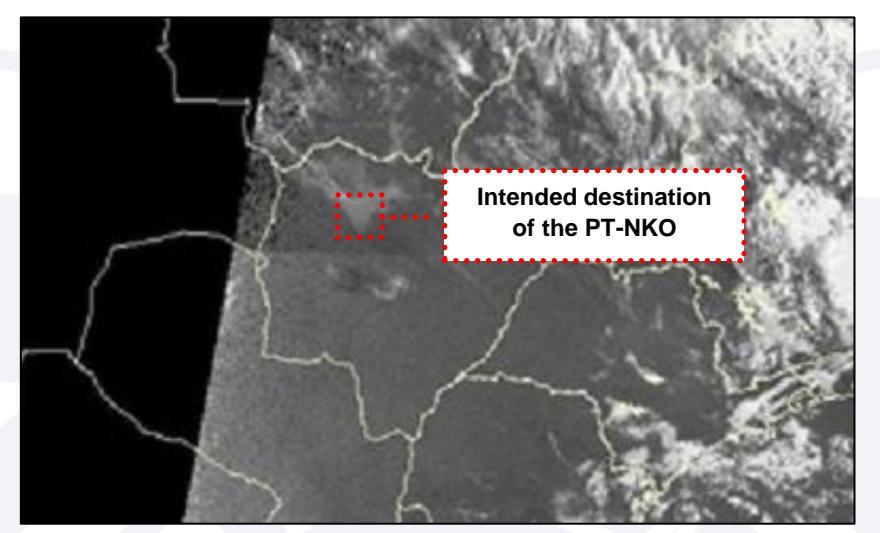
In the satellite image of 09:30 UTC (Figure 4), prior to the aircraft takeoff, it is possible to observe that fog was already present over the destination.

Figure 4 – Nebulosity over the intended destination of the PT-NKO at 09:30 UTC.

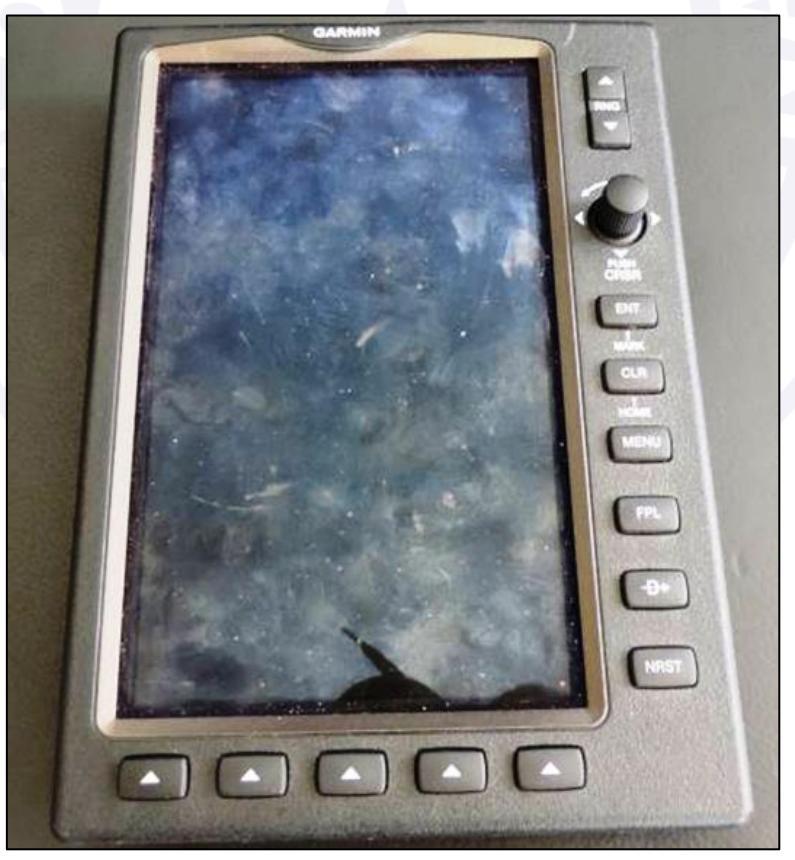
Some pieces of information were gathered from the GPS equipment (Garmin 695, Figure 5), which was thrown out of the aircraft at the moment of the crash and, for this very reason, was not burnt with the remainder of the wreckage.

Figure 5 - GPS of the PT-NKO (Garmin 695).

Since the GPS was damaged, the commission was not able to identify the recording time interval programmed in the equipment.

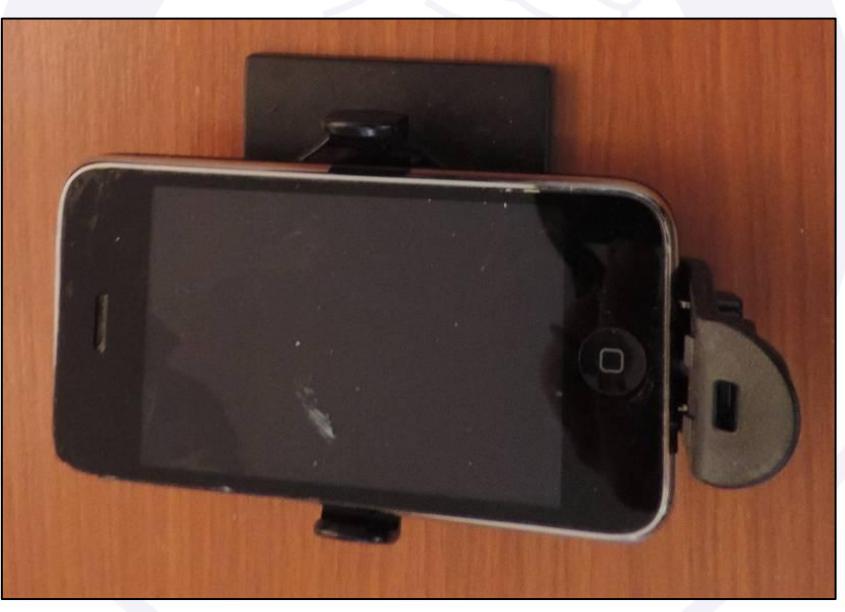
There is no concrete evidence that the pilot might be utilizing an application as a navigation aid at the moment of the accident. However, pilot's friends confirmed that he owned aeronautical utility programs such as artificial horizon, ROTAER consultation, GeoRef maps, etc.

Figure 6 - IPhone in the holder.

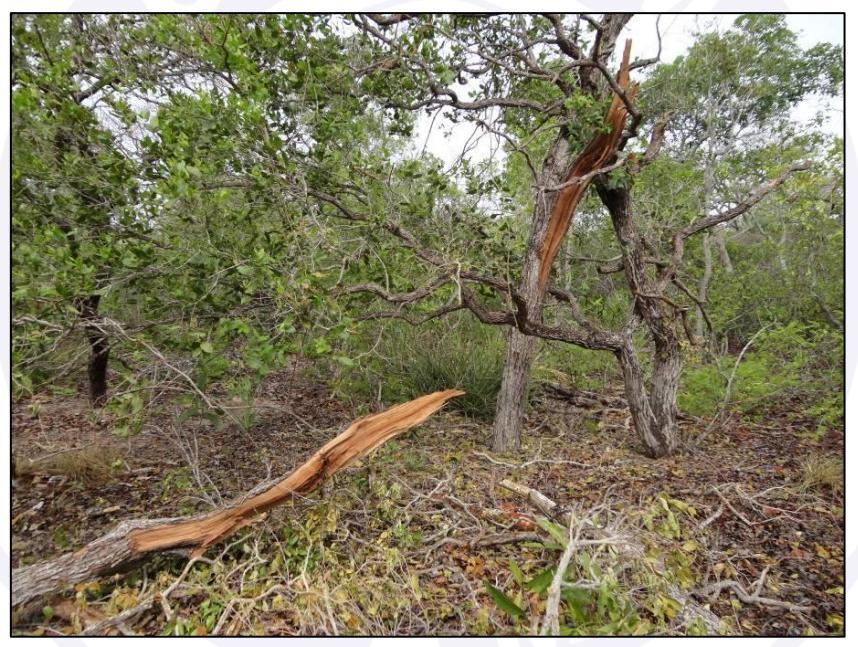
In the second impact with another tree, the aircraft hit a higher section of the branch making it cleave at the junction with the tree trunk, as shown in Figure 7.

Figure 7 - Fracture of the branch, which was detached from the trunk of the tree.

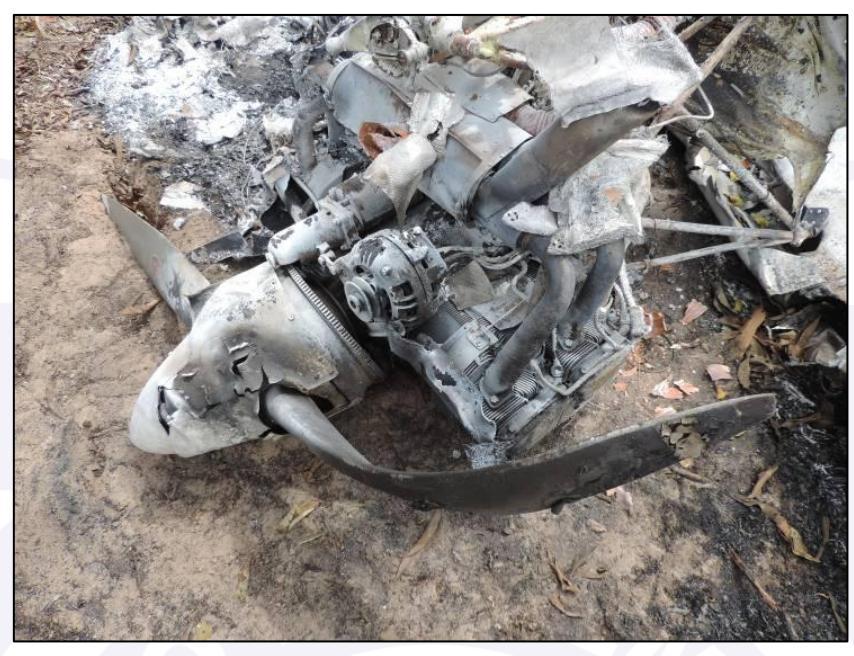
The backward direction of the propeller deformation indicates that the engine had little or no power at the moment of impact (Figure 8).

Figure 8 – Propeller bent backwards.

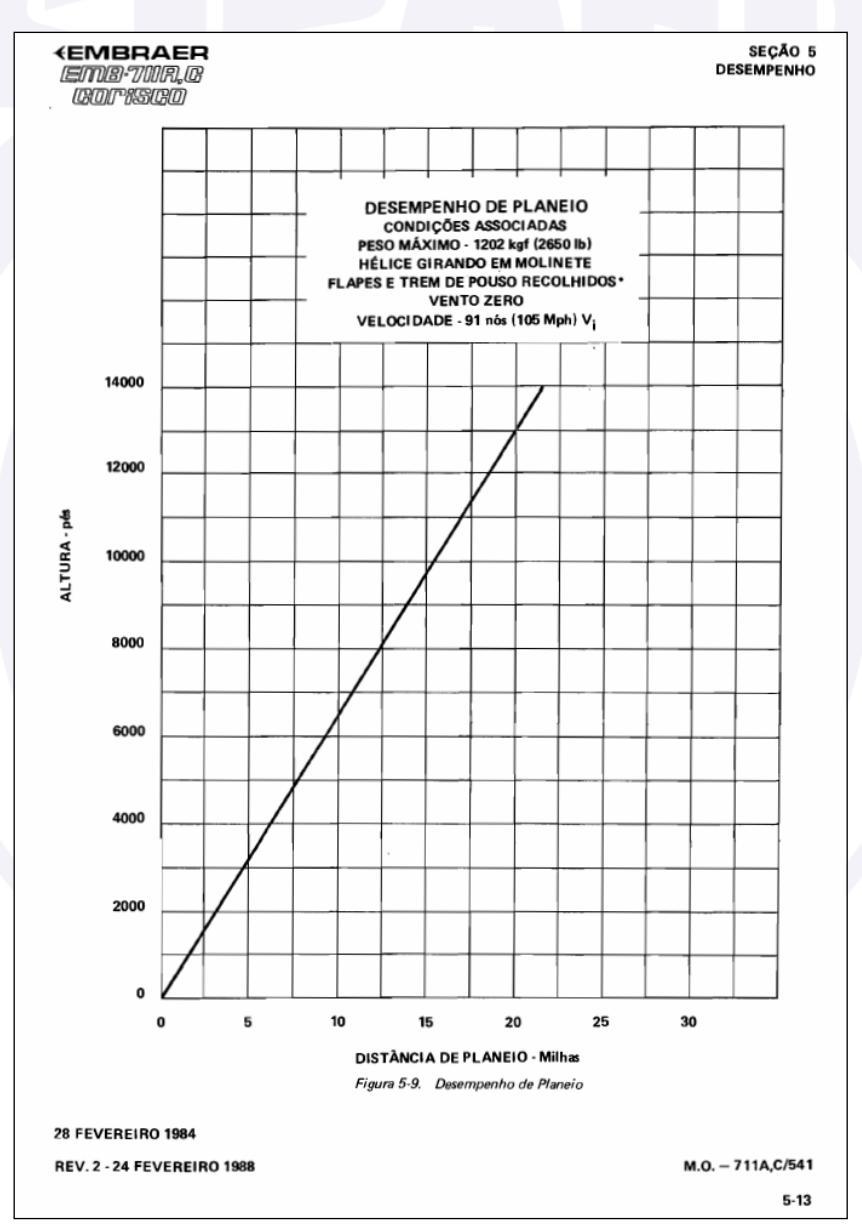
The *Corisco* aircraft Manual of Operations MO 711C Rev. 05, Section 05 – Performance – contains a graph of the aircraft glide performance with the propeller windmilling, with flaps and landing gear retracted, and a weight of 1,202 kg.

From this graph, one determines that, in such condition, the trajectory angle of the *Corisco* is 6.1^o (tangent arc of the height divided by the glide distance in the same measurement unit).

Figure 10 – Graph of the EMB-711C glide performance.

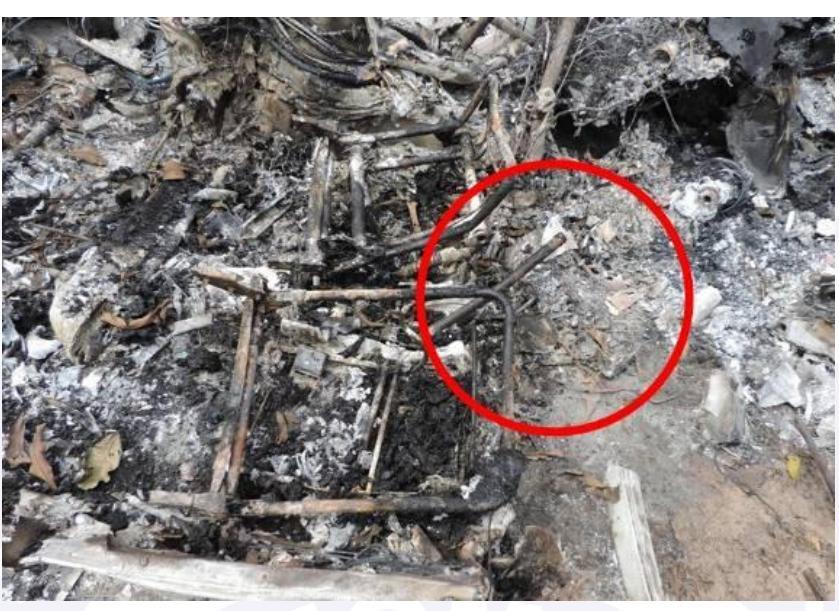
First, the flaps of the accident aircraft were partially deflected, judging from the position of the surfaces and respective control lever (Figures 11 and 12).

Figure 11 – Flap control.

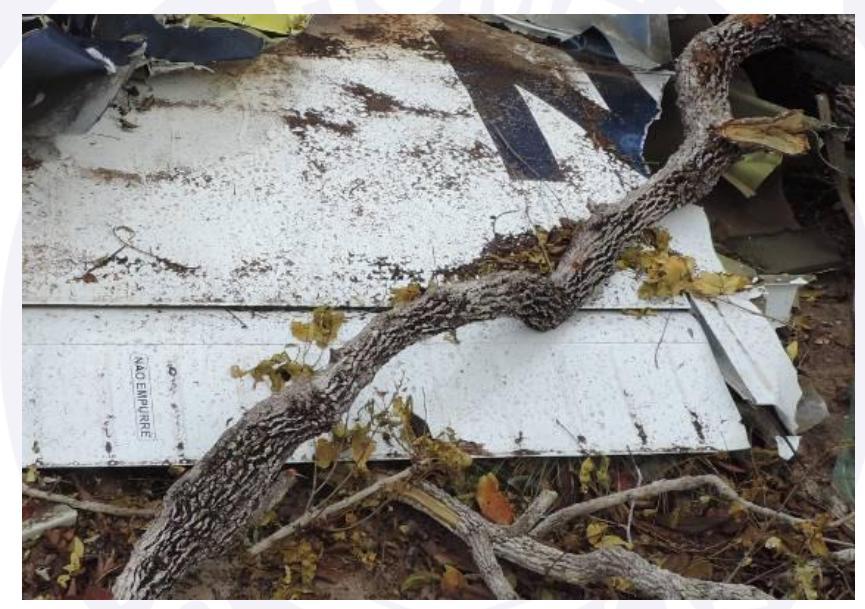
Figure 12 – Position of the right-hand-side flap (10°).

Based on this fact, it is possible to infer that the aircraft was in a condition of drag higher than the one presented in the manual and, therefore, it had to fly with a larger glideangle. Besides, it is not possible to know for sure the status of the engine operation at the moment of the impact. From the damage observed in the propeller, it is known that the engine was not turning with high power, but it is not possible to determine whether the propeller was windmilling or turning at IDLE.

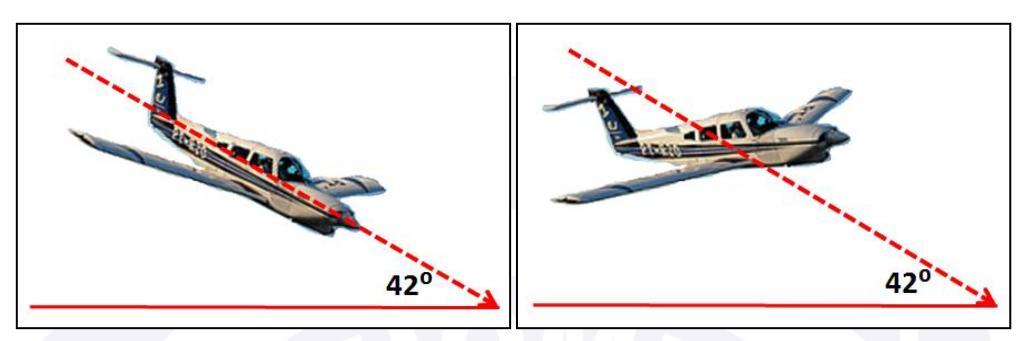
It is worth highlighting that the trajectory-angle of 42° refers to the movement of the aircraft relative to the ground after the collision with the tree, and not to the aircraft pitch-angle.

Figure 13 - two pictures showing the same trajectory angle with different pitch angles.
