COMMAND OF AERONAUTICS AERONAUTICAL ACCIDENT INVESTIGATION AND PREVENTION CENTER

FINAL REPORT A - 223/CENIPA/2013

OCCURRENCE:ACCIDENTAIRCRAFT:PT-CNLMODEL:172ADATE:16DEC2013

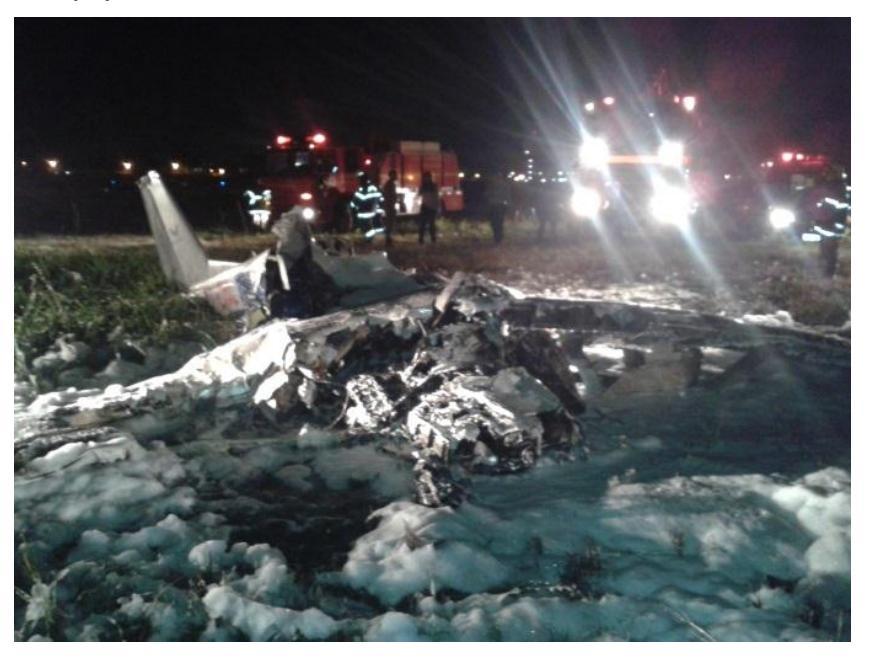
The distribution of the wreckage was of the concentrated type.

The level of destruction and the charred condition of the aircraft hindered a better observation of the equipment and instruments.

Figure 1 – Aspect of the aircraft wreckage.

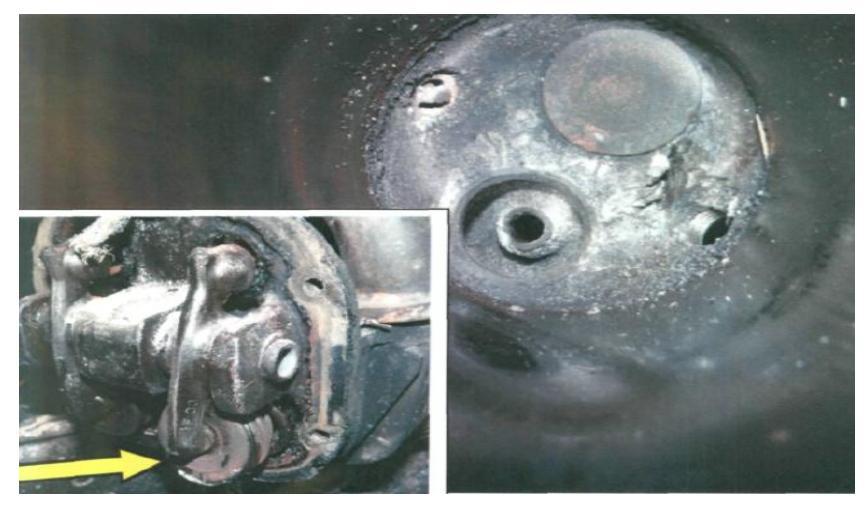
What caused the loss of engine power was a failure of the exhaust-valve head of the cylinder number 6. The valve head was expelled from the cylinder through the exhaust duct. After a period of operation, the valve rod was displaced into the combustion chamber due to the effort made by the rocker arm on its foot. Such displacement was facilitated by high temperature to which it that was exposed, and especially due to the wear sustained by the valve locks.

A deeper research showed that the piston of the cylinder number 6 had marks of impact on its head. After disassembly, a fracture in the cylinder exhaust valve was observed, according to Figures 2 and 3.

Figure 2 – View of the cylinder number 6, without the exhaust valve, and with the exhaust spring caught by the rocker arm.

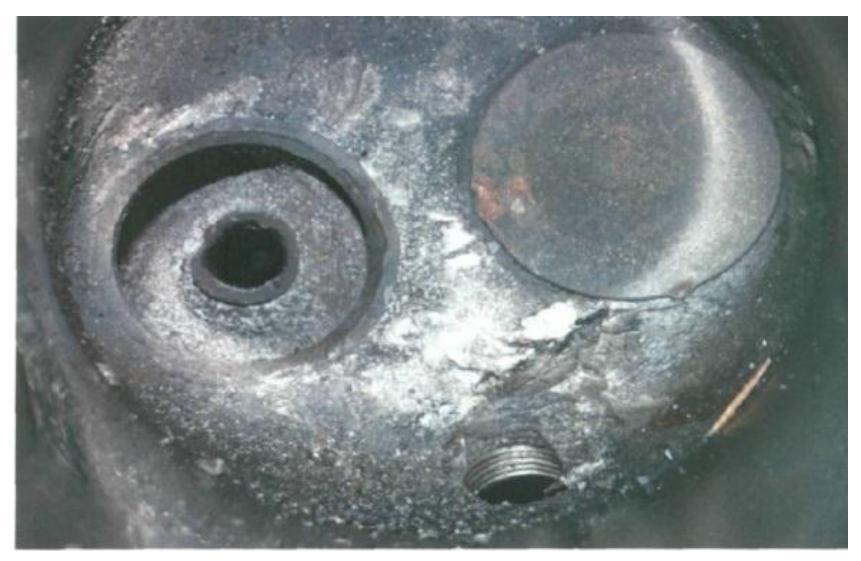
Figure 3 – Cylinder number 6 without the exhaust valve.

It was possible to observe that the exhaust-valve guide was also deformed.

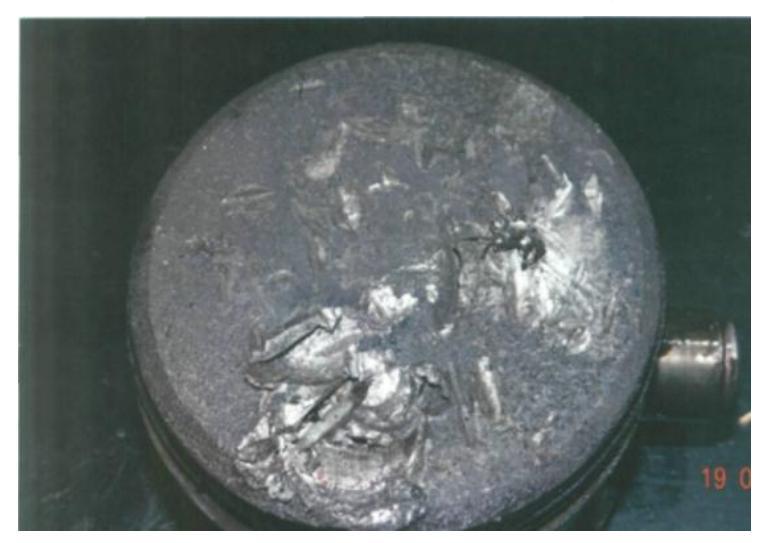
There were marks of impact both on the piston head (cylinder number 6) and on the wall of the respective combustion chamber.

Figure 4 – General view of the piston-head of cylinder number 6.

The damage to piston head of the cylinder no. 6 (Figure 4) showed that the head of the exhaust valve was fragmented by the piston of cylinder, and the residues were expelled through the corresponding exhaust duct.

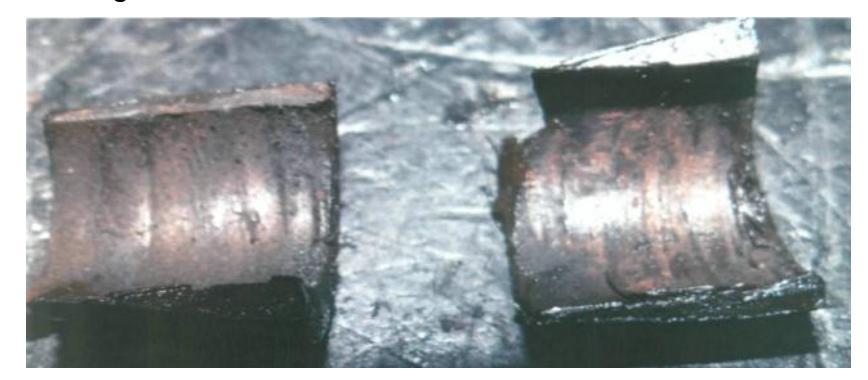
The locks aimed at catching the exhaust-valve rod of the cylinder had signs of wear (without the projection that allow them to connect with the valve rod), in addition to being fractured, as seen in Figure 5.

Figure 5 - Wear/fracture observed in the locks of the cylinder number 6 exhaust valve.

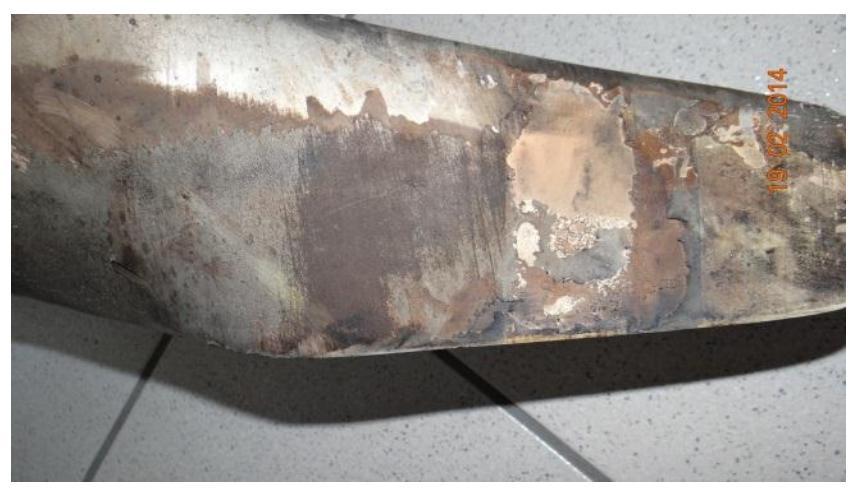
The blades of the propeller assembly had transversal scratches, an indication that they were rotating at the moment of impact with the ground (Figure 6).

Figure 6 – Transversal marks on the propeller blade.

The deformations and bending observed in the propeller blades indicated that the engine was not developing high power at the time of collision.

The transversal marks, deformations, and bends found on the propeller blades showed that at the moment of collision with the ground, the engine had rotation, but was not developing high power.

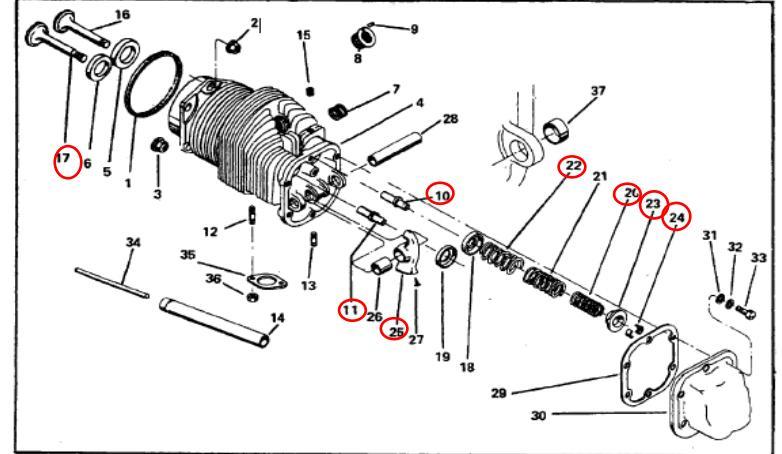
The exhaust valve locking assembly consists of three mutually concentrical springs (items 20, 21 and 22), a washer (item 23) and two retention latches (key 24), as shown in Figure 7.

Figure 7 – Exploded view of the cylinder, showing the exhaust valve, rocker arm, and exhaust valve guide with the respective valve retention assembly.

For this reason, the aircraft engine manufacturer recommends by means of the Service Bulletin 97-6B of 18 Nov 2009 (item 9, page 1), that on the occasion of the overhaul the retention locks of the intake and exhaust valves be replaced, as well as all engine exhaust valves (item 17, Figure 7).
