# COMANDO DA AERONÁUTICA <u>CENTRO DE INVESTIGAÇÃO E PREVENÇÃO DE</u> <u>ACIDENTES AERONÁUTICOS</u>

# FINAL REPORT A-155/CENIPA/2020

ACCIDENT PR-HFT C525 22DEZ2020

This Final Report pertains to the accident involving the Cessna aircraft PR-HFT, model C525, which occurred on 22 December 2020. The occurrence was classified as "[SCF-NP] System/component failure or malfunction" and "[RE] Runway excursion".

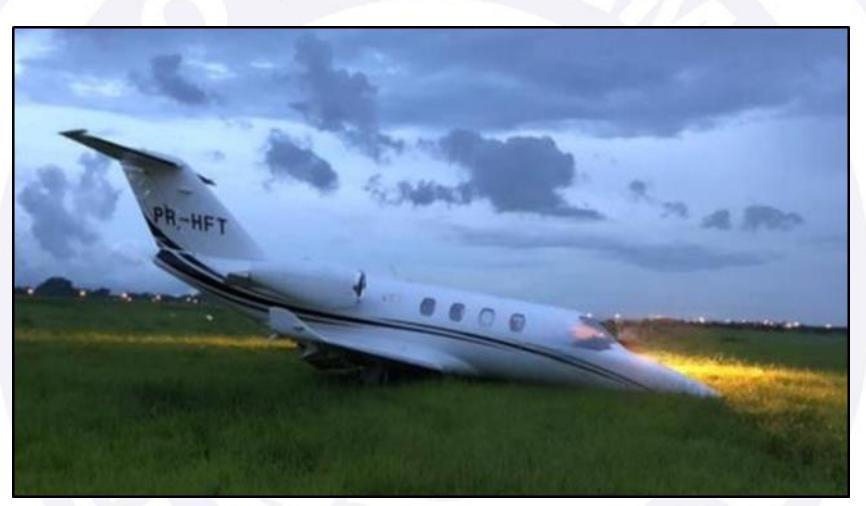
Figure 1 - Final position of the aircraft

The aircraft sustained substantial damage to the nose landing gear, radome, antennae of the VHF COM, DME, and Marker Beacon, as well as to several fairings on the lower fuselage.

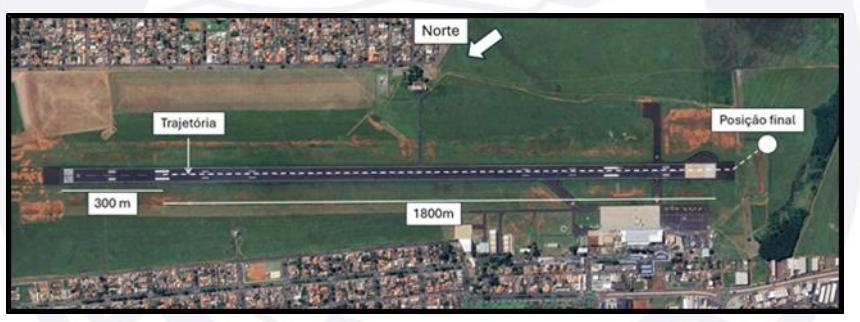
Upon analyzing the camera footage, the Investigation Committee estimated that touchdown occurred approximately 300 meters from the threshold of runway 04, leaving a remaining distance of about 1,800 meters for the aircraft to come to a complete stop.

Figure 4 - Croquis of the accident. Source: adapted from Google Earth.

After touchdown, the aircraft traveled in a straight line along the entire remaining length of the runway without adequately decelerating, ultimately overrunning the opposite threshold and coming to a stop at a distance of approximately 50 meters beyond the departure end.
