FINAL REPORT A-125/CENIPA/2021

OCCURRENCE: AIRCRAFT: MODEL: DATE: ACCIDENT PR-HHH R44 II 08NOV2021

This Final Report pertains to the November 8, 2021 accident involving the model R44-II aircraft of registration marks PR-HHH. The occurrence was typified as "[SCF-PP] Powerplant failure or malfunction."

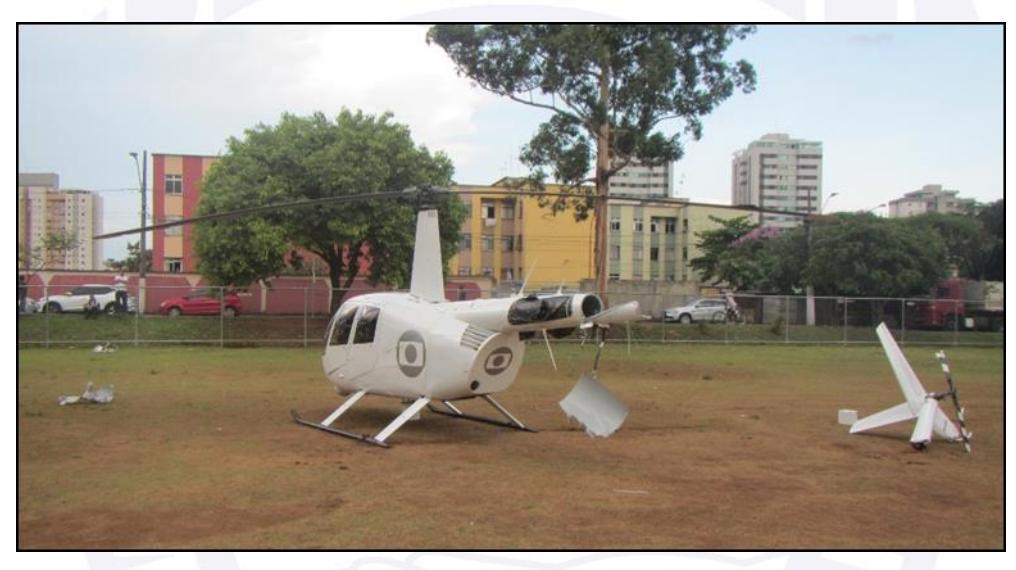
Figure 1 – Rear view of the aircraft after coming to a complete stop.

The main rotor blades struck the aircraft's tail cone, causing it to separate.

This control input caused the main rotor disc to tilt excessively rearward, resulting in the main rotor blades striking the aircraft's tail cone, severing it and triggering the entire sequence of damage observed.

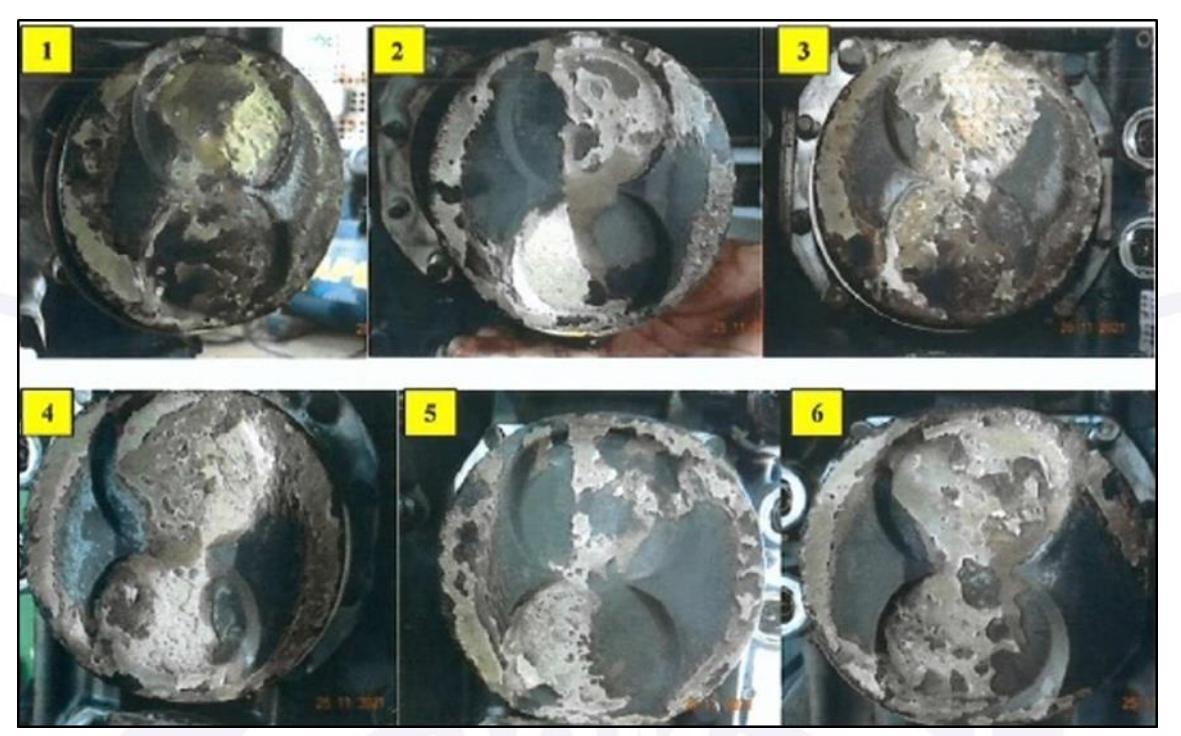
This condition was consistent with the presence of carbon deposit fragments detached from inside the combustion chamber, which may have remained trapped between the valve and its seat.

During the examination of the cylinders and the combustion chamber, one observed that there was a significant amount of carbon buildup on the cylinder heads (Figure 2), as well as clear evidence of pre-ignition and detonation in all six cylinders.

Figure 2 – View of the heads of the six engine pistons, numbered, showing the significant amount of carbon deposits accumulated on them.

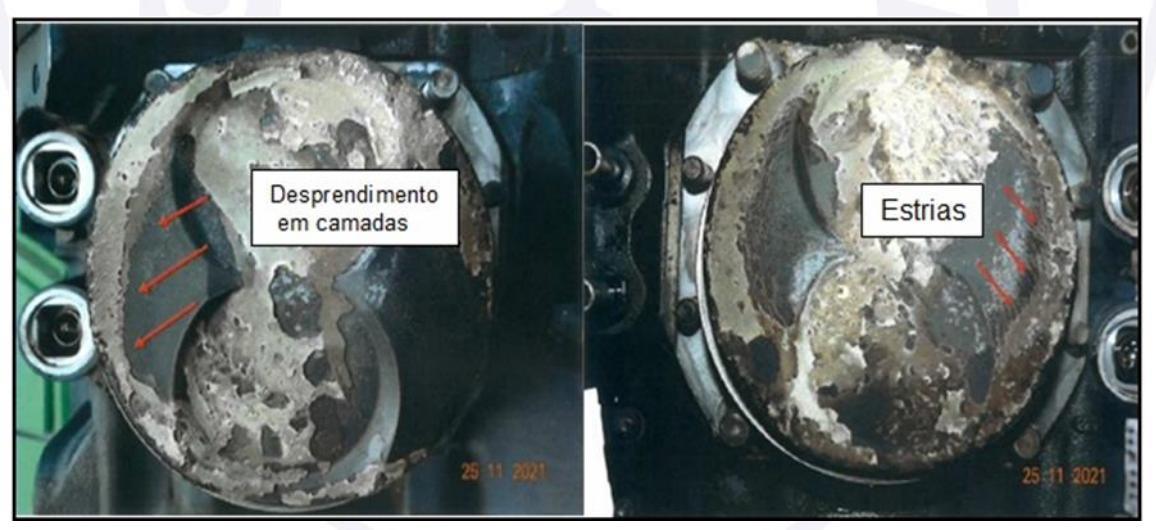
The engine analysis considered that part of the carbon deposits found on the piston heads had detached and subsequently settled on the upper surfaces of the intake valves, preventing proper sealing and disrupting the combustion cycle, leading to abnormal engine operation (Figure 3).

The images in Figure 3 show scoring marks that may indicate the cylinders were in an early stage of detonation.

Figure 3 – View of the heads of two pistons, showing evidence of detached combustion residues.
