# FINAL REPORT A - 041/CENIPA/2019

OCCURRENCE: AIRCRAFT: MODEL: DATE: ACCIDENT PR-RVO A188B 11MAR2019

This is the Final Report of the 11MAR2019 accident with the A188B aircraft model, registration PR-RVO. The accident was classified as "[LALT] Low Altitude Operations".

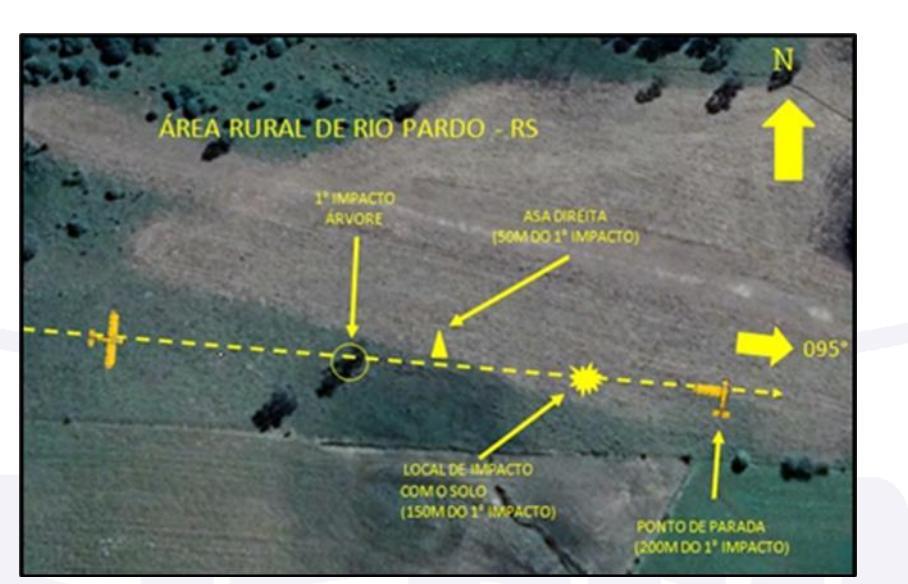
The distribution of the debris was linear (Figure 1).

Figure 1 - Trajectory and layout of the aircraft debris.

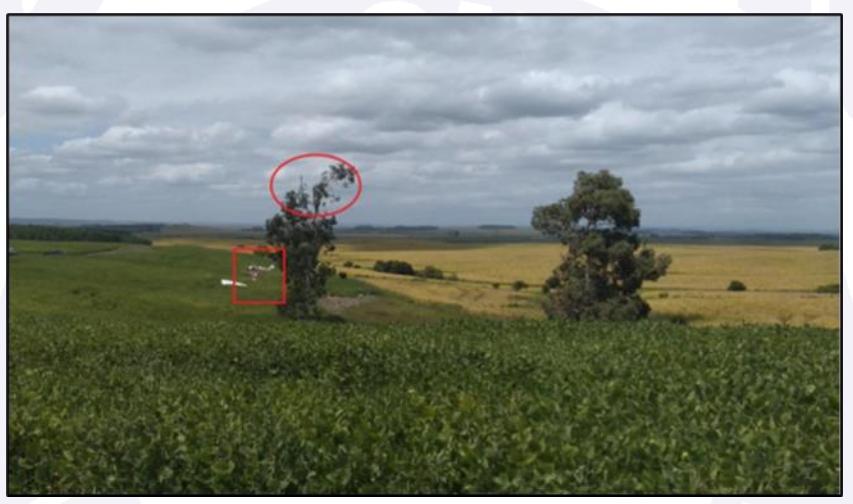
Figure 2 shows the point of the first impact and the place where the aircraft stopped.

Figure 2 - point of the first impact and the place where the aircraft stopped.

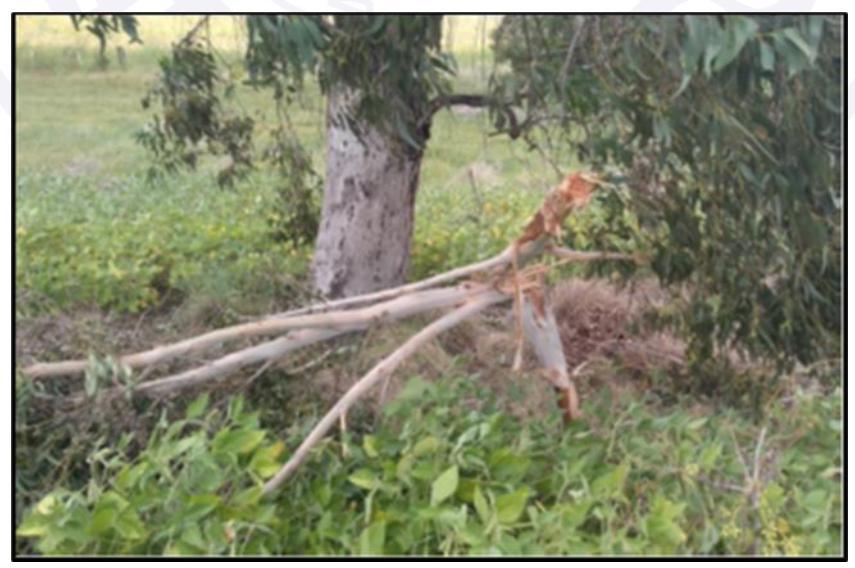
Due to the impact, parts of the tree were torn off, as seen in Figures 3 and 4.

Figure 3 - Tree branch torn off due to the impact.

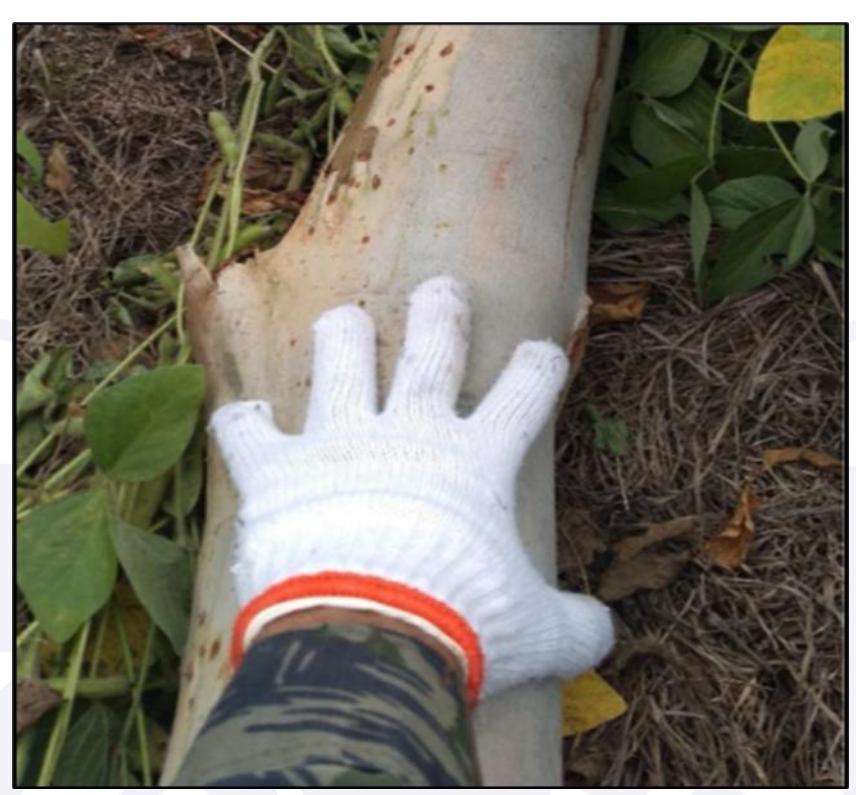
Figure 4 - Upper part of the tree trunk torn off after the impact.

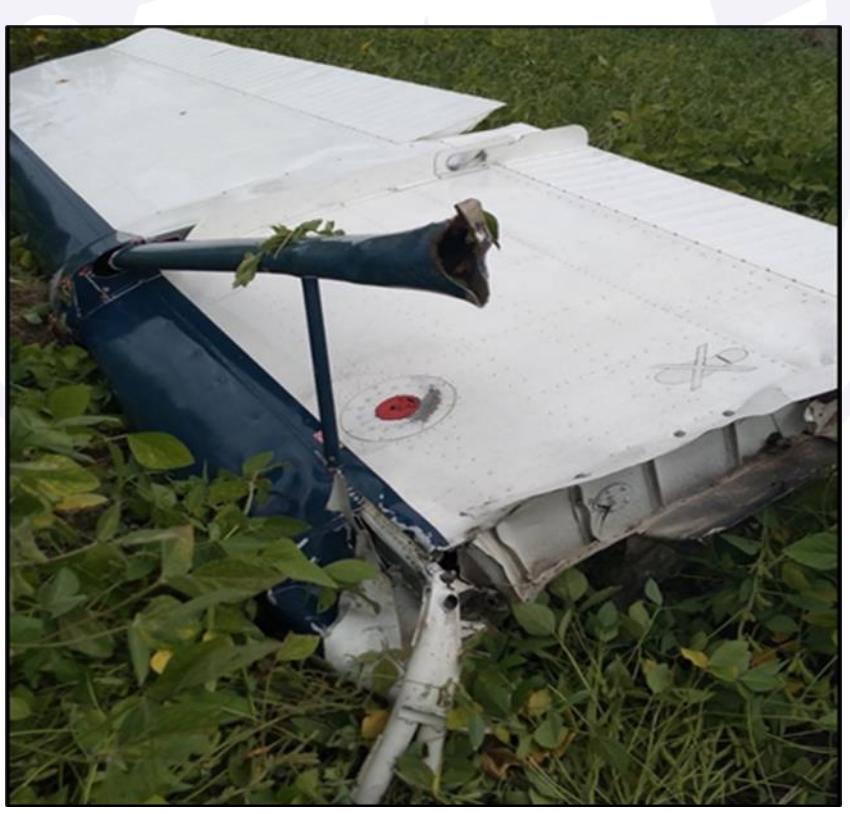
After the impact, the right wing separated from the aircraft and was found approximately 150 meters from the fuselage. Small fragments of the tree were observed together with the twisted metal, at the point of impact between the wing and the tree (Figure 5).

Figure 5 - Part of the wing detached when colliding with the tree.

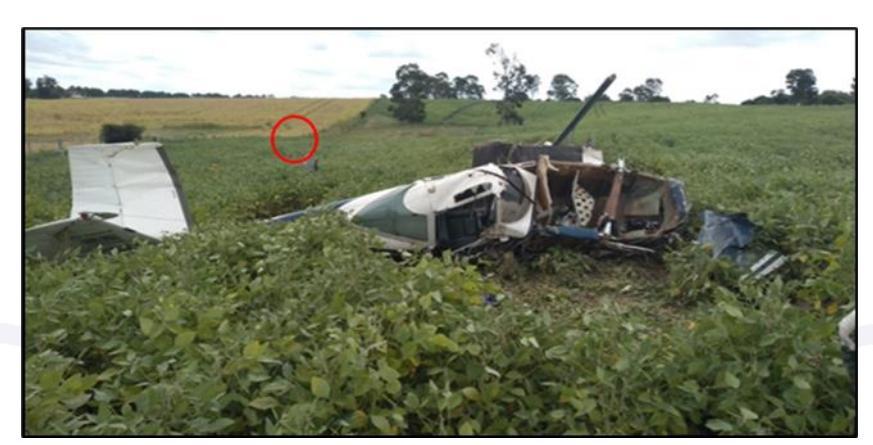
The second impact hit the ground and separated the engine from the rest of the fuselage (Figure 6).

Figure 6 – The aircraft after total stop. The red highlight shows the place where the engine was found.

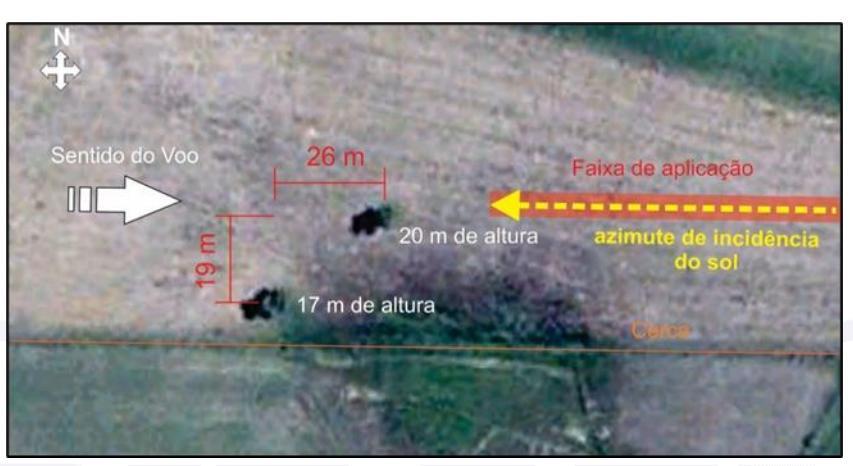
Upon analyzing the characteristics of the application area, the Investigation Team found that there were two trees (eucalyptus) of 20 and 17m high, one in the alignment of the application range, while the other was 19m to the right and 26m before (Figure 7).

Figure 7 - Position of trees in relation to the application range.

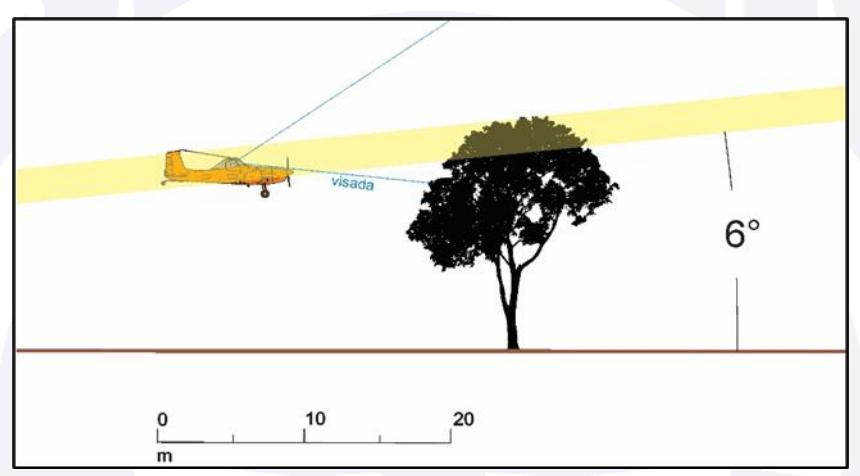
The sunrise occurred at 0929 (UTC). At the moment of the aircraft's impact (0945 UTC), the sun was at azimuth 089° and with an elevation of 06°. In that position, the sun fell directly on the pilot's field of view, affecting visibility ahead (Figure 8).

Figure 8 - Vertical section of the angle of incidence of sunlight in relation to the aircraft and the obstacle.

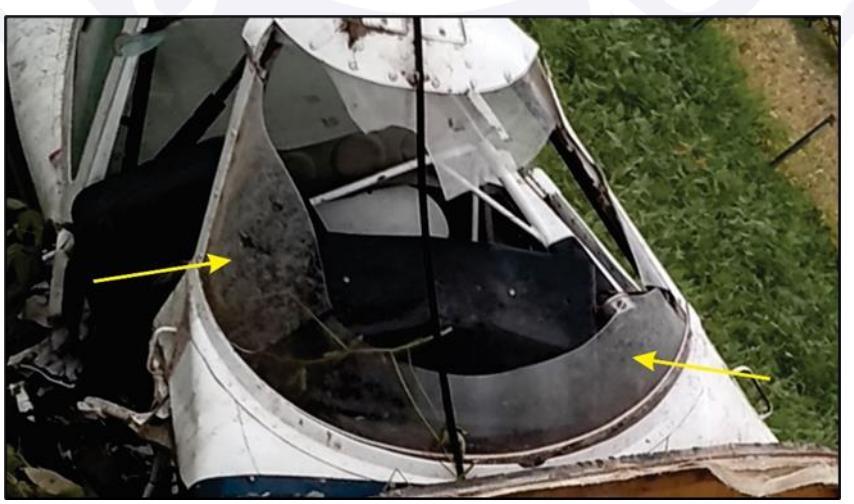
When analyzing the fragments of the aircraft's windshield, it was observed that there was a significant amount of dust accumulated in the regions close to the edges. However, due to fragmentation, it was not possible to check the condition of the front part of the windshield (Figure 9).

Figure 9 - Detail of the accumulated dust on parts of the windshield.

The visual difficulty generated by the glare of the sunshine can be exacerbated if the aircraft's windshield is covered with agricultural residues, insects, dirty or damaged.

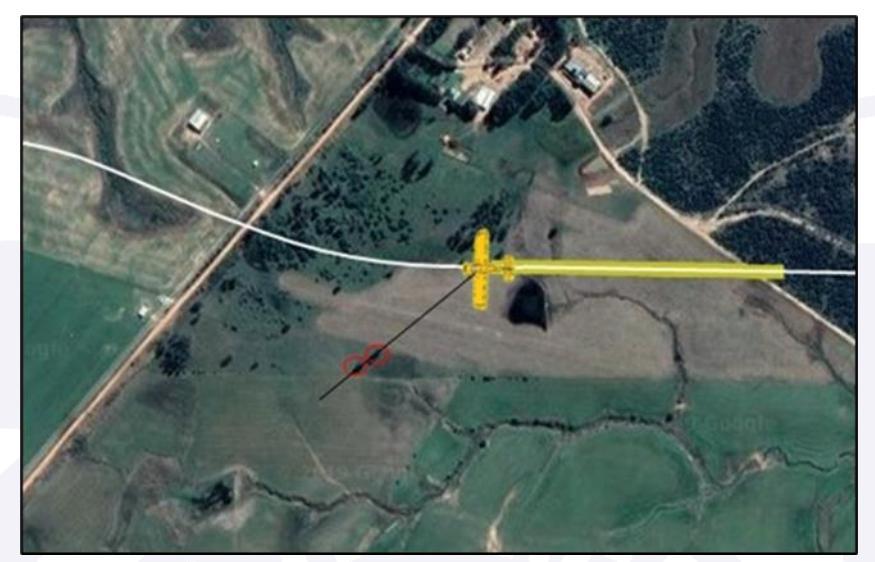
The pilot performed the first application pass in the opposite direction to the moment of impact (with the sun on his back). When finishing this passage, in the position where it is usual for the agricultural pilot to observe the side to which he intends to turn for the next passage, it is observed that the position of the trees in relation to the aircraft resulted in an alignment that may have induced the pilot to identify just one tree.

Figure 10 – Possible pilot's line of sight when "clearing the area".

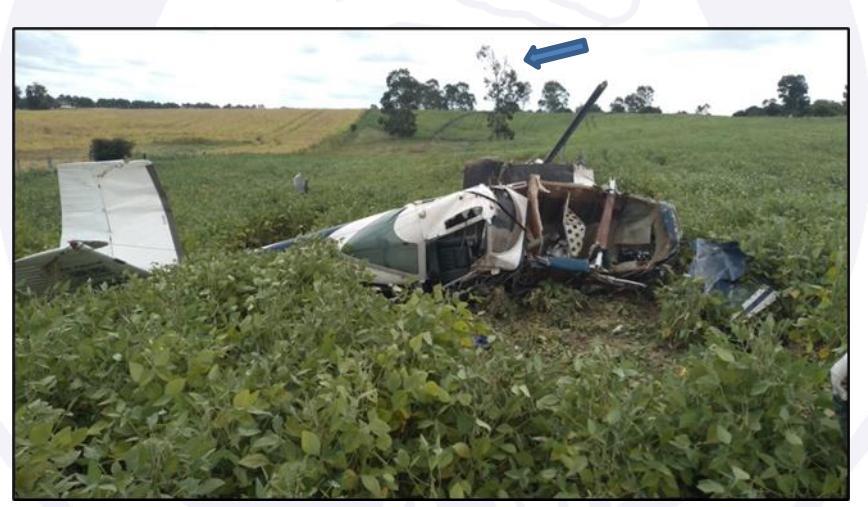
Furthermore, a characteristic of the impacted tree, in relation to the closest one, is that it had less dense foliage and, therefore, did not completely block the incidence of sunlight (Figure 11).

Figure 11 – Detail of the foliage density of the impacted tree in relation to the others.

To minimize the effects of the sun's glare on vision, it is recommended to wear appropriate sunglasses, as well as to avoid the use of light-colored clothing, which can create a reflection on the windshield or on the instrument panel. It was not possible to specify, however, whether the pilot was wearing a visor or sunglasses at the time of the accident.

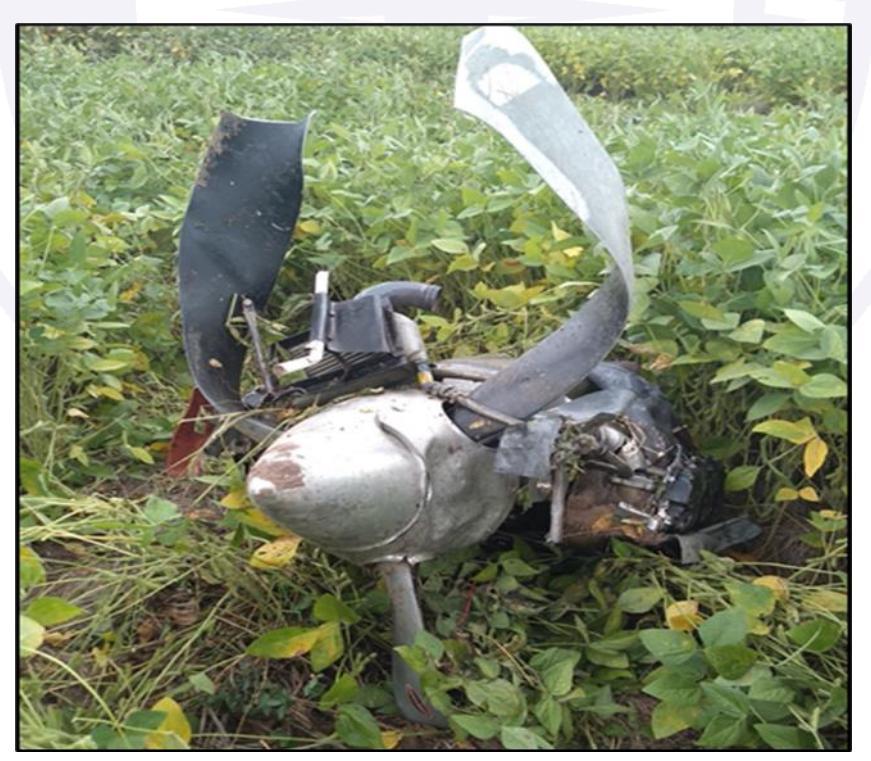
The components examined and/or tested did not show signs of malfunction. All the evidence found indicated that the thruster developed power at the moment of the first impact.

Figure 12 shows the aircraft's powertrain, with deformations in the propeller blades which indicated that it was developing power at the time of the accident.

Figure 12 - Aircraft engine and propeller with typical deformations of impact with power.

The examinations and tests carried out on the powerplant that equipped the aircraft showed that its components did not show signs of malfunction and that the type of deformation found in the propeller blades indicated that the propeller was developing power at the moment of impact.

Thus, the possibility that an engine failure contributed to this accident was ruled out.

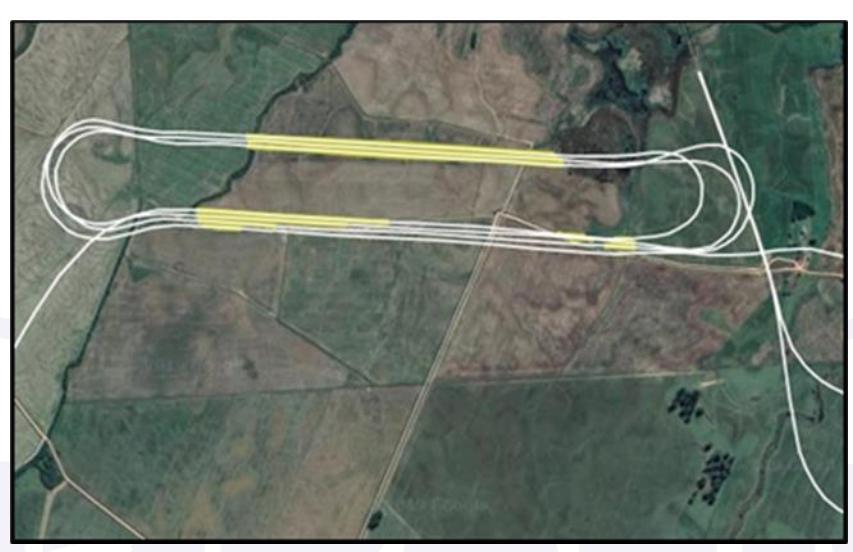
Figure 13 shows an image based on data extracted from the aircraft's DGPS. It shows the plane's trajectory from the take-off, flight in the first area, and abandonment to the second application area.

Figure 13 - First application area (before the accident).

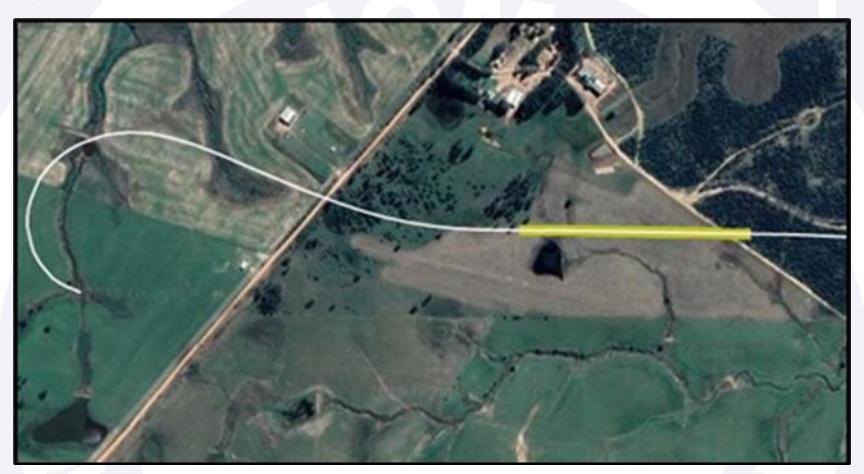
Figure 14 shows the aircraft entering the second operating area (accident area), an application pass (in yellow), a reversal curve and the end of the DGPS recording.

Figure 14 - First pass in the application area where the accident occurred.

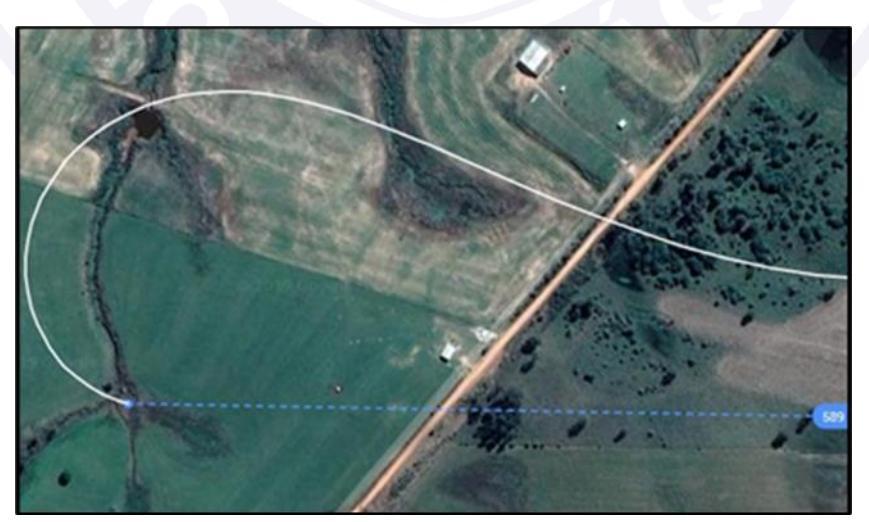
After completing the DGPS recording, the aircraft traveled 589m to the first impact point. In this trajectory, it was estimated that the plane flew with the heading 095° (Figure 15).

Figure 15 - Estimated trajectory between the end of the DGPS recording and the first impact on the tree.
