FINAL REPORT A-133/CENIPA/2021

OCCURRENCE: AIRCRAFT: MODEL: DATE: ACCIDENT PR-YRH A320-251N 25NOV2021

This Final Report pertains to the November 25, 2021 accident involving the model A320-251N aircraft of registration marks PR-YRH. The event was typified as "[SCF-NP] System/Component Failure or Malfunction (Non-Powerplant)" and "[EVAC] Evacuation."

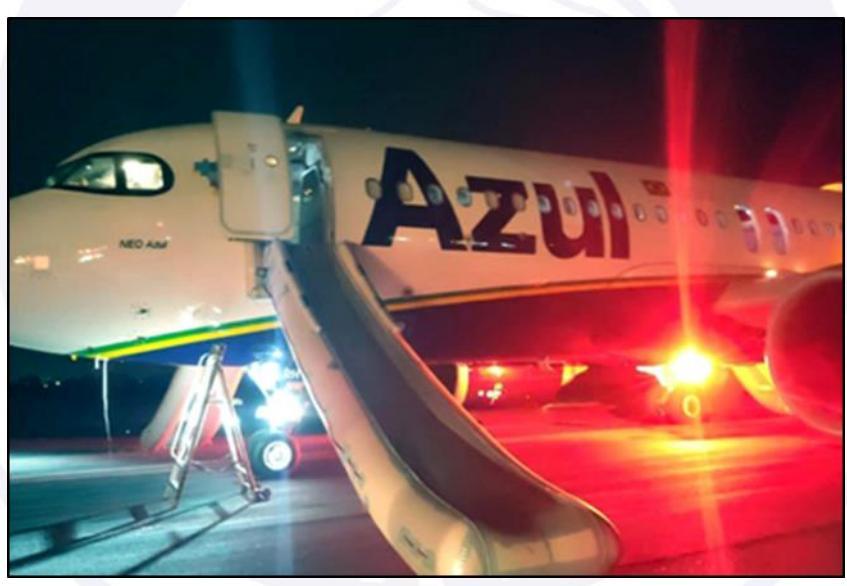
After the complete stop on the runway, the evacuation of the aircraft took place without being commanded by the pilots, with the engines still running at reduced power.

Figure 1 – Image of the aircraft on the runway with the 1L escape slide extended (Door Fwd L).

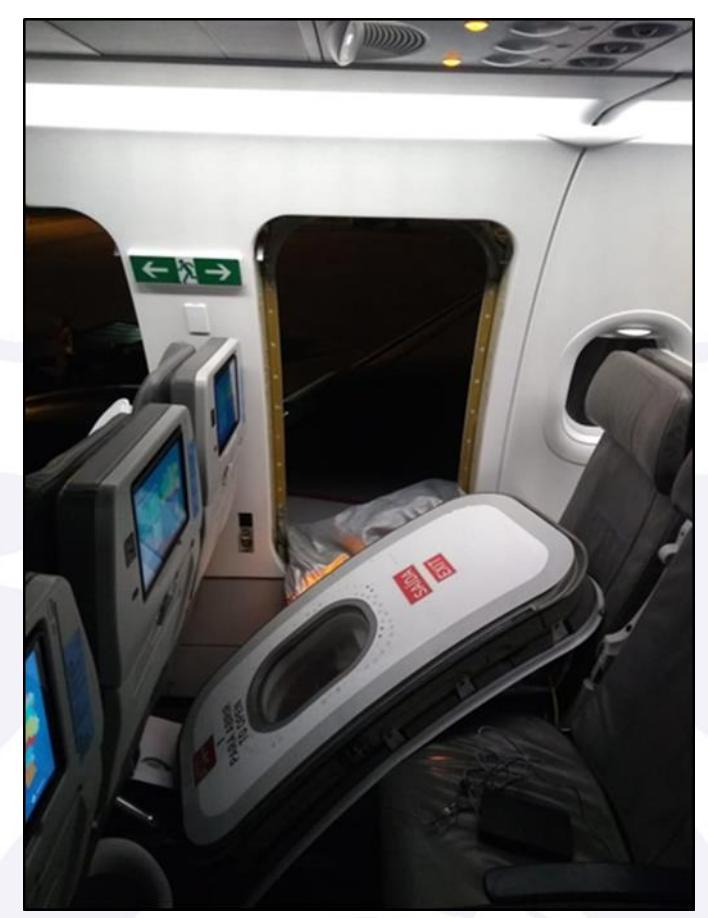
Figure 2 – Emergency exit (Emer Exit Aft R) opened by one of the passengers during evacuation from the aircraft.

Also according to the CC, in addition to the turmoil caused by passengers who believed the aircraft was on fire, another factor contributing to his decision to begin the evacuation through door 1L was the perception that one of the passengers had already opened the emergency window, which made the situation harder to control.

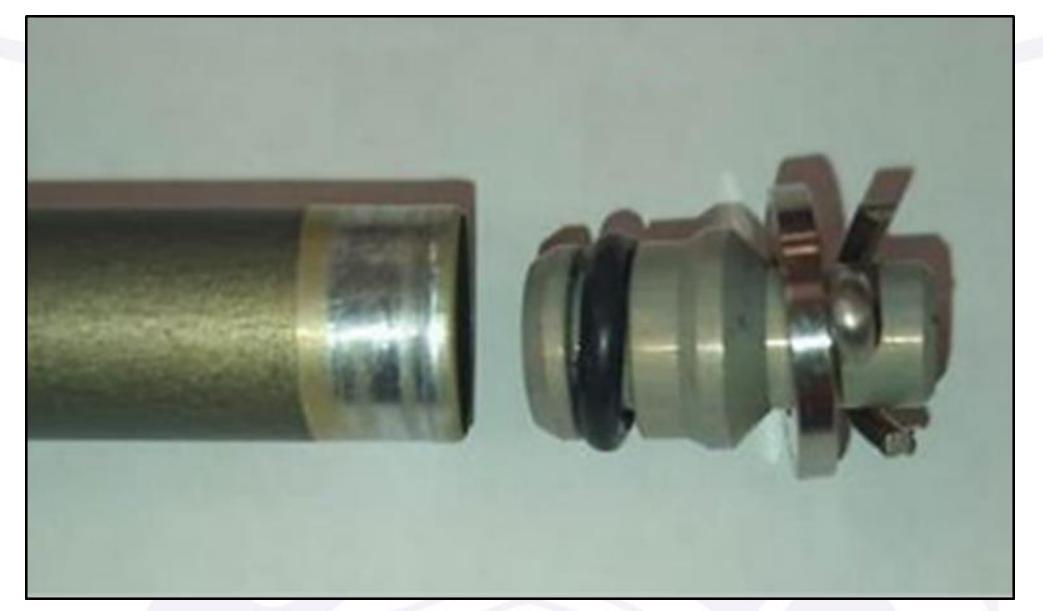
Subsequent examinations following the accident revealed that a small component of one of the hydraulic system sensors had detached from the assembly and fallen into the oil reservoir, triggering the HYDRAULIC Y RSVR LO LVL warning light. Therefore, it was a case of an indication problem, with no actual fluid leakage.

Eaton Aerospace Group, the sensor manufacturer, was unable to determine the cause of the component's detachment but reported having no previous records of similar occurrences.

Figure 4 – On the right, the component of the hydraulic system sensor that detached and fell into the oil reservoir, causing the low-level warning light of the yellow hydraulic system to illuminate.

Post-accident examinations showed that a small component of one of the hydraulic system sensors had detached from the main part and fallen into the oil reservoir, triggering the HYDRAULIC Y RSVR LO LVL warning light. It was, therefore, an indication issue, with no actual leakage.

When consulted about this failure, the sensor manufacturer reported being unable to identify the cause of the component detachment and added that there had been no previous reports of similar occurrences.

Thus, this failure was not characterized as a latent unsafe condition requiring corrective action.

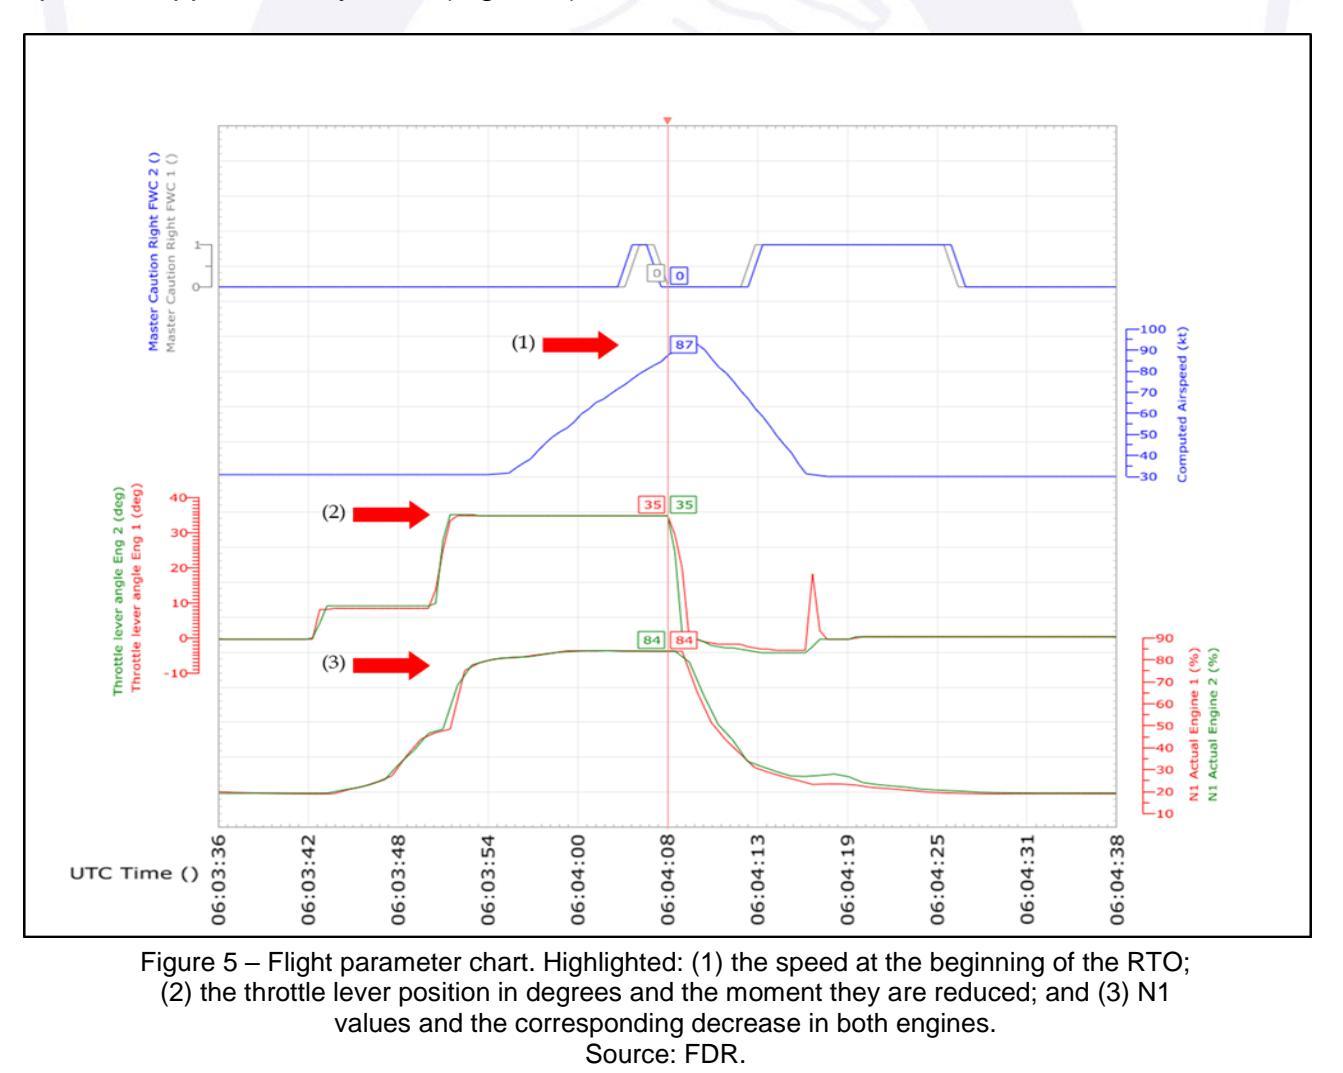
During the takeoff roll on Runway 35 at SBCY, the pilots received a low-level warning for the yellow hydraulic system (HYDRAULIC Y RSVR LO LVL) and rejected the takeoff.

According to the FDR, the rejected takeoff occurred during the low-energy phase, at a speed of approximately 90 kt (Figure 5).

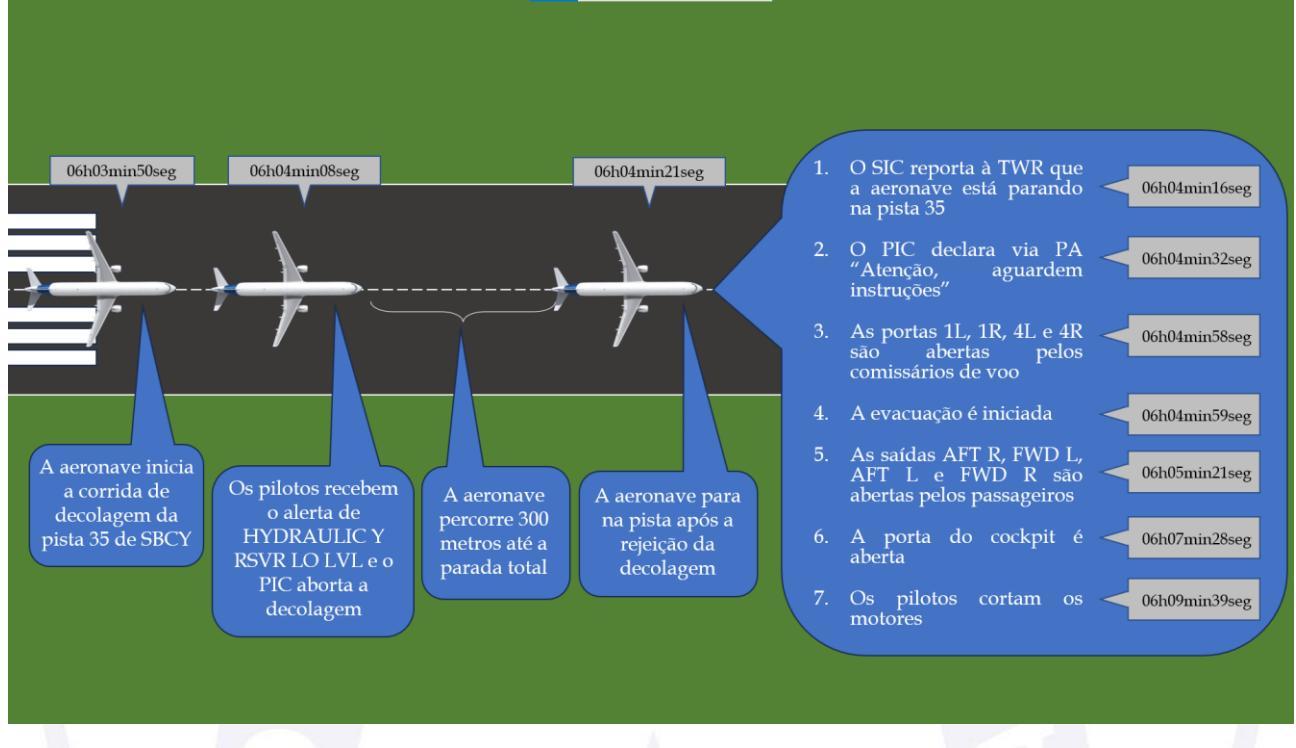
At 06:04:58 UTC, door 1L was opened by the Lead Flight Attendant (CC). Subsequently, the other flight attendants followed the CC's action and opened their respective doors while the engines were still running, without any command from the flight crew and without verifying the conditions that would warrant an evacuation without command (i.e., evacuation based on evidence).

Figure 7 – Timeline and sequence of the RTO followed by evacuation of PR-YRH on runway 35 at SBCY.
