FINAL REPORT IG - 042/CENIPA/2019

OCCURRENCE: AIRCRAFT: MODEL: DATE: SERIOUS INCIDENT PR-AQV ATR-72-212A 12MAR2019

This is the Final Report of the 12MAR2019 serious incident with the ATR-72-212A aircraft model, registration PR-AQV. The serious incident was classified as "[SCF-PP] System/Component Failure or Malfunction Powerplant – Engine Failure on the Ground".

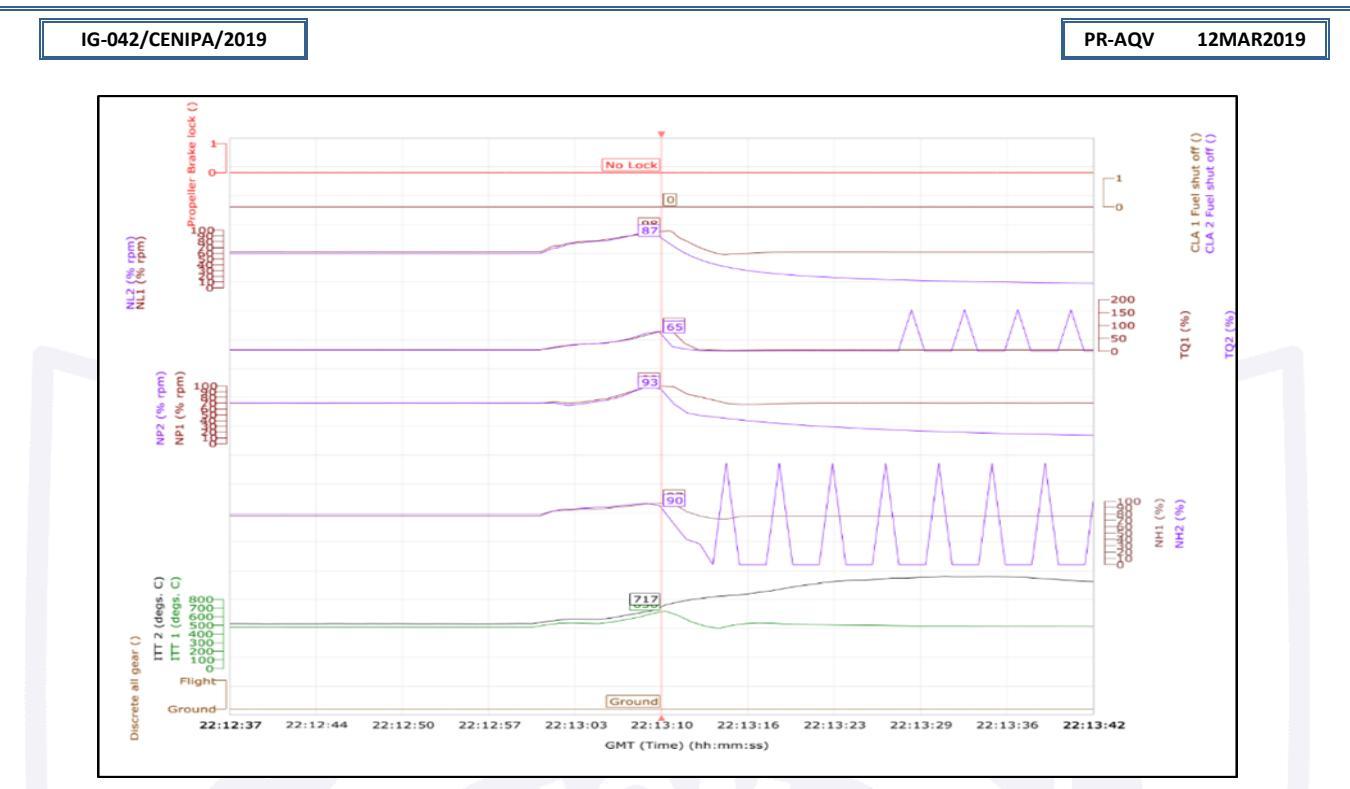
- when starting the engine acceleration, at 22h13min10sec (UTC), there was a simultaneous drop in the indications of NL2, NP2, TQ2, NH2 and an increase in the indication of ITT2. Such facts pointed to a sudden engine failure causing an abrupt loss of performance (Figure 3);

Figure 3 - Graph of engine parameters. Information taken from the FDR.

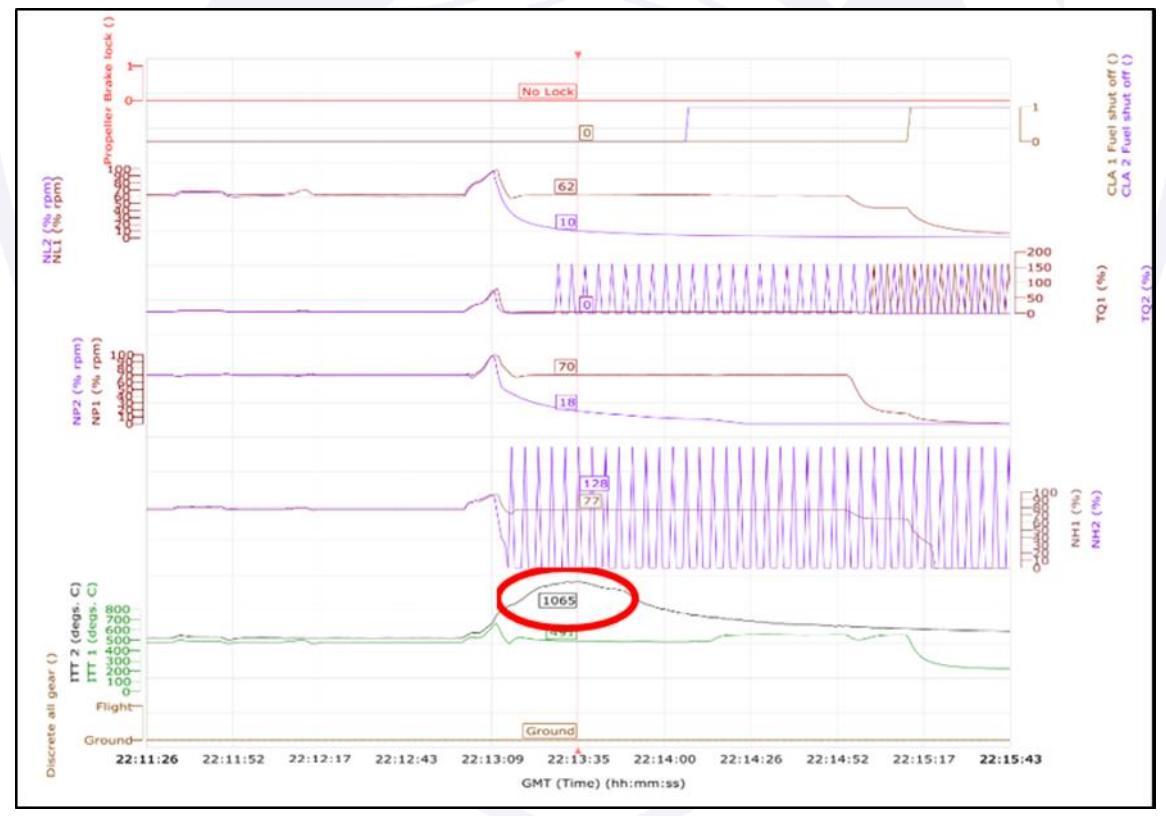
- the peak of ITT2 reached 1,065°C, approximately, 25 seconds after the beginning of the engine failure (Figure 4);

Figure 4 - Graph of engine parameters. Information taken from the FDR.

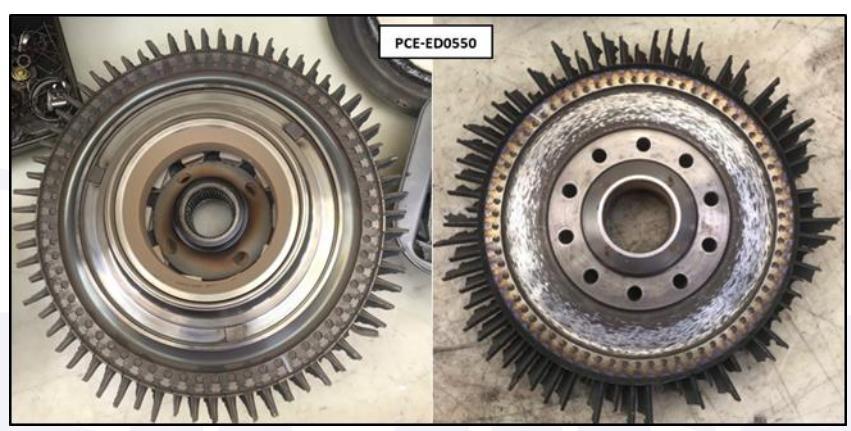
• Generally presented separations in all blades of the Power Turbine (PT) Disks 1 and 2, and the Low Pressure (LP) Turbine Disk, in different lengths, caused by the impact of debris (Figures 6 and 7).

Figure 6 - Power Turbine Disks 1 and 2 of the SN PCE-ED0550 engine with all blades fractured.

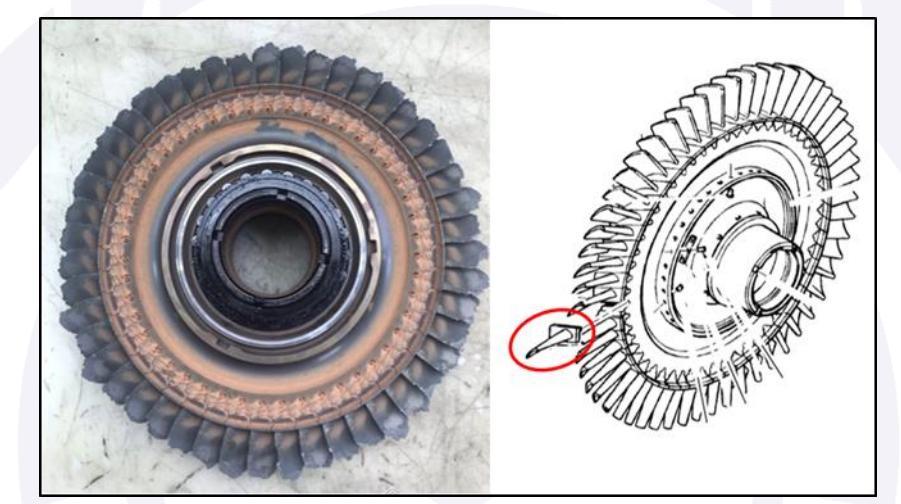
Figure 7 - Low Pressure Turbine Disk removed from the SN PCE-ED0550 engine with all blades fractured at the ends and an intact disk design.

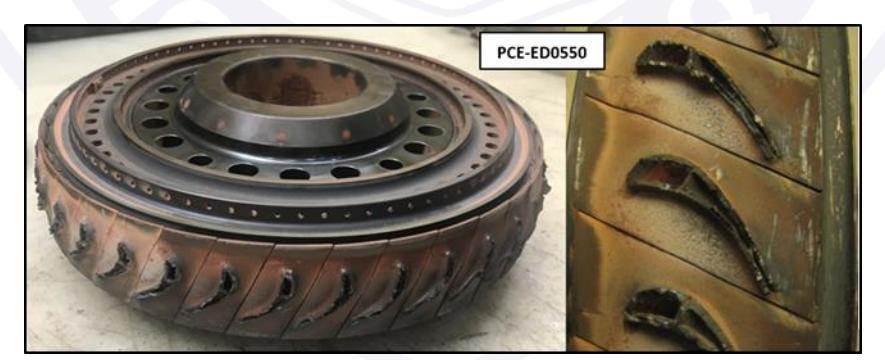
• Most High Pressure Turbine Disk (HPT) blades showed overload fractures near the platform (Figure 8).

Figure 8 - High Pressure Turbine Disk of the SN PCE-ED0550 engine with all blades fractured near the platform and, in most cases, with signs of rupture due to overload.

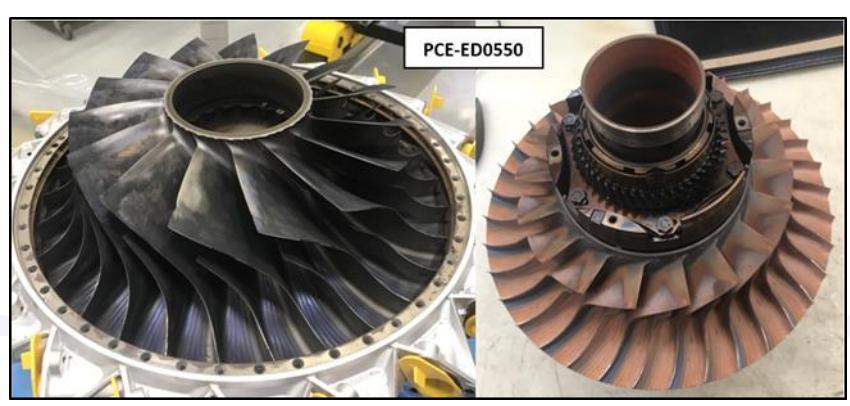
• The Low Pressure Impeller and High Pressure Impeller showed only material loss at the tops of the blades and small dents. In the stationary elements positioned after the impellers, considering the flow of the gaseous mass, and even immediately before the HP Disk, no signs were found that any particle could have come off them and caused damage to the HP Blades (Figure 9).

Figure 9 - Low Pressure Impeller and High Pressure Impeller of the SN PCE-ED0550 engine without significant damage.

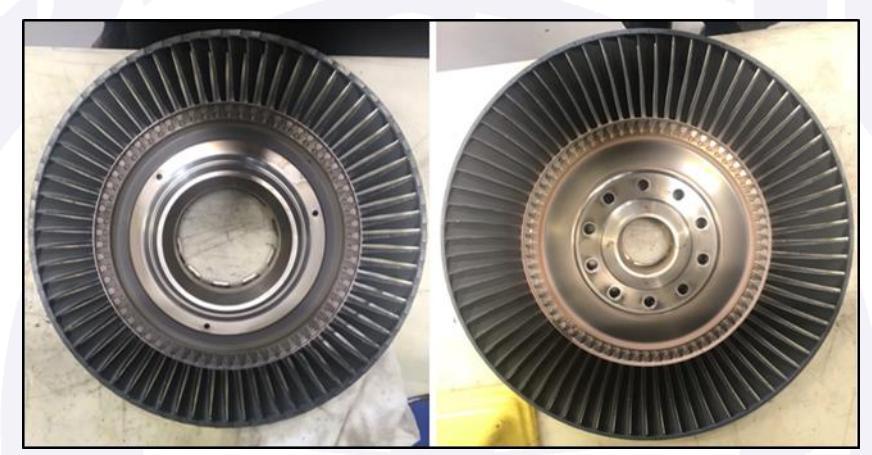
• It did not present significant damages in the blades of the Power Turbine (PT) Disks 1 and 2. The Low Pressure (LP) Turbine Disk presented all the blades fractured in the extremities, caused by impact of debris (Figures 10 and 11).

Figure 10 - Power Turbine Disks 1 and 2 of the SN PCE-ED0604 engine without significant damage.

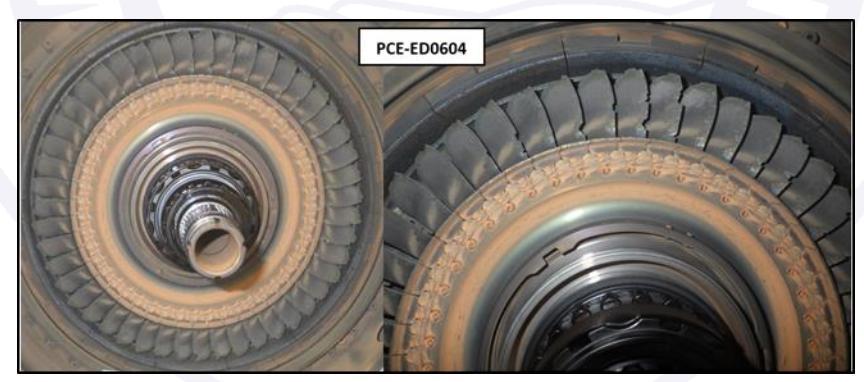
Figure 11 - Low PressureTurbine Disk of the SN PCE-ED0604 engine with all blades fractured at the ends.

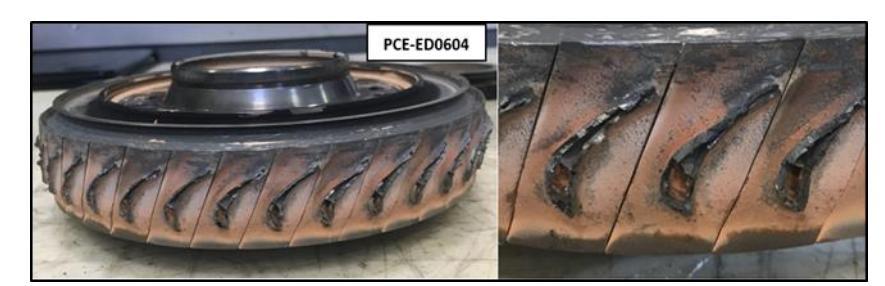
The High Pressure Turbine Disk had all blades fractured near the platform, most of them due to overload (Figure 12).

• Figure 12 - High Pressure Turbine Disk of the SN PCE-ED0604 engine.

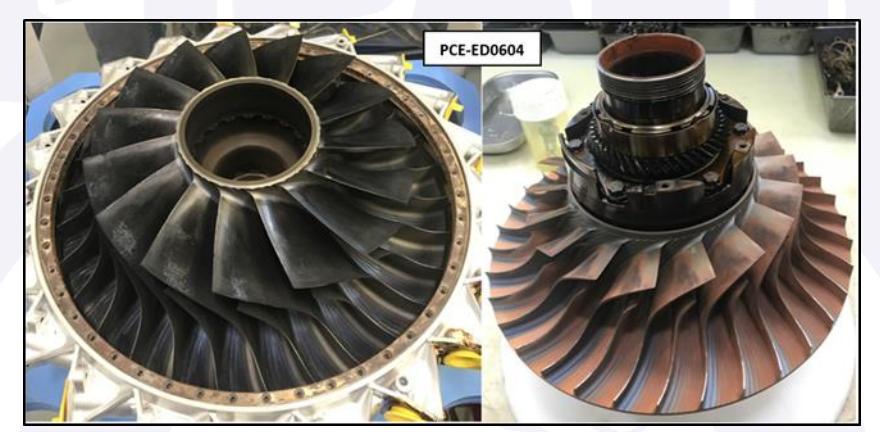
• Low Pressure Impeller and High Pressure Impeller showed only material loss at the tops of the blades and small dents. In the stationary elements positioned after the impellers, considering the flow of the gaseous mass and, even immediately before the HP Disk, there were no signs that any particle could have come off them and caused damage to the HP Blades (Figure 13).

Figure 13 - Low Pressure Impeller and High Pressure Impeller of the SN PCE-ED0604 engine without significant damage.

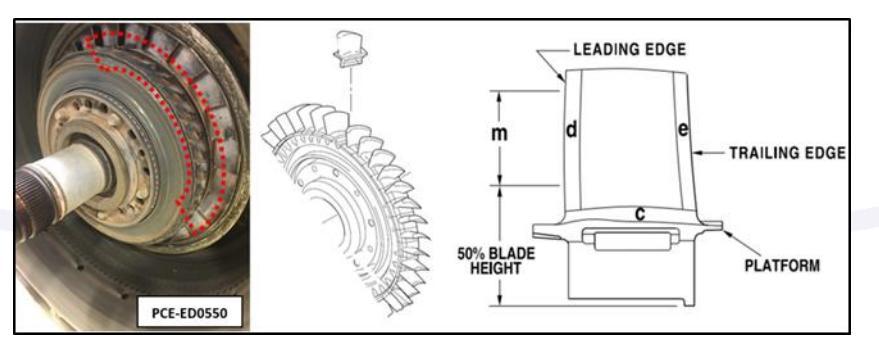
• The initial optical inspection of the High Pressure Turbine Disk for this engine did not reveal the presence of a point where the blades fracture could have started. Subsequently, the 38 blades, PN 3115601-01, which constituted the disk, were removed and the

dimensional verification found that, in all of them, the fractures were positioned approximately 0.1 inch above the platform (Figure 14).

Figure 14 - HPT Disk of SN PCE-ED0550 engine installed and with all fractured blades above the platform (dotted detail). Drawings of part of an intact disk and a blade with theoretical regions.

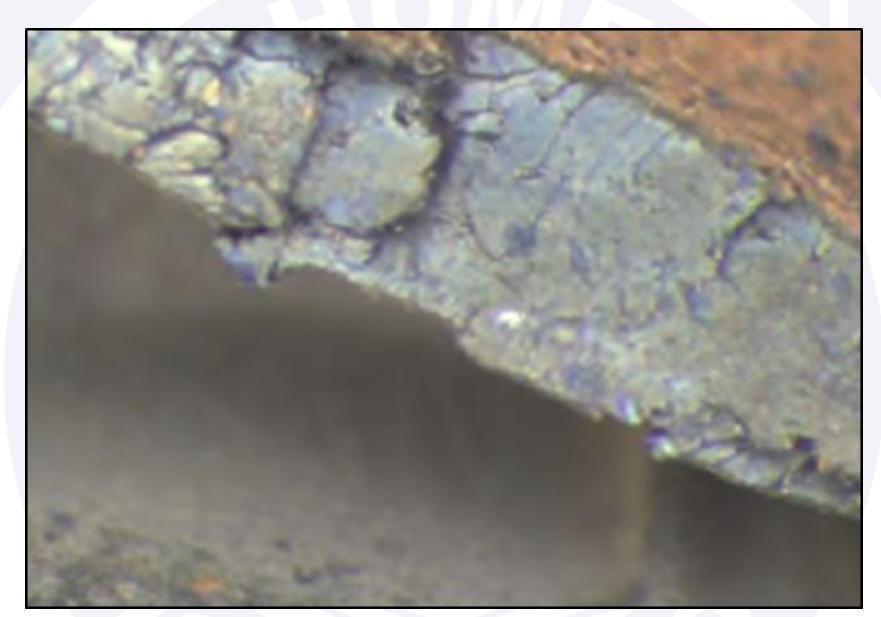
• The fracture surface presented a rough topography, the fracture angles were acute and the appearance was consistent with fractures caused by overload. It was also found that the thickness measurements of the blades' walls were in accordance with the project specifications (Figure 15).

Figure 15 - Fractured surface of one of the HP blades of the SN PCE-ED0550 engine.

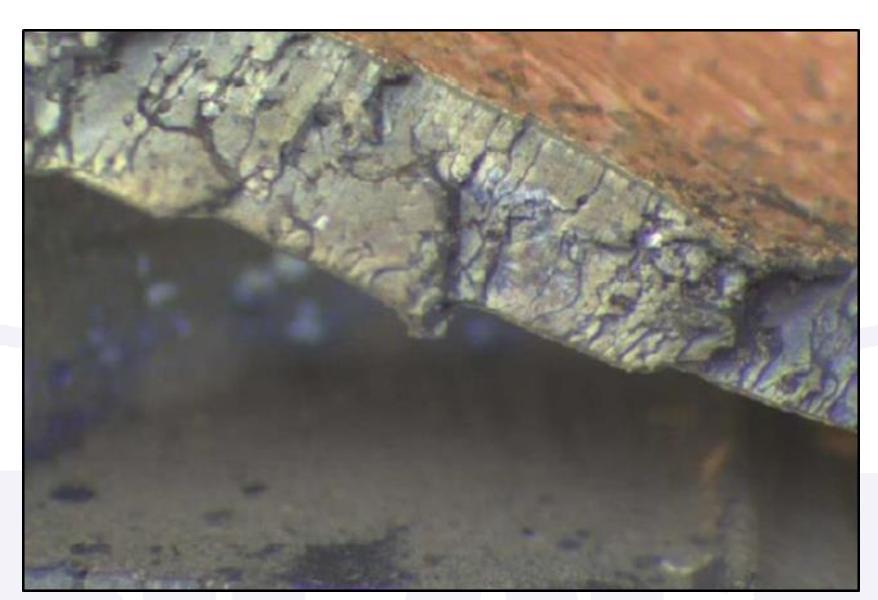
• The blades' fractures surface presented a rough topography, with sloping regions, whose aspect was consistent with fractures resulting from overload. Except for a blade, which had a small area of its fractured surface with smoothed topography (absence of relief with peaks and valleys that characterized rough topography - Figure 16).

Figure 16 - Fractured surface of one of the HP blades from the SN PCE-ED0604 engine.

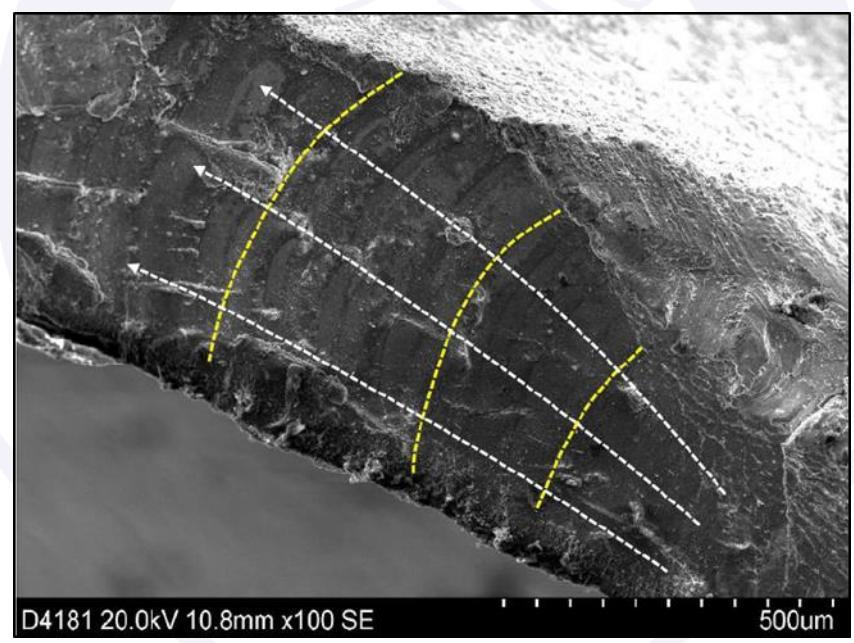
• This area indicated cracks caused by material fatigue. The image of the area, observing the white dotted arrows in Figure 17, indicating a direction of propagation and the dotted lines in yellow, indicating the stages of propagation, were compatible with material fatigue.

• Through the scanning electronic microscope, a larger view of the smoothed area of this blade was obtained. There were progression marks that were indicative of the propagation of high cycle fatigue cracks.

Figure 17 - Smoothed area of the HP blade from the SN PCE-ED0604 engine with fatigue marks.

In the case of the SN PCE-ED0604 engine, laboratory tests indicated that the first blade failed due to material fatigue (High Cycle Fatigue). However, regarding the SN PCE-ED0550 engine, the findings did not allow this confirmation.
