FINAL REPORT A - 035/CENIPA/2019

OCCURRENCE: AIRCRAFT: MODEL: DATE: ACCIDENT PR-ENM T182T 23FEB2019

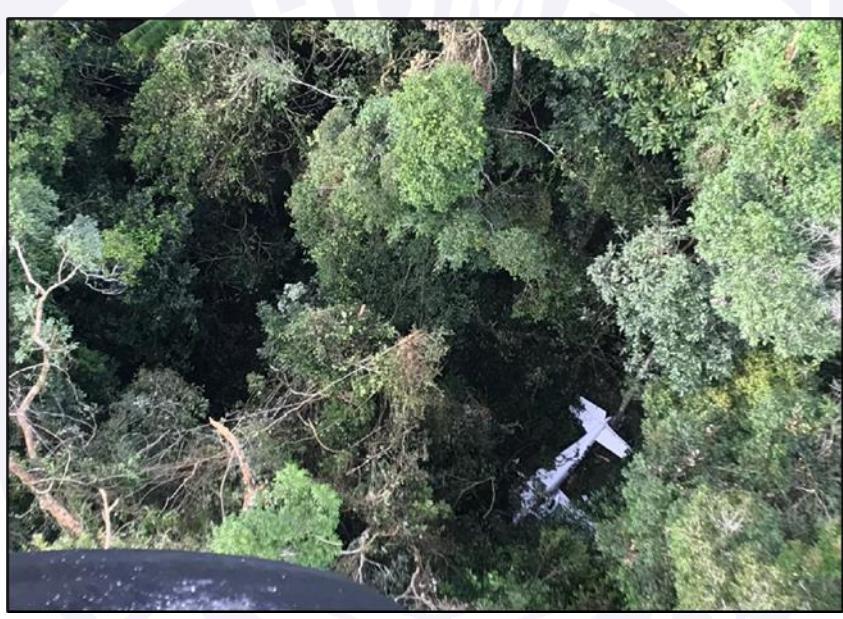
Figure 1 - Aerial view of the aircraft at the accident site.

The aircraft had substantial damage.

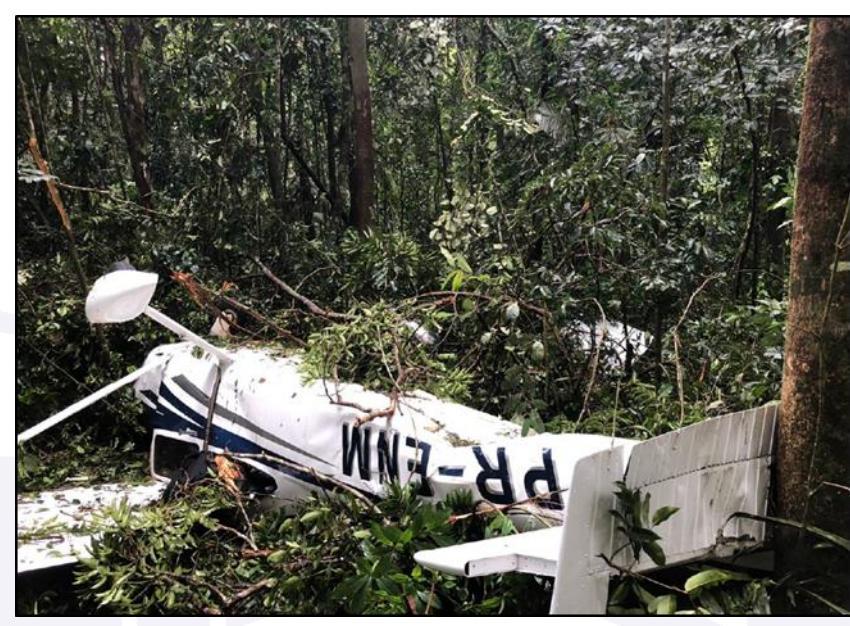
The aircraft had substantial damage to the engine, the propeller assembly, the wings, the vertical and horizontal stabilizers, the fuselage, the cabin, the rudder and the elevator.

Fractures were found in the structure of the nose landing gear and the main train.

Figure 2 - View of the aircraft at the accident site.

The first impact was against local vegetation, with no trace of a previous collision. The distribution of the wreckage was the concentrated type. The aircraft was turned on its back after the stop (Figure 2).

Evidence of fractures found in the aircraft's fuselage is compatible with impact against large trees, present around the aircraft.
