FINAL REPORT A-054/CENIPA/2019

OCCURRENCE: AIRCRAFT: MODEL: DATE: ACCIDENT PT-FEG EMB-121 A1 02ABR2019

This is the Final Report of the 02 April 2019 accident involving the EMB-121 A1 aircraft of registration marks PT-FEG. The occurrence was typified as "[SCF-NP] System/component failure or malfunction".

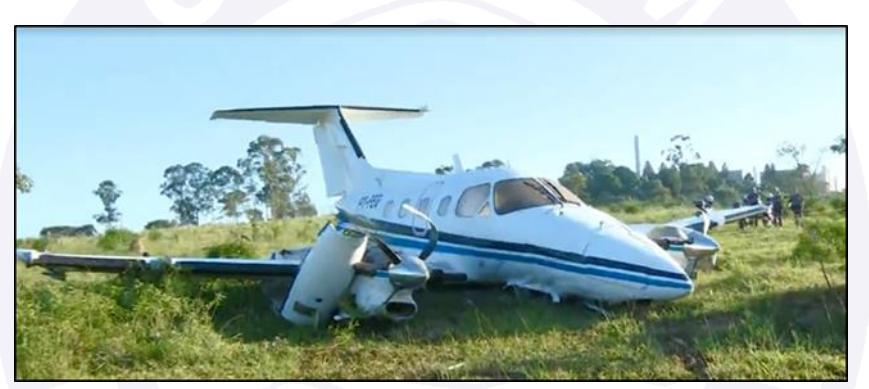
Figure 1 - Image of the aircraft after coming to a complete stop.

The aircraft sustained substantial damage to the lower section of the fuselage, landing gear assembly, propellers, engines, flaps, ailerons, underside of the wings, and empennage.

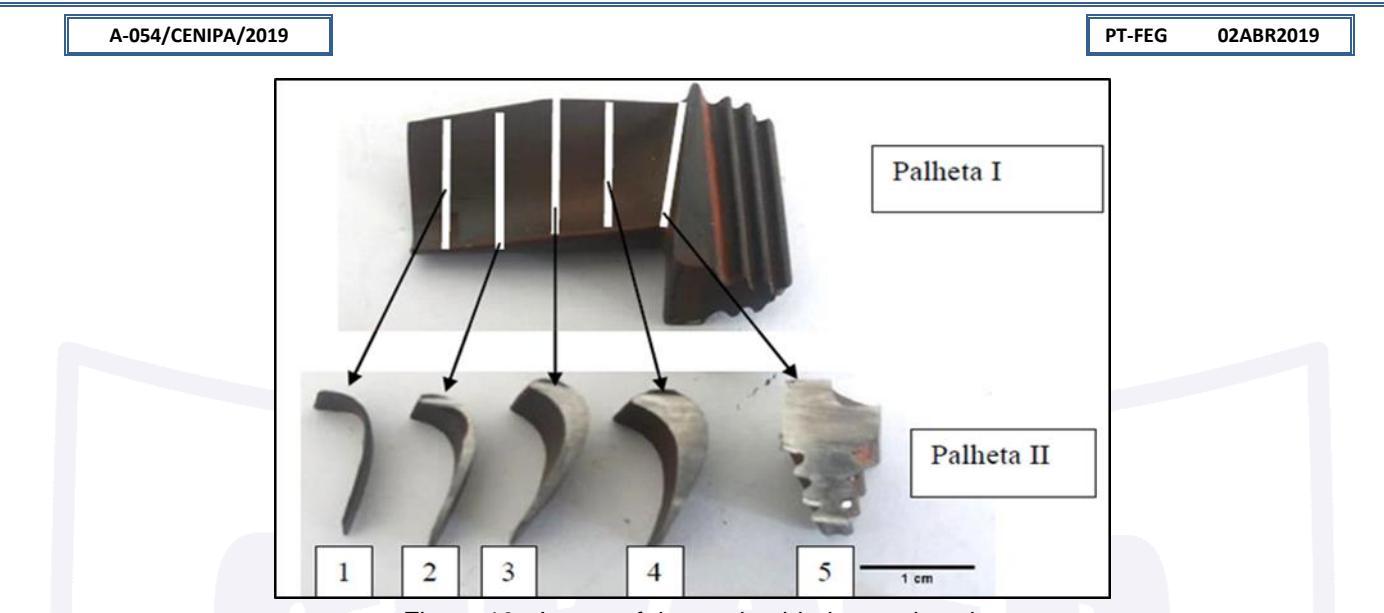
In addition to the analyses mentioned above, since it was not possible to perform a bench-test of the right-hand engine, one removed two of its CT disk blades and analyzed them in a laboratory specific for analysis of materials. For this analysis, one blade was kept intact, while the other one was sectioned into five parts, in order to evaluate its microstructure (Figure 10).

Figure 10 - Image of the engine blades analyzed.

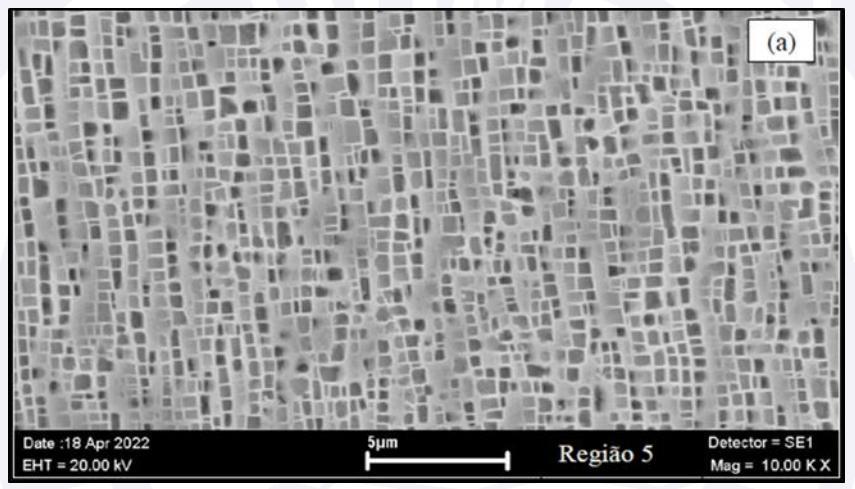
The analysis showed that, at the base of the blade, the microstructure was homogeneous (Figure 11) and, at the end, the microstructure was heterogeneous (Figure 12), indicating that there was growth and coalescence² of the grains.

Figure 11 - Homogeneous microstructure at the base of the blade.

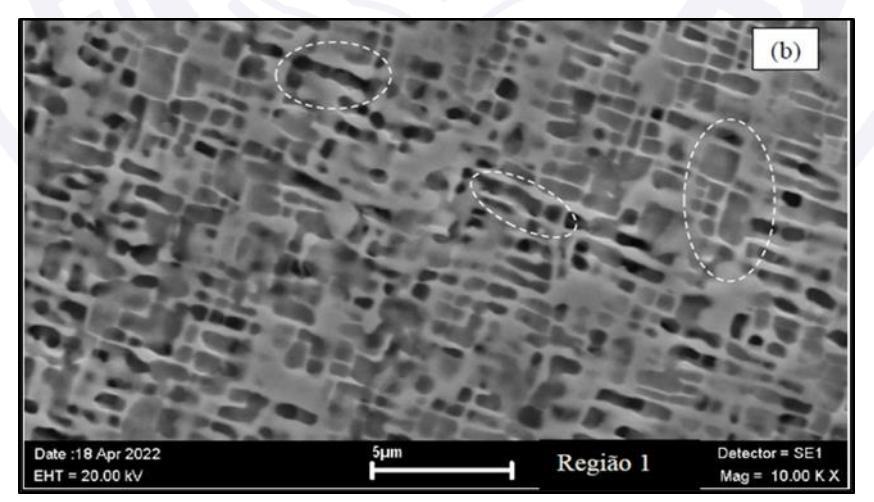
Figure 12 - Heterogeneous microstructure at the tip of the blade

- m) evidence of overheating was found in one of the CT disk blades, but it was not possible to determine on which flight the phenomenon had occurred;
- n) no evidence of fire was identified in the right-hand engine during the technical analyses and borescope inspection carried out on the powerplant;

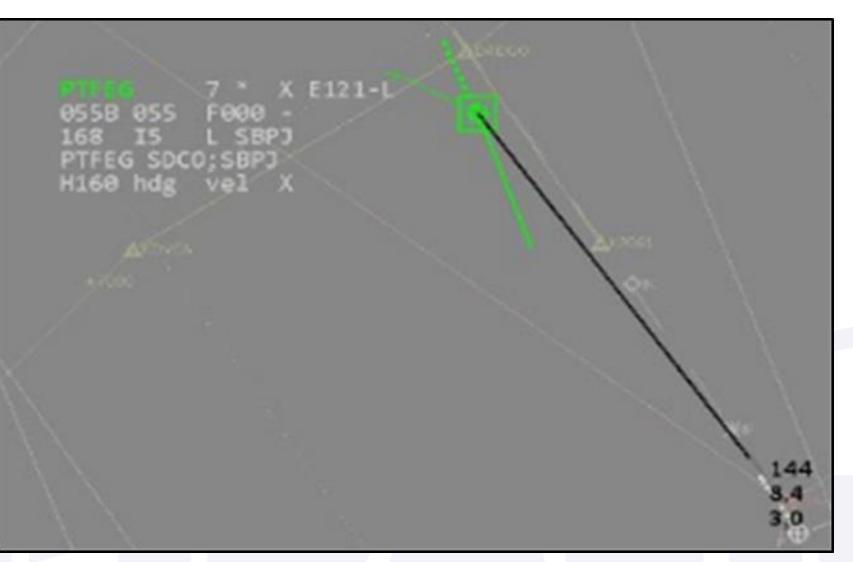
By means of the RADAR image rerun, it was possible to observe that, during the final approach to SBKP, there was a reduction in the speed of the aircraft. As it approached the runway, the speed gradually dropped from 168 kt. at 3 NM from the threshold to 104 kt. at 1.4 NM (Figures 16 and 17). When initiating the right turn, the speed initially decreased to 90 kt. and, during the turn, increased to 126 kt. at the moment of impact with the ground.

Figure 16 - Aircraft position at 3 NM from the threshold, speed 168 kt.

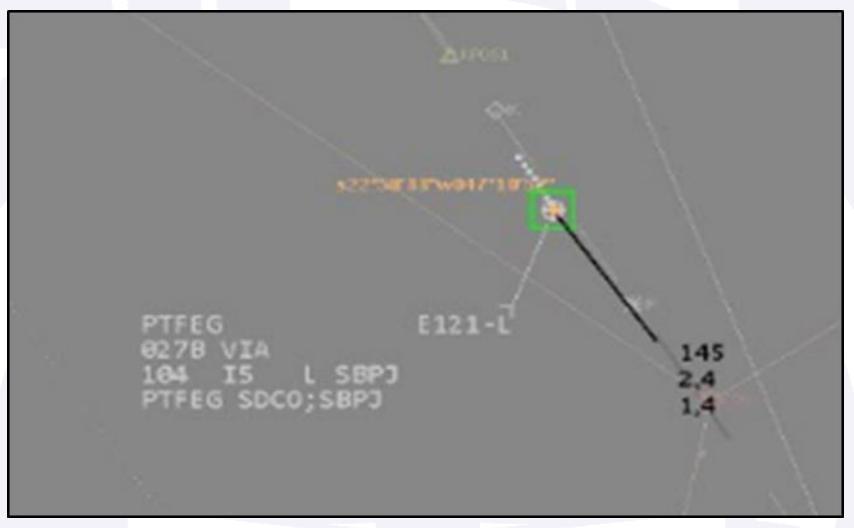
Figure 17 - Aircraft position at 1.4 NM from the threshold, speed 104 kt.

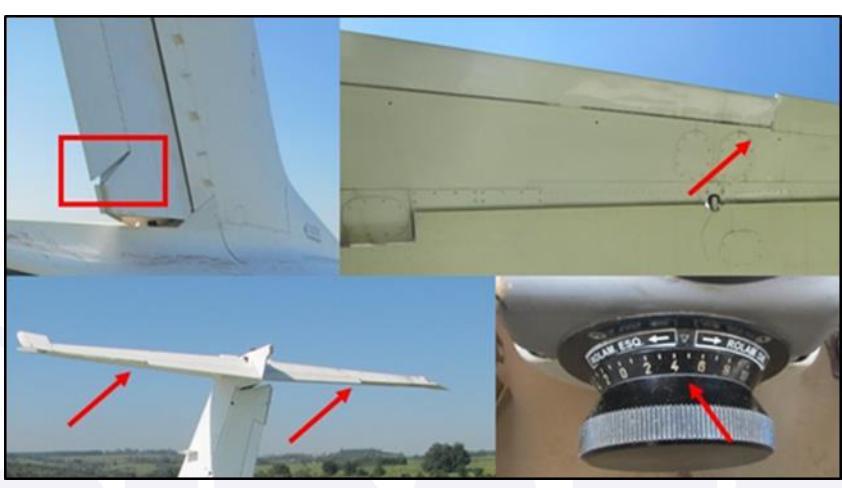
According to images obtained at the crash site, it was possible to observe that the trim tabs were deflected, and that the flaps were lowered to 100% (Figures 21 and 22).

Figure 21 - Image of the rudder, elevator, and aileron trim tabs deflected.

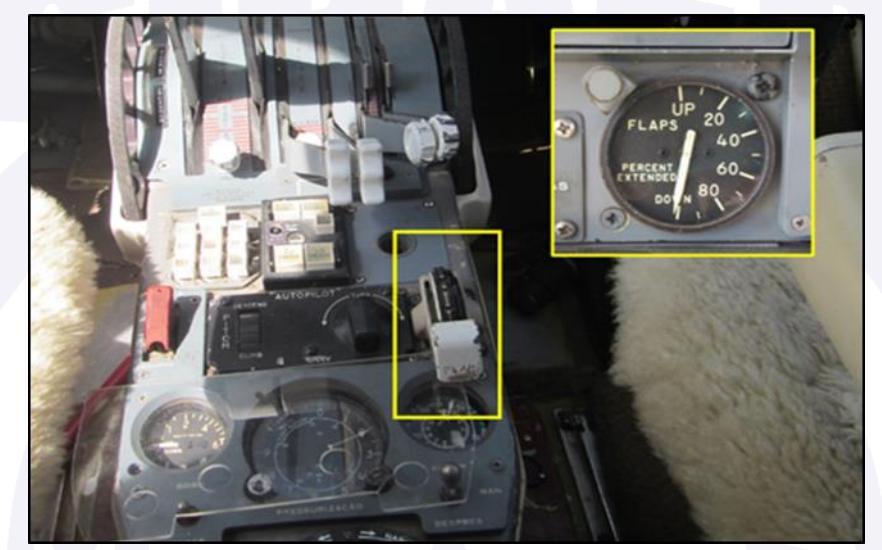
Figure 22 - Position of the flap actuation lever and its indicator showing that the flaps were deployed at 100%.

In addition, the early configuration of the aircraft, with the landing gear lowered and with flaps at 100%, led it to fly a ramp that was below the recommended one and influenced the failure to achieve the required landing parameters.
