FINAL REPORT A-070/CENIPA/2022

OCCURRENCE: AIRCRAFT: MODEL: DATE: ACCIDENT PT-HMD HB-350B 09JUN2022

This is the Final Report of the June 9, 2022, accident involving the model HB-350B helicopter of registration marks PT-HMD. The occurrence was classified as "[LOC-G] Loss of Control – Ground."

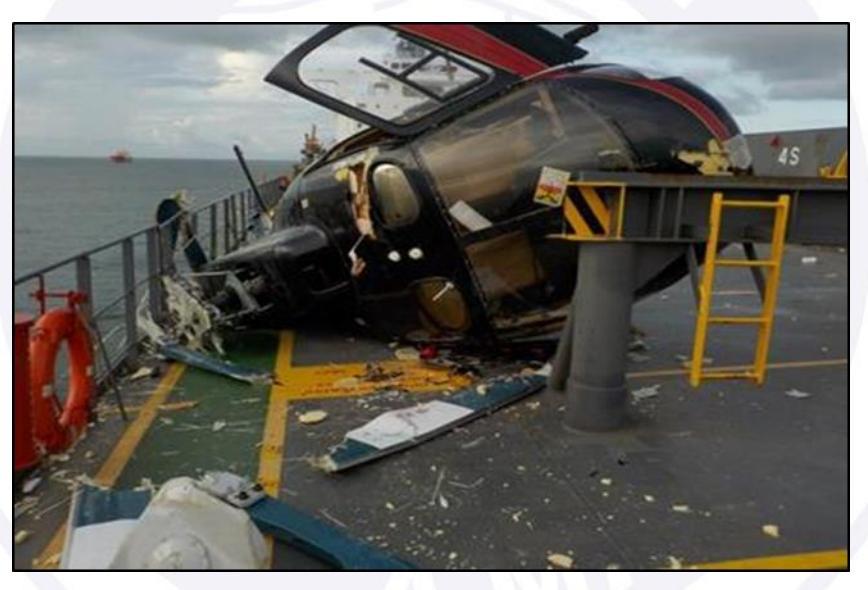
Figure 1 - PT-HMD helicopter after the accident.

The aircraft sustained substantial damage. The tail section separated, resulting in the destruction of the tail rotor blades, along with the partial severing of the left skid. Additionally, one observed twisting of the tail boom and deformation with exposure of the tail-rotor drive shaft.

There was also damage to the transmission, and the main rotor blades were destroyed. The right door's plexiglass was shattered, and there was damage to the front left section of the roof.

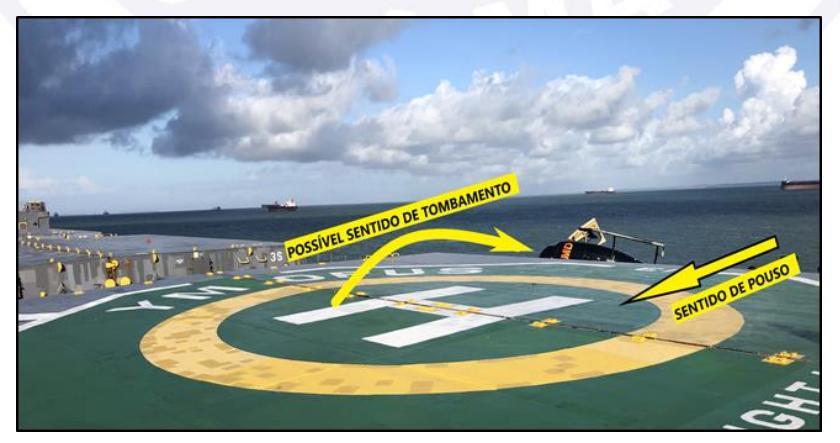
According to reports, the aircraft approached from the right side of the vessel, whose bow was facing toward the coast of *São Luís*, MA. The helicopter's fuselage had rolled over to the right, resting at a heading of 130°, at the edge of the right-hand guardrail of the bulk carrier YM OPUS.

These pieces of evidence suggest that, during the loss of control, the aircraft yawed to the right, rolled over in the same direction, and fell off the helideck (Figure 2).

Figure 2 - Direction of landing and possible direction of the rollover.

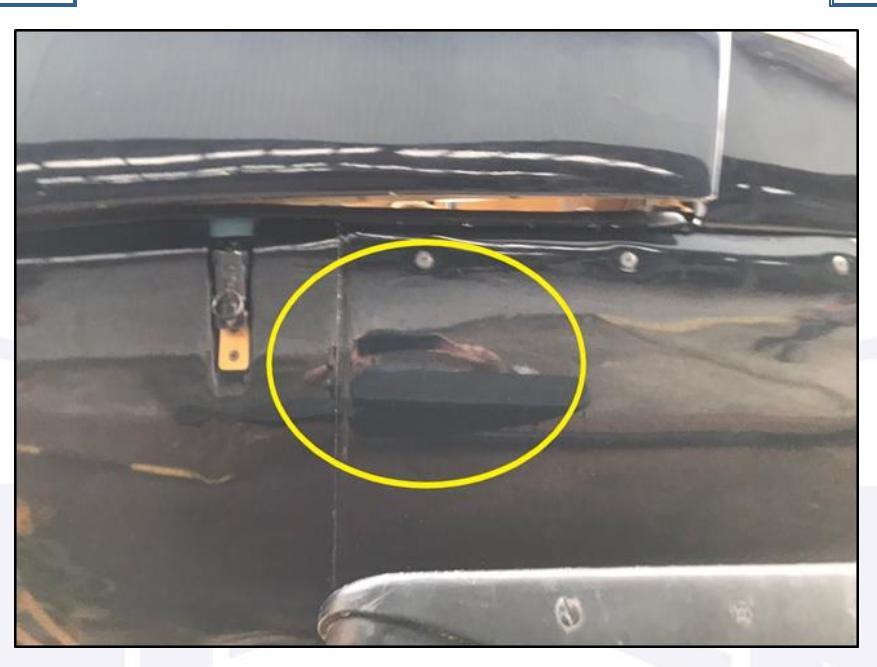
Small dents were noted on the fuselage, below the aircraft's left cabin door (Fig. 3).

Figure 3 - Dents concentrated on the fuselage below the left door.

Besides, dents and marks were observed on the left fuselage below the door, which may have resulted from repeated impacts of the buckle against the fuselage, driven by relative wind forces following the takeoff from the bulk carrier SM GEMINI 2.

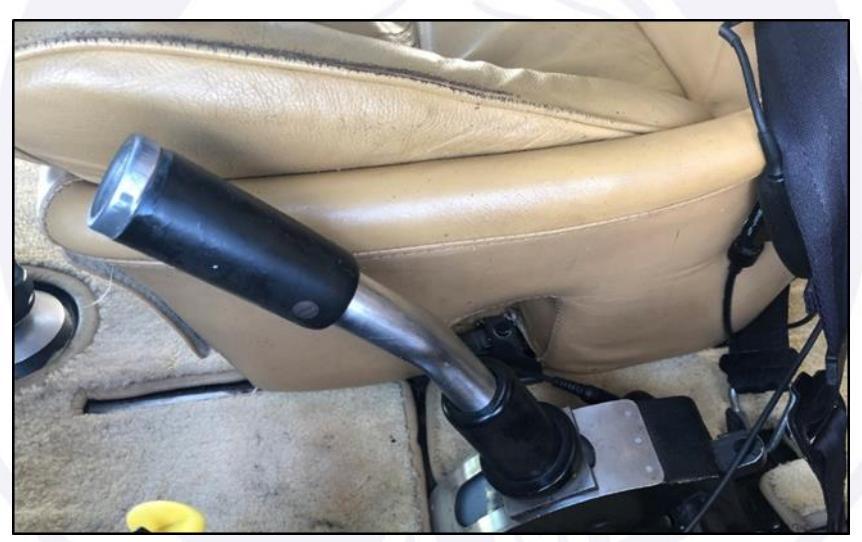
The collective pitch control was found unlocked and positioned fully upward, while the cyclic control was found fully tightened with friction applied (Figure 4).

Figure 4 - Collective pitch control positioned fully upward.

- s) after the accident, the cyclic control was found with full friction applied;
- t) after the accident, the collective pitch control was found unlocked and fully raised;

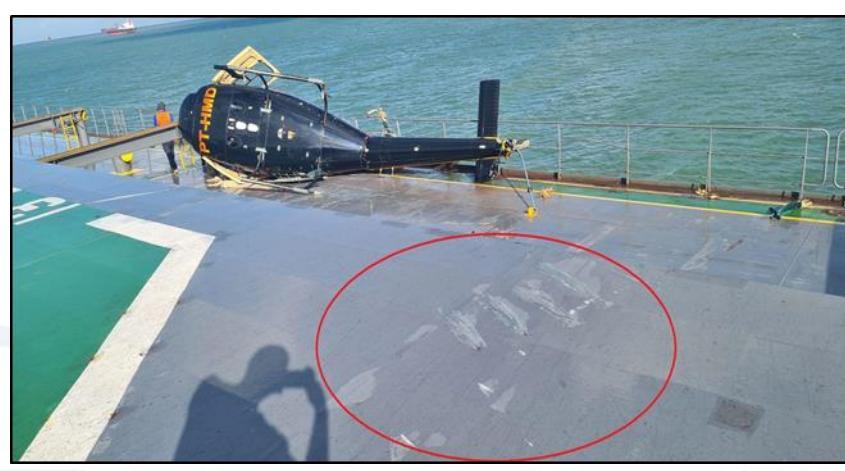
There were scratches and marks on the helideck, caused by the dragging of the right skid in the direction where the fuselage had come to rest. Additionally, there was evidence of tail rotor strikes on the helideck surface (Figure 5).

Figure 5 – Tail-rotor contact marks on the helideck.
