FINAL REPORT IG-010/CENIPA/2022

OCCURRENCE: AIRCRAFT: MODEL: DATE: SERIOUS INCIDENT PT-OSO C90 19JAN2022

This present Final Report pertains to the serious incident involving the King Air C90 aircraft (registration marks PT-OSO). The incident occurred on 19 January 2022 and was classified as "[SCF-NP] System/component failure or malfunction".

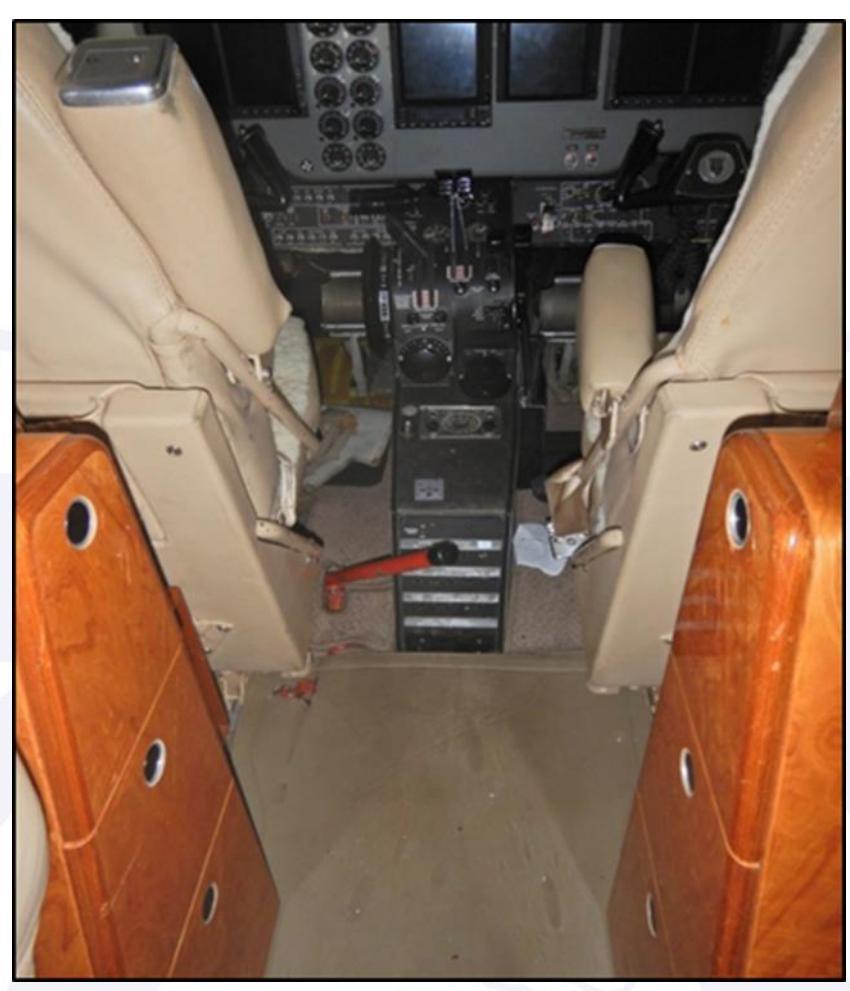
The aircraft was used for personnel transport, meeting the travel demands of the Governor of the State of *Minas Gerais*' office. As these travels included transporting dignitaries, the aircraft was given special adornments. Among them was a tapestry installed in the passenger cabin, extending to the pilots' throttle pedestal, as shown in Figure 1.

Figure 1 - Image of the carpet.

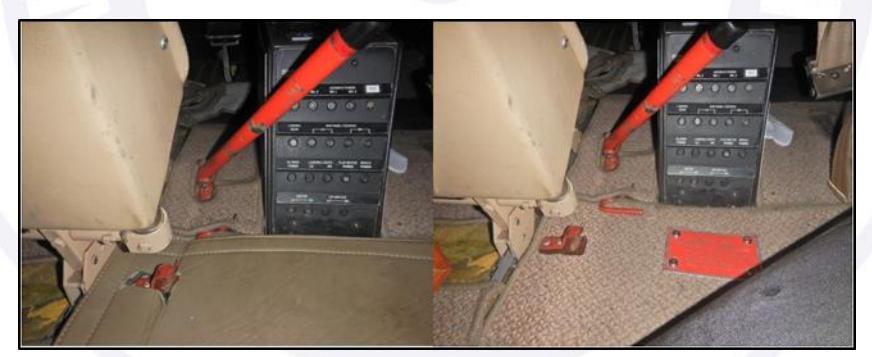
As shown in Figure 2, next to the throttle pedestal was the lever for landing gear emergency extension. In this position, there was also a manufacturer-installed instructional placard describing the procedures. However, the said tapestry covered the placard.

Figure 2 - On the left, a photo of the carpet in the position it was in during the accident and, on the right, the placard appearing after the carpet was manually folded.

Regarding the referred modifications, it is important to note that a portion of the tapestry wound up covering a placard. The referred placard was a mandatory item in the aircraft manual, meant to remain visible to the pilots as an aid for the proper execution of procedures. It served as the final line of defense against improper execution of the landing gear extension procedures.

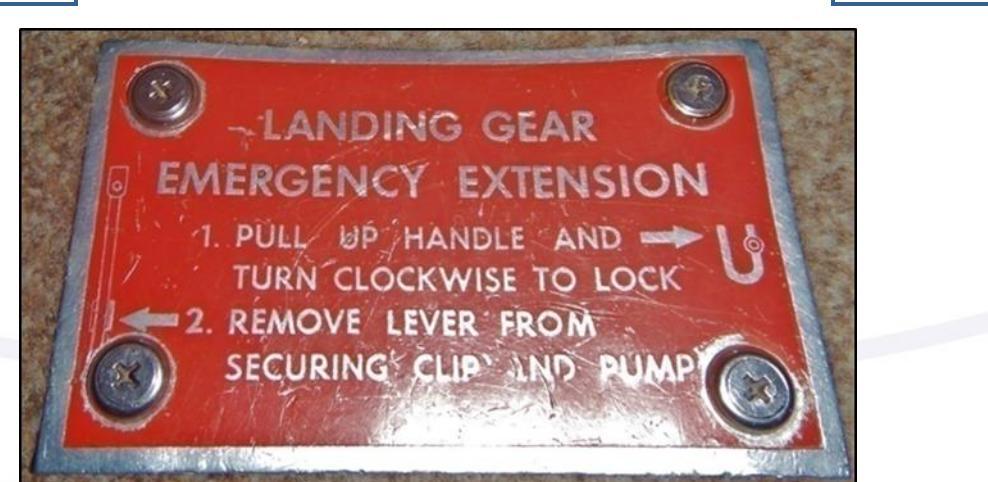
The placard showed an excerpt containing a two-step instruction for landing gear emergency extension, as shown in Figure 3.

Figure 3 – Instruction placard covered by the tapestry.

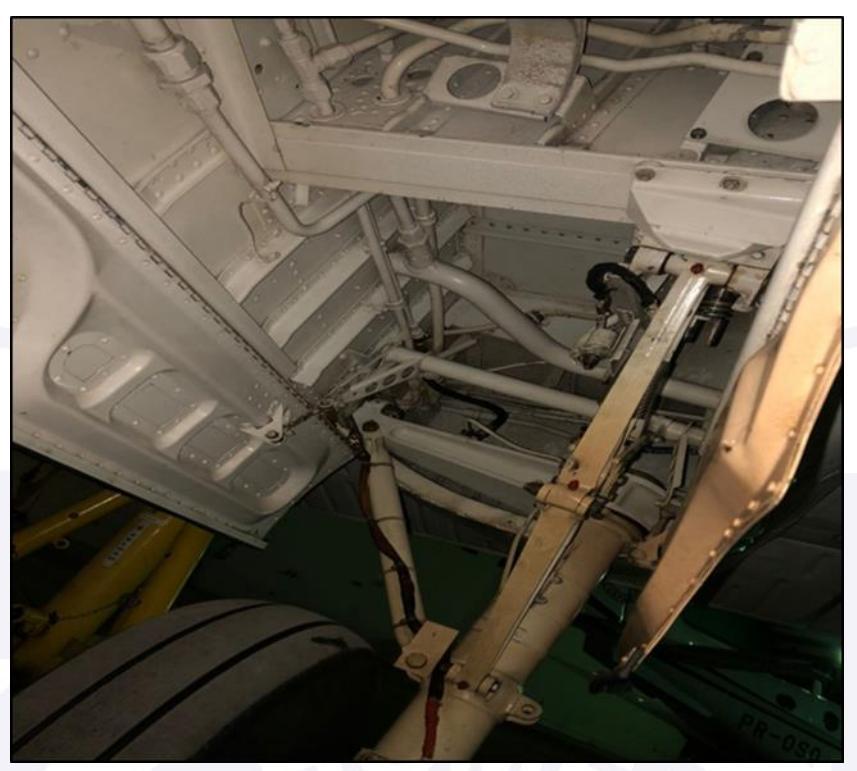
Still on the subject of the landing gear, the Investigation Committee found that there was no significant damage to this system on the occasion of landing, as shown in Figure 8.

Figure 8 - Image of the landing gear.

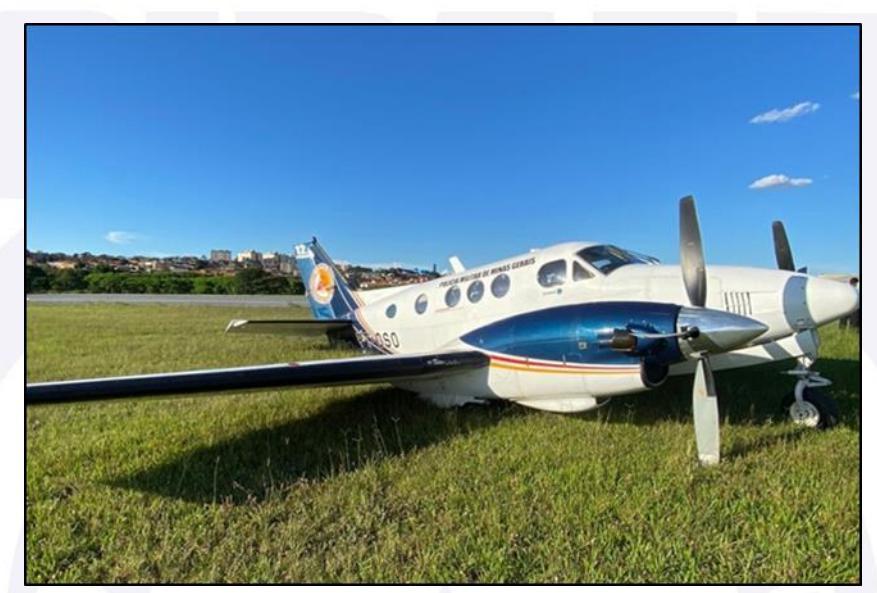
In aircraft's final stop location, the main landing gears were in the retracted position, whereas the nose landing gear remained locked down, as shown in Figure 10.

Figure 10 - Main landing gear retracted, with the nose gear down and locked.

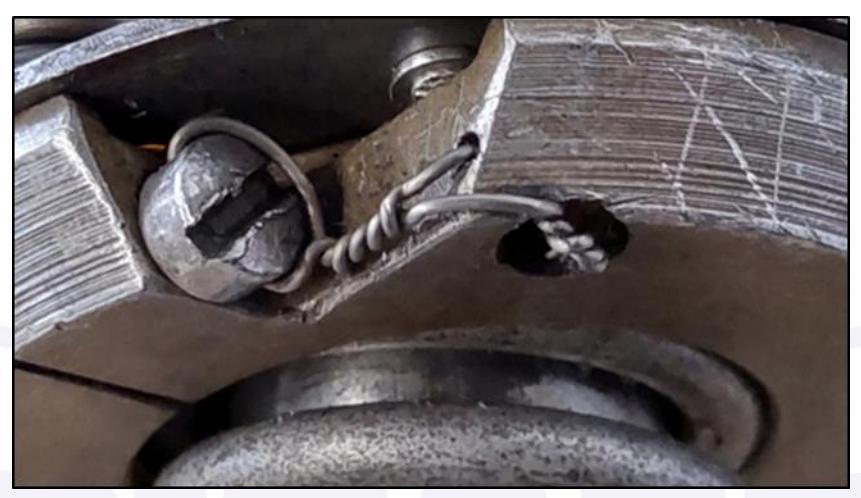
It was observed that the screw fastening the Tension Nut was not properly secured, resulting in a "loose" condition. The safety-wiring mechanism, intended to keep the screw in its designated position, was installed in a way that might have allowed the screw to rotate within its cavity (Figure 12). The maintenance records did not provide information on the most recent action concerning to the adjustment and securing of this screw.

Figure 12 - Screw secured on the Tension Nut.

During the investigation process, it was found that a set screw securing the Tension Nut was not properly safety-wired, remaining in a "loose" position within its cavity. Consequently, only the Tension Nut rotated while the Clutch Housing remained stationary, preventing the landing gear from moving.

After analyzing all components of the landing gear system, reassembly was performed with appropriate safety wiring, restoring the full functionality of the system without the need for repairs. It is important to note that no element of this system required intervention, confirming that the landing gear failed to lock due to the identified issue.

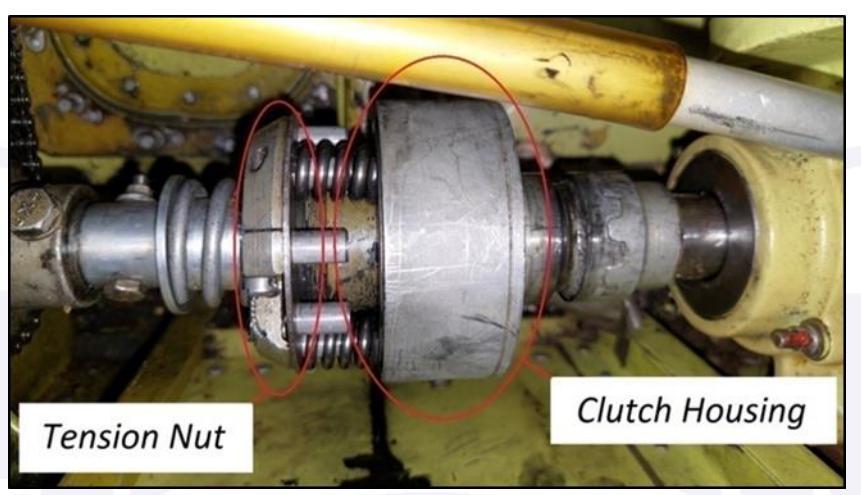
During the bench test, it was observed that within this assembly, only the Tension Nut moved, meaning the Clutch Housing remained stationary, as the set screw did not secure the Tension Nut. Consequently, this item was unable to transmit the electric motor's movement to the landing gear shaft.

Figure 14 - Tension Nut and Clutch Housing.

After completion of this test, the components were reassembled by certified technicians under the supervision of the Investigation Committee, following the standards established by the manufacturer. After this procedure, the assembly operated correctly, and it is important to highlight that no repairs were needed on any of the components.
