# COMANDO DA AERONÁUTICA <u>CENTRO DE INVESTIGAÇÃO E PREVENÇÃO DE</u> <u>ACIDENTES AERONÁUTICOS</u>

# FINAL REPORT A - 134/CENIPA/2014

OCCURRENCE: AIRCRAFT: MODEL: DATE: ACCIDENT PR-AFA CE 560XLS+ 13AUG2014

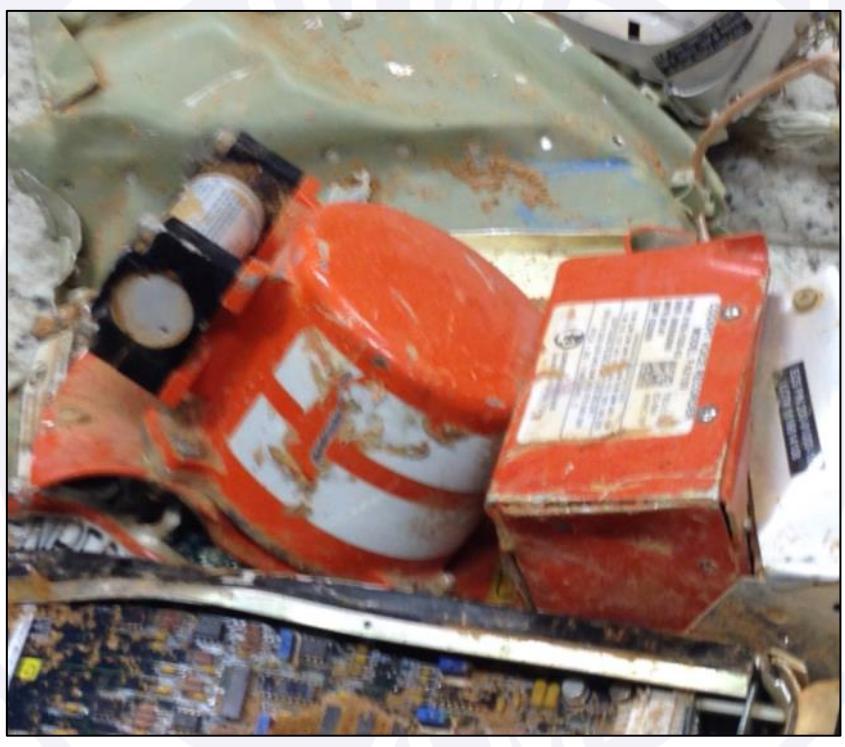
Figure 19 – Severely damaged CVR recovered from the crash site.

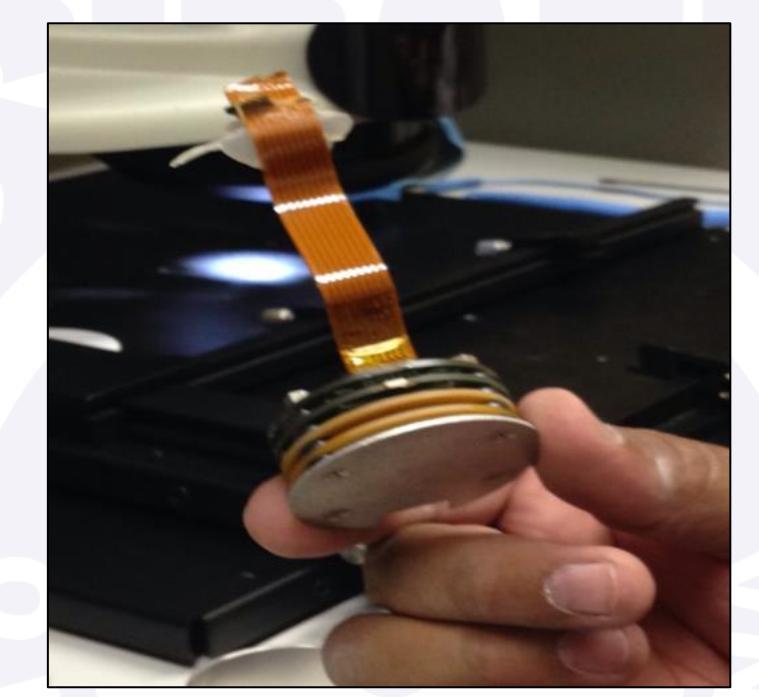
It is observed, however, the need of a technical intervention for the replacement of the wiring that makes the interface between the FLASH memory modules and the Acquisition Processor Board (AP), due to the damage sustained in the accident (Figure 22).

Figure 26 – FLASH memory modules with respective wiring damaged.

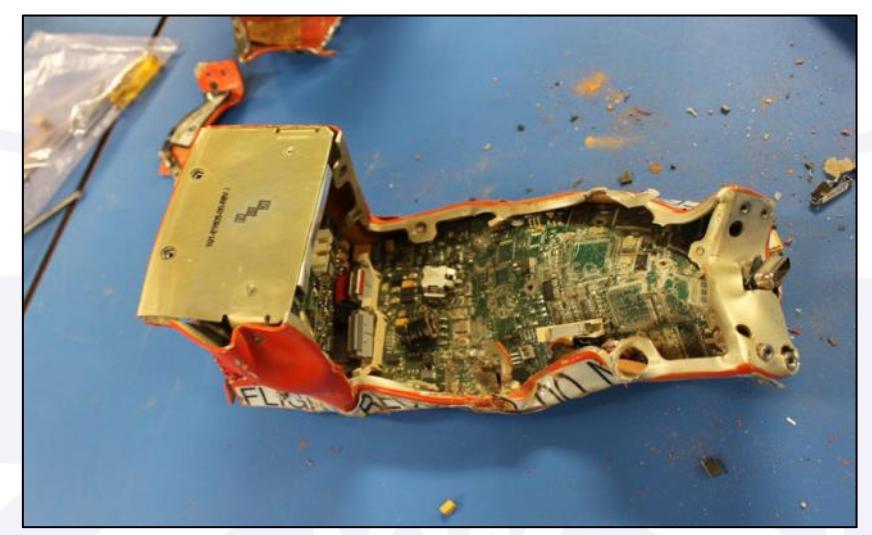
However, due to the severity of the aircraft impact with the ground, the CVR chassis (which houses the AP with its respectiveNVRAM) was completely damaged.

Figure 29 – Chassis damaged on account of the severity of the impact with the ground.

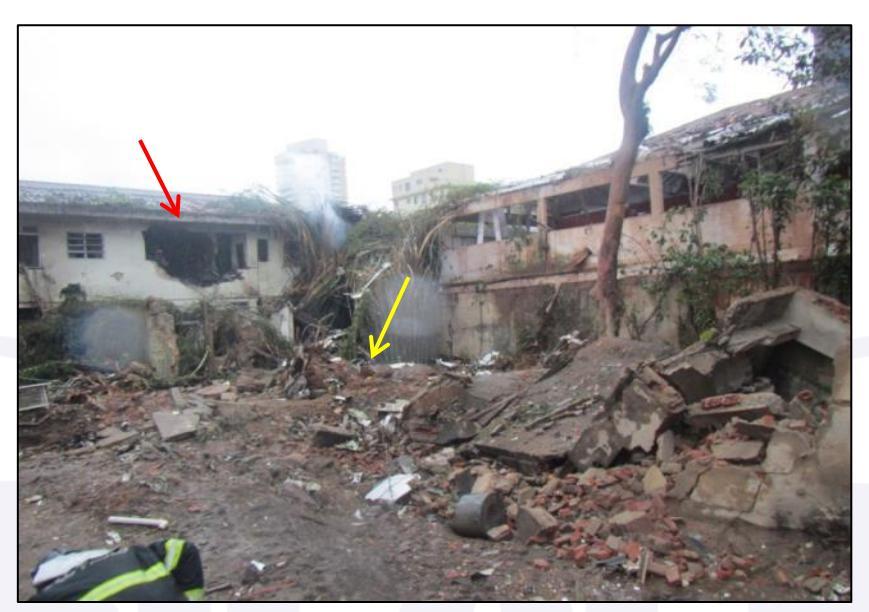
The left engine was recovered from the second floor of the building forward of the impact site and concentration of the wreckage (Figure 38). It exhibited heavy crushing of the diffuser, and its N2 shaft was protruding (Figure 39), while the other engine, found on the ground close to most of the wreckage (Figures 40 and 41), exhibited one impeller visible and had dirt adhered to it. Both engines and separated engine parts were secured for inspection by the investigators and the Pratt & Whitney representative.

Figure 38 – Spot where the left engine was found (red arrow) and place where the right engine and most of the wreckage were located (yellow arrow).

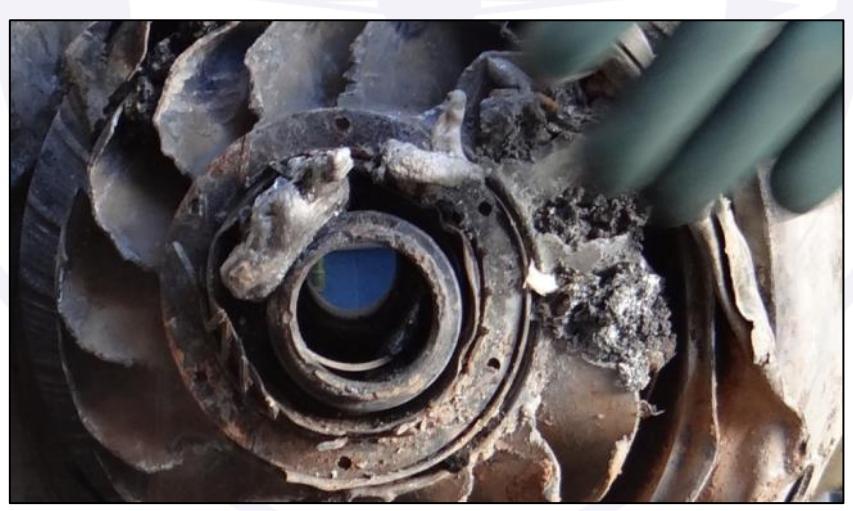
Figure 89 – Front view of the first axial stage of compression, showing melted aluminum and damaged vanes.

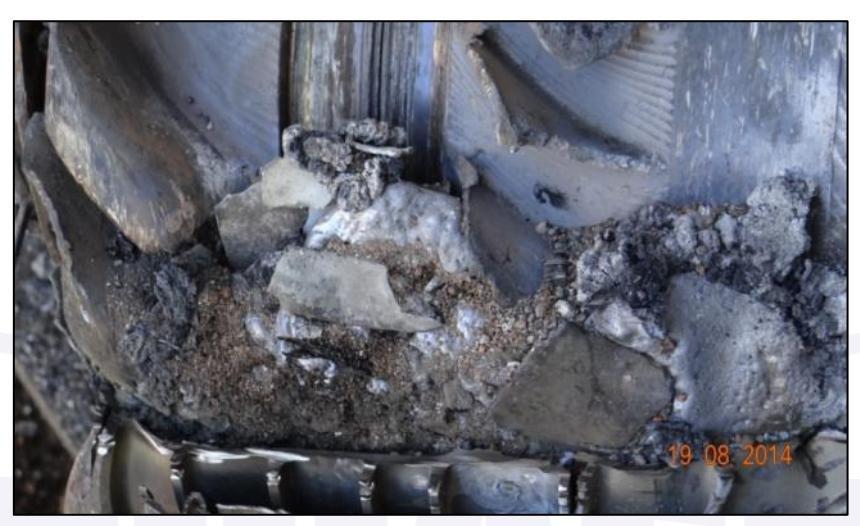
Figure 90 – View of more material which melted and got mixed with dirt in the axial stages of the compressor.

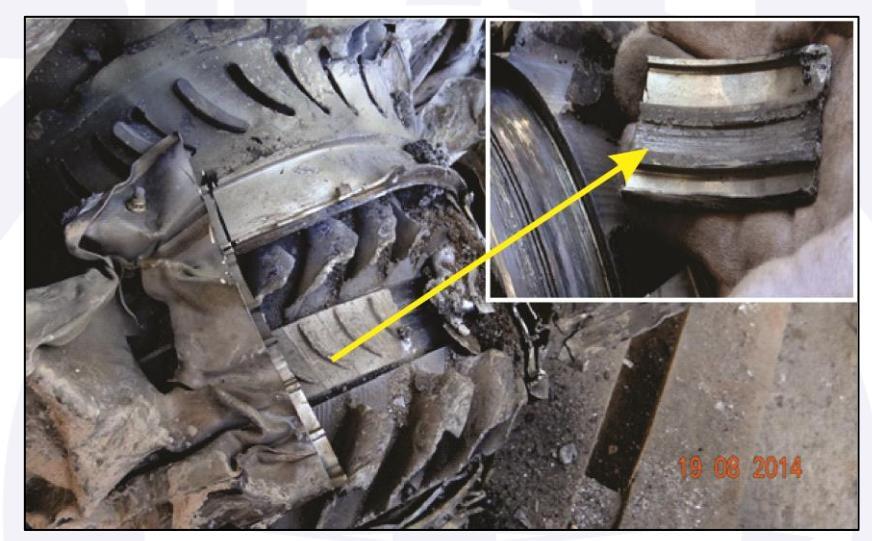
Figure 91 – View of the stator with ruptured vanes. In highlight, the internal side of the stator with pronounced wear and signs of intense rubbing.

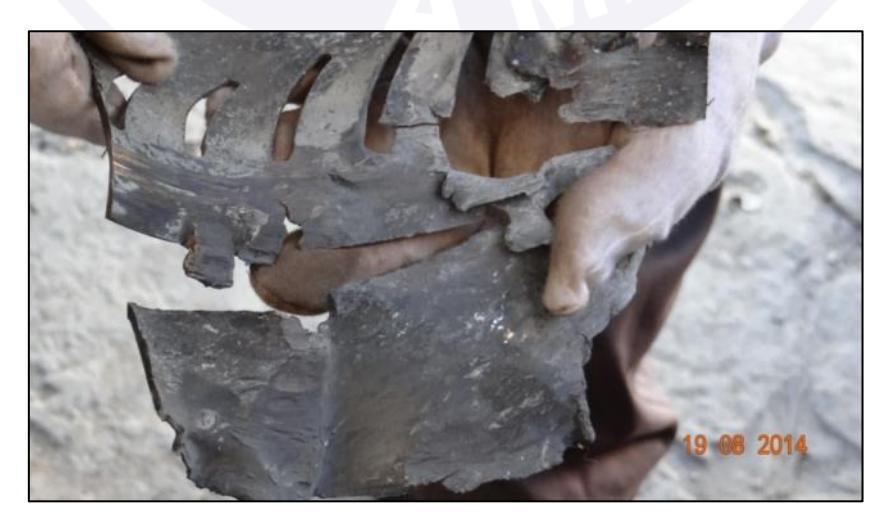
Figure 92 – View, from the internal side, of part of the carcass of the centrifugal stage which was cut for inspection, showing marks of intense rubbing with the rotor.

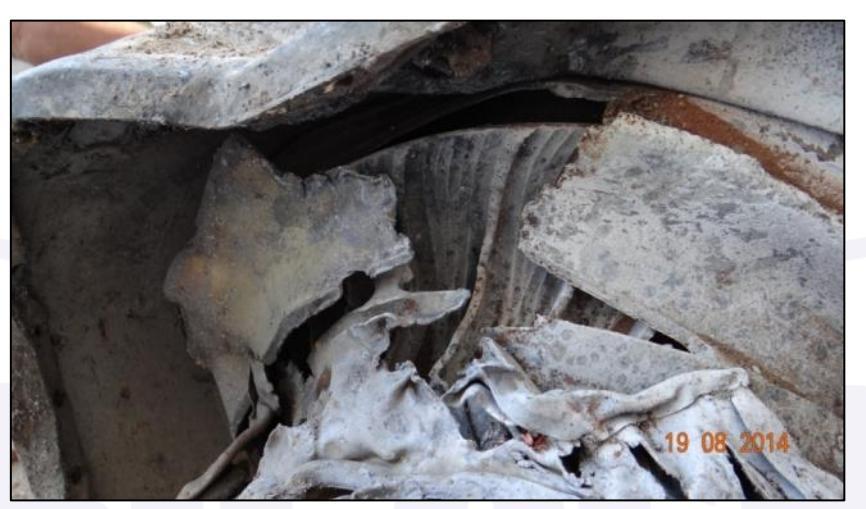
Figure 93 – Detail of the centrifugal stage vane with wear caused by rubbing.

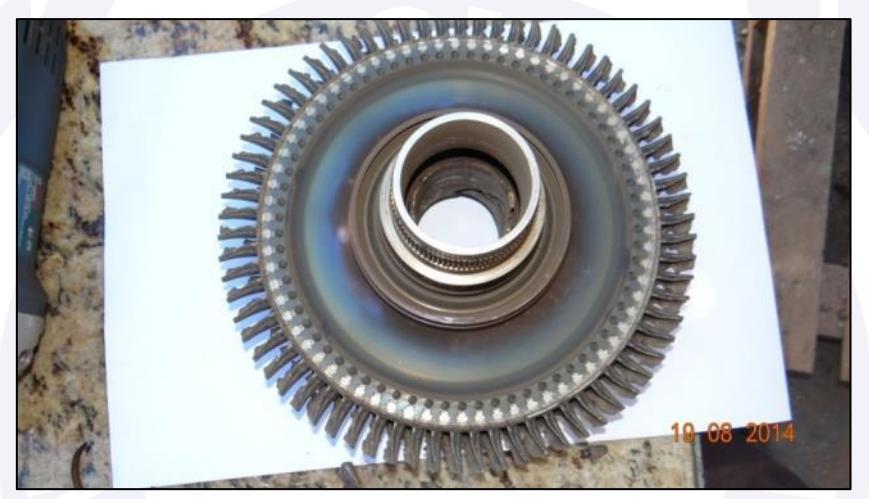
Figure 96 – Front view of the same rotor with marks of rubbing at the roots of the vanes.

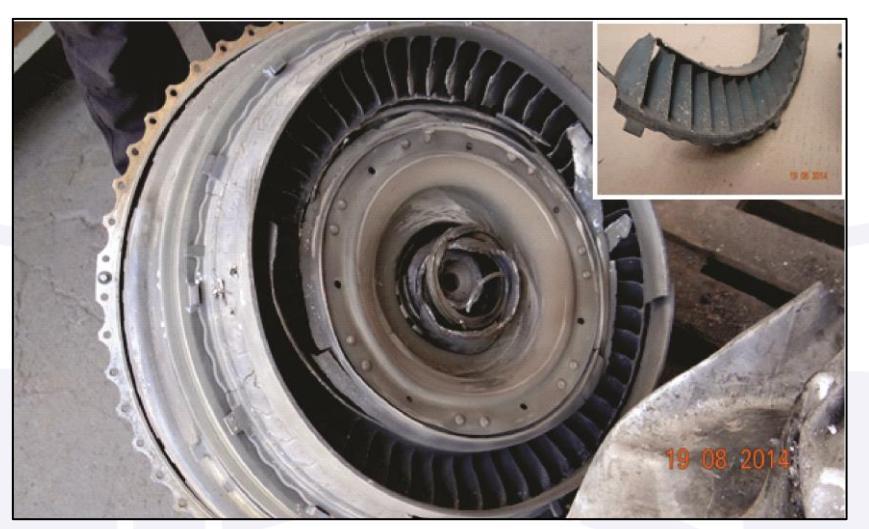
Figure 98 – General view of the stator of the first-stage of the low pressure compressor turbine. It is possible to observe marks of impact caused by fragments which passed through the vanes.

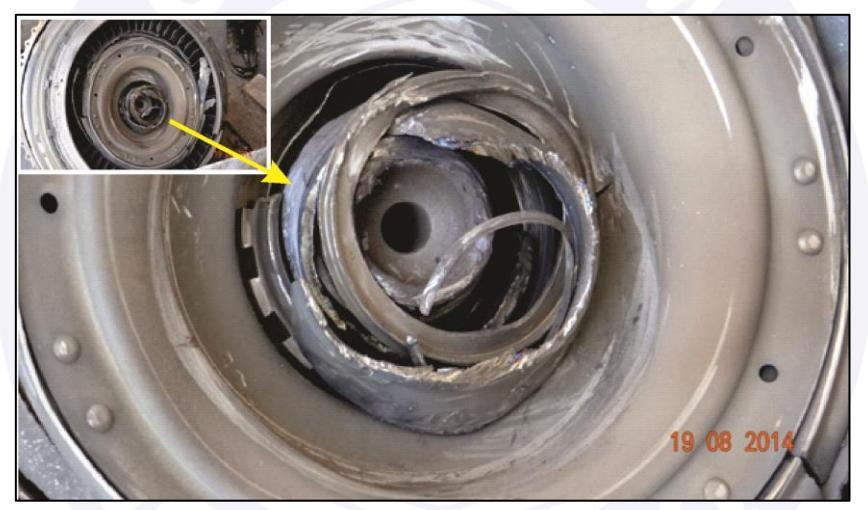
Figure 99 – Closer view of the engine diaphragm, with signs of intense rubbing.

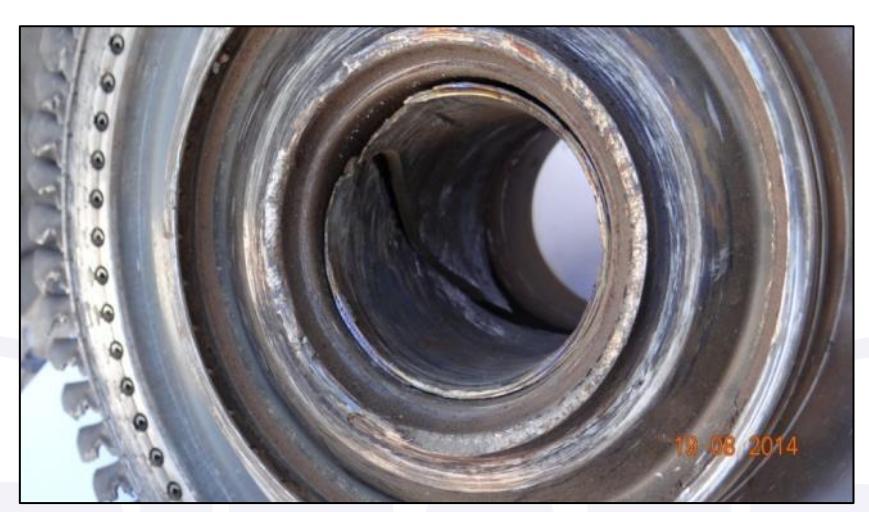
Figure 100 – View of the ruptured glove in the interior of the rotor.

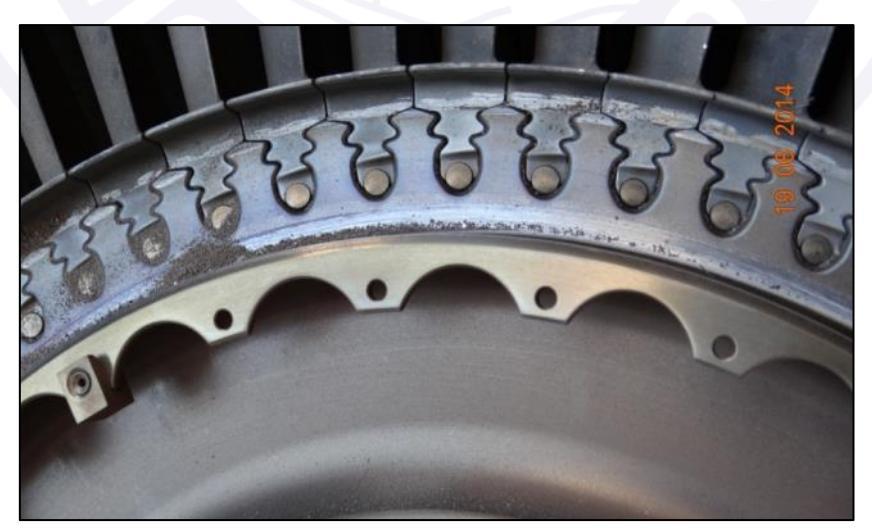
Figure 102 – Detail of the rubbing observed in the vane roots.

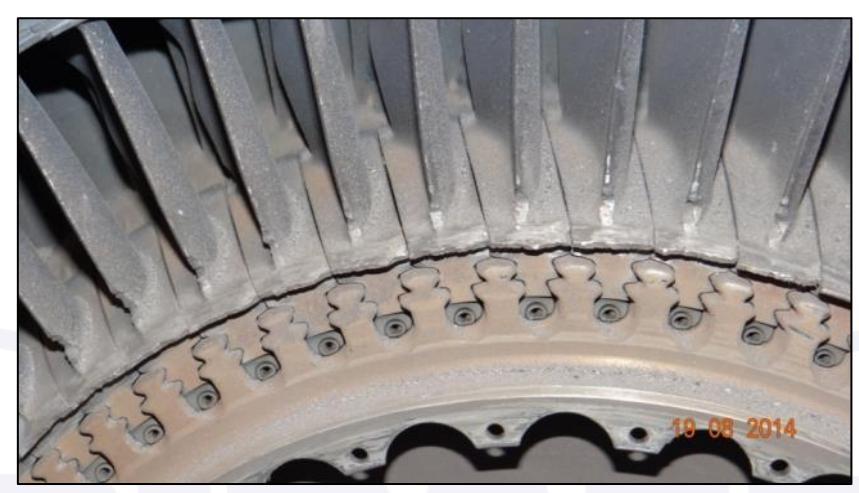
Figure 103 – Detail of the damage to the vane bases. It is possible to observe soot in the vanes, resulting from smoke after impact of the engine.

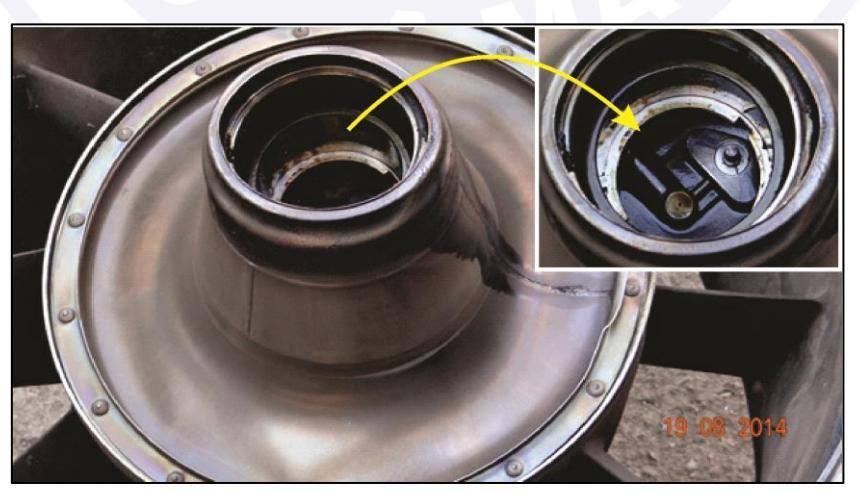
Figure 105 – View of the rear support of the engine, showing oil leakage and the housing of the rear bearing. In the highlight, the oil injector of the rear bearing.

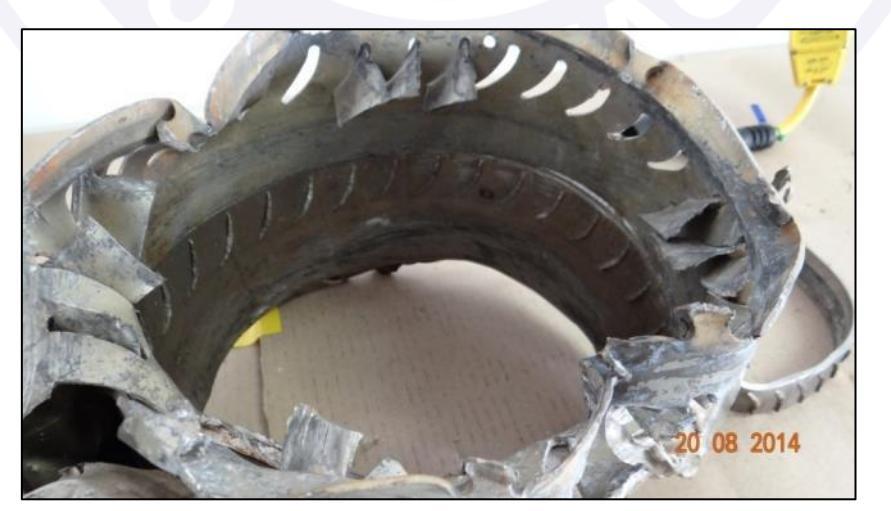
Figure 112 – View from the internal side of the first and second stages of the high pressure compressor, with damaged stator vanes.

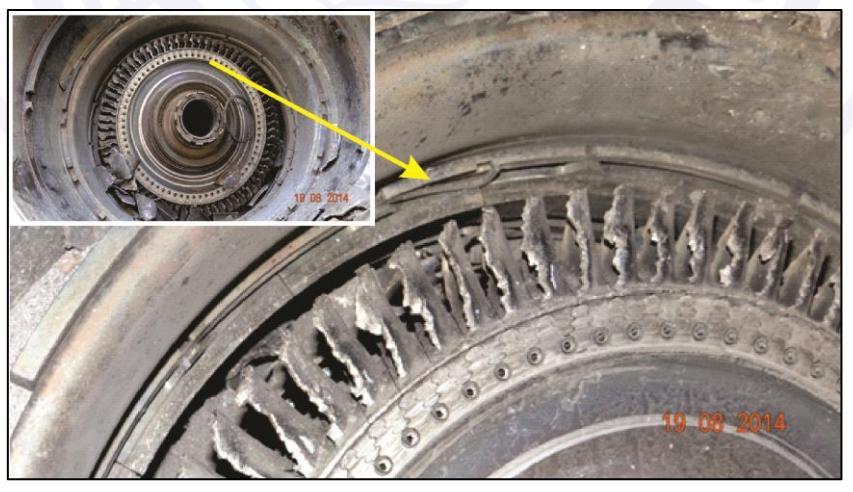
Figure 115 – Detailed view of the damage to the vanes and of the intense rubbing in the base of the high pressure compressor turbine rotor.

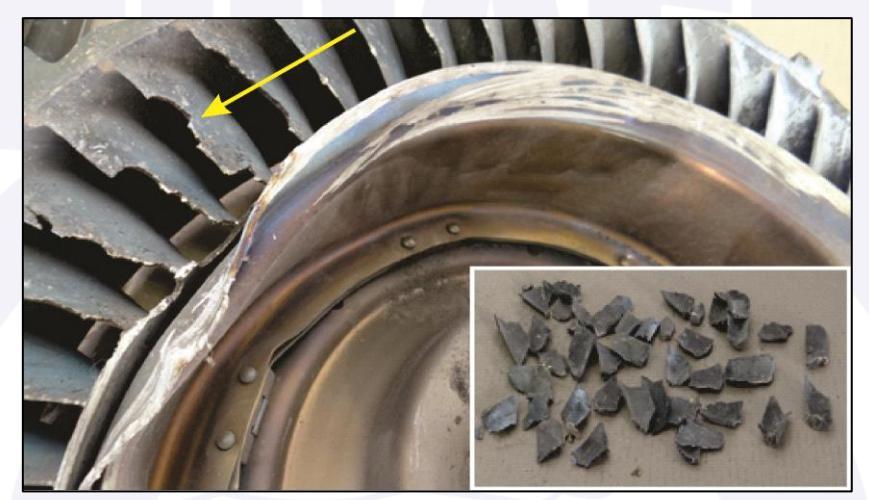
Figure 117 – Detail of the damage to the vanes and intense rubbing of the diaphragm of the same stator (left). In the highlight, fragments of the vanes which were found inside the engine (right).

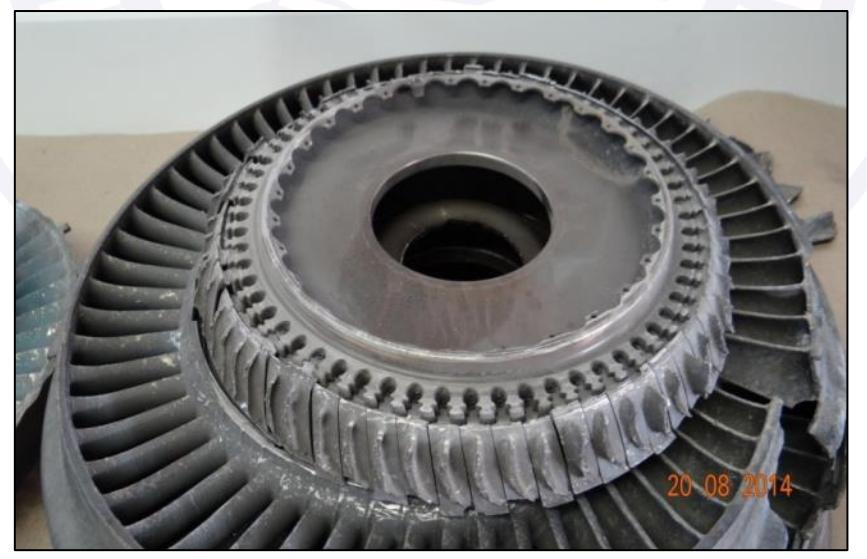
Figure 118 – General view of the set of low pressure compressor turbines, showing the first-stage rotor with all its vanes ruptured.

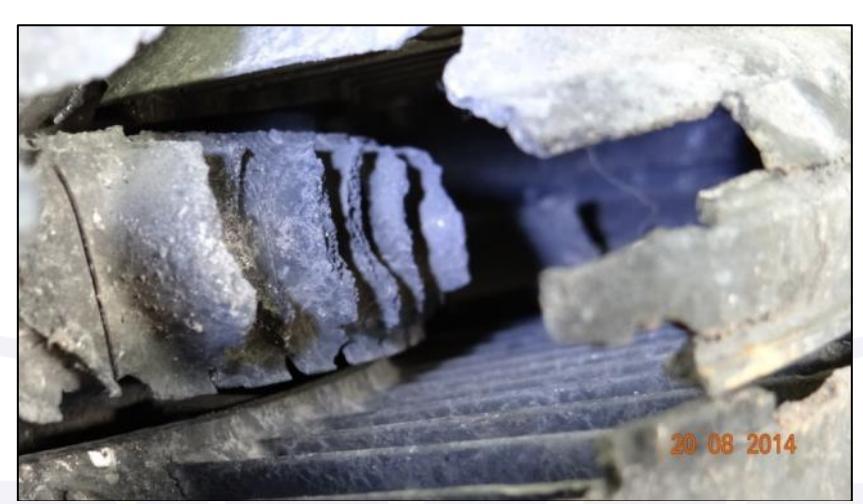
Figure 119 – View of the low pressure compressor turbine second-stage rotor and fan disk with all vanes fractured.

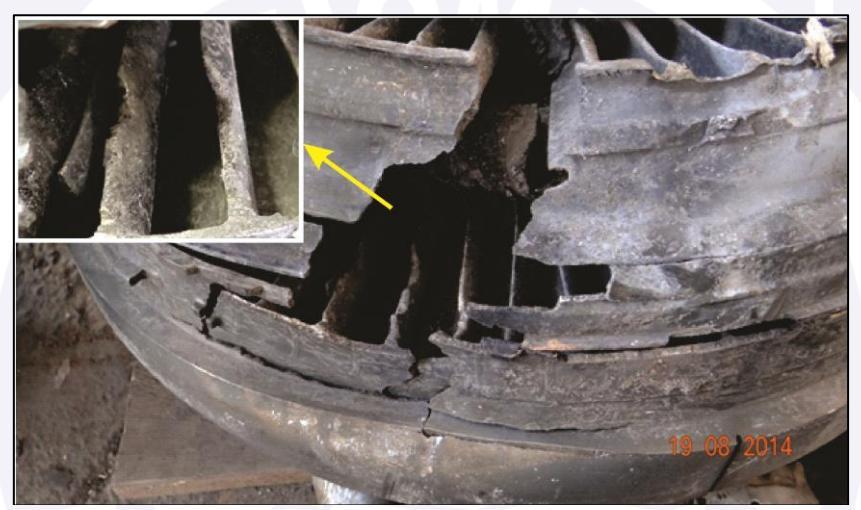
Figure 120 – Damage to the low pressure turbine third-stage stator and fan disk. In the highlight, a closer view.
