COMMAND OF AERONAUTICS AERONAUTICAL ACCIDENT INVESTIGATION AND PREVENTION CENTER

FINAL REPORT IG - 007/CENIPA/2014

OCURRENCE: SERIOUS INCIDENT

TBM700N

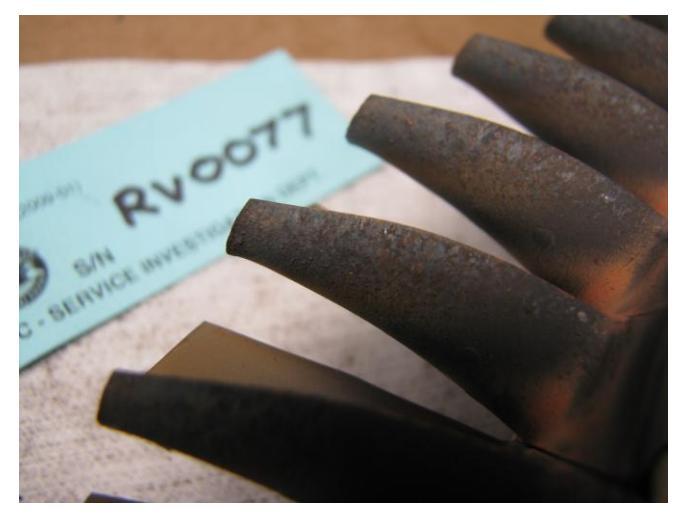
a) During the external inspection, no sign of damage was observed in the engine. Then, the engine was separated in the flange "C" for access to the Hot Section. In this section, the compressor turbine and the power turbine were inspected. Deposited fragments were found on the leading edge of the power turbine rotor blades, which had an overheated condition. The figure below shows in detail the erosion caused by the passage of the fragments through the compressor turbine rotating blades.

Figure 1 – Blades of the compressor turbine rotor.

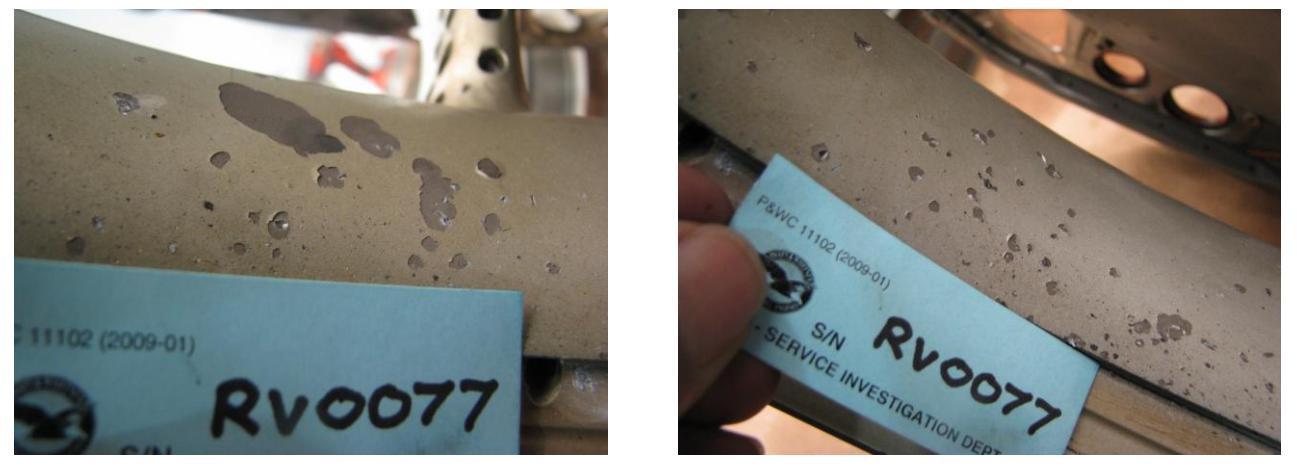
b) The next step was to identify the source of the fragments found in the whole Hot Section of the engine. In the air inlet of the compressor, several marks of impact were identified on the screen in a direction from the inside out. Marks of impact were also found on the framework of the gearbox near the compressor air inlet.

Figures 2 and 3 – Marks of impact on the compressor air inlet.

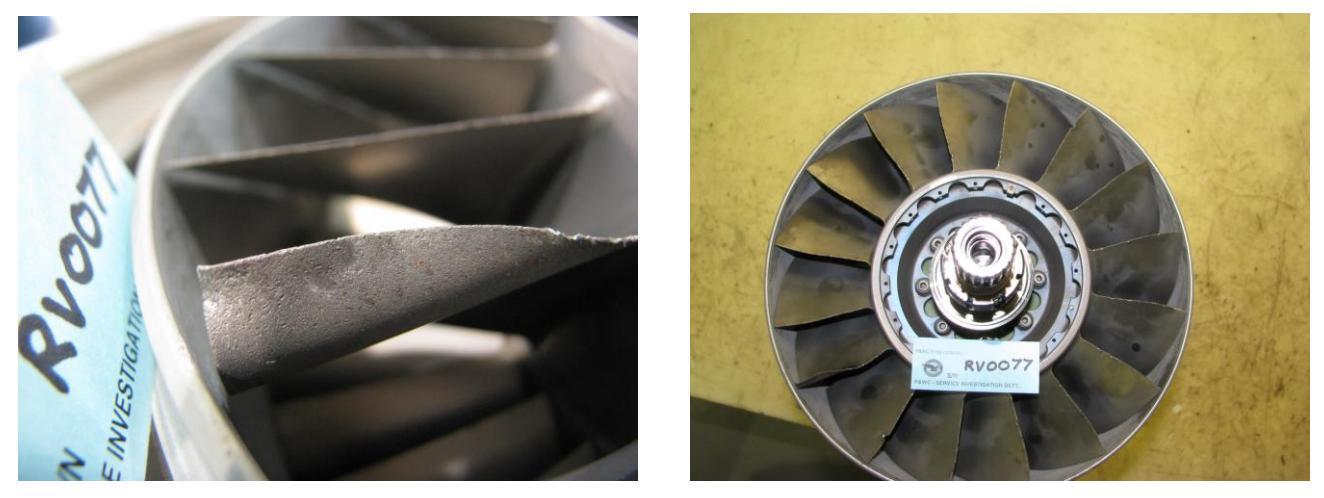
c) It was observed that one of the first stage compressor rotor blades was bent forward, and that the other blades had dents caused either by impact or rubbing. When this rotor was removed, one of the first stage stator blades was found broken. The other stator blades of this stage had serious damage, such as cracks, cuts, dents and deformation caused by the passing of the fragments through them.

e) The fatigue process may have been triggered by a dynamic stimulation caused by the bending of the first stage compressor rotor blade. This happened on account of the fluctuation of pressure and air flow, when this blade passed by the stator blades. The chemical analysis showed that the material was compatible with the design requirements. The other fractures were caused by overload and impact with fragments.

f) After a meeting involving Pratt & Whitney investigators, DCTA representatives and SERIPA V investigators, a consensus was reached that the bending of the rotor blade was compatible with ice impact. Such ice may have built in the engine inlet case. When it was released, it collided with the blade, causing the deformation observed in the pictures below.

Figures 4 and 5 – Close view of the deformation and impact on the other blades.
