FINAL REPORT IG - 551/CENIPA/2014

OCCURRENCE: SERIOUS INCIDENT

PR-RVC

AS-350B3

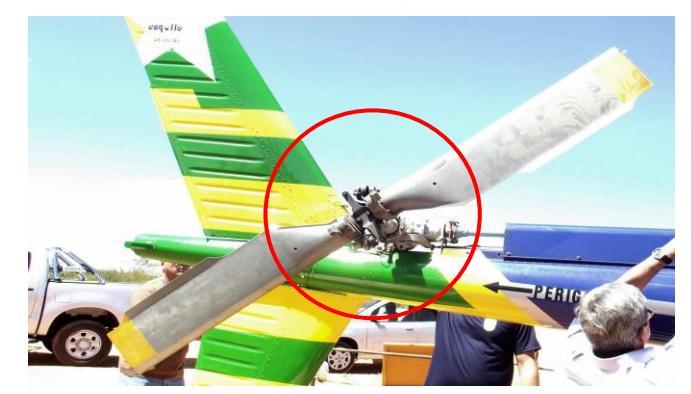
Figure 1 – Location of the half-bearings.

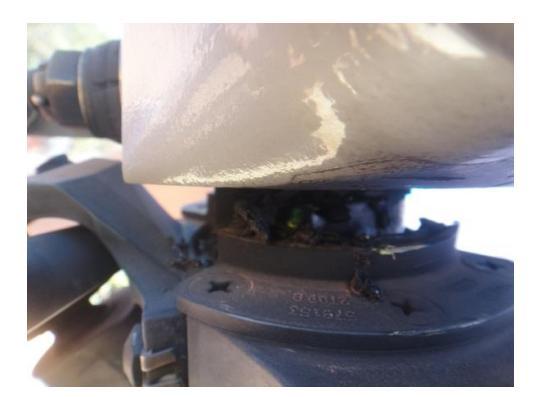
During the initial action, the investigating team observed that the four laminated half-bearings had been damaged.

Figure 2 – Overview of the hal-bearing.

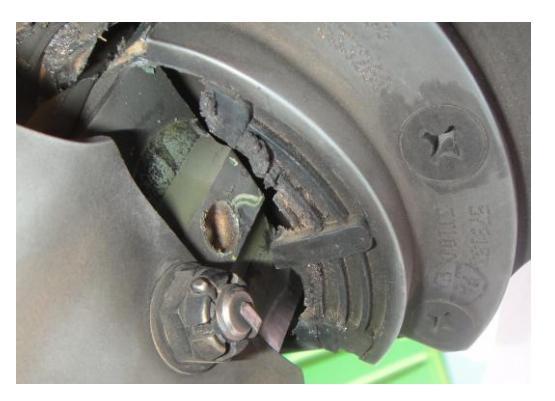
- The observed aspects indicate that the elastomer ended up melting, causing the failure with the interface of the metal blades, as well as the loss of volume and mass of the shock absorbing assembly.

- The melting of the elastomer can be confirmed by the aspects of dripping found in the vicinity of the shock absorbing assembly, where it was possible to observe the melting of the elastomer and its draining along the surface.

Figure 3 – Overview of the elastomer's melting.

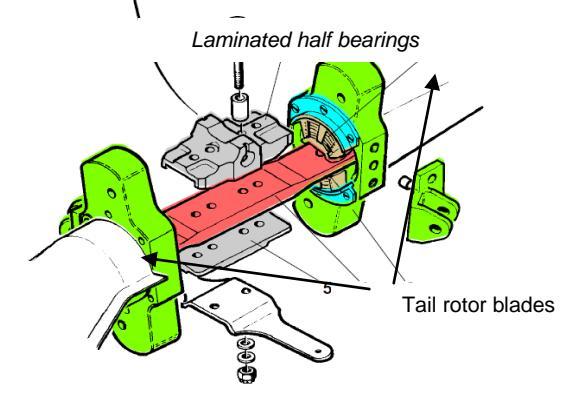
Figure 4 – Assembly of the laminated half bearings in conjunction with the blades of the tail rotor.
