FINAL REPORT
IG - 072/CENIPA/2017

OCCURRENCE:	SERIOUS INCIDENT
AIRCRAFT:	PT-YSW
MODEL:	AS 350 BA
DATE:	05MAY2017

This is the Final Report of the 05MAY2017 serious incident with the AS 350 BA aircraft model, registration PT-YSW. The serious incident was classified as “[BIRD] Bird Strike”.

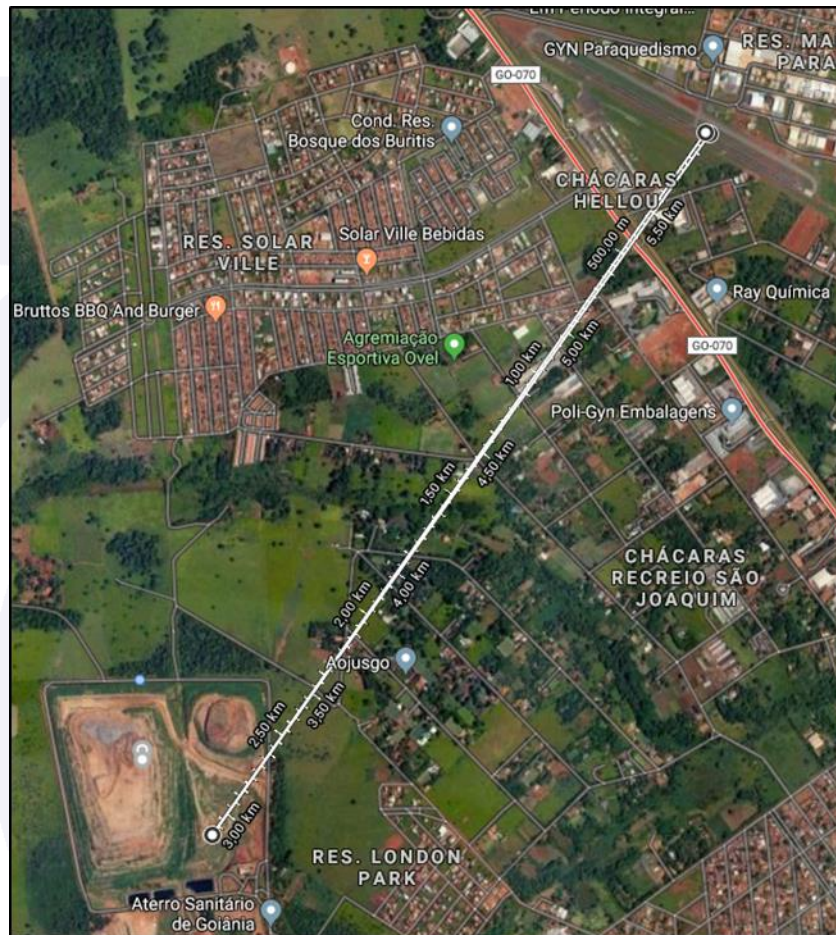
In the city of Goiânia - GO, there were activities with potential wildlife attraction among them the Goiânia Sanitary Landfill stood out, located at 16°38'44"S / 049°21'55"W, at about 3km away from SWNV (Figure 2).

Figure 2 - Distance from the sanitary landfill to SWNV.
(Source: Google Maps)

In this sense, the possibility was raised that the Goiânia Sanitary Landfill, at about 3km away from SWNV, was configured as a possible attractive wildlife activity and represented a potential risk for air traffic at the National Aviation Aerodrome, since the sanitary landfill was within the ASA.

Influence of the environment: the existence of a sanitary landfill, at about 3km away from the SWNM runway, constituted an activity with attractive wildlife potential, which may have contributed to the presence of the vulture near the Aerodrome.

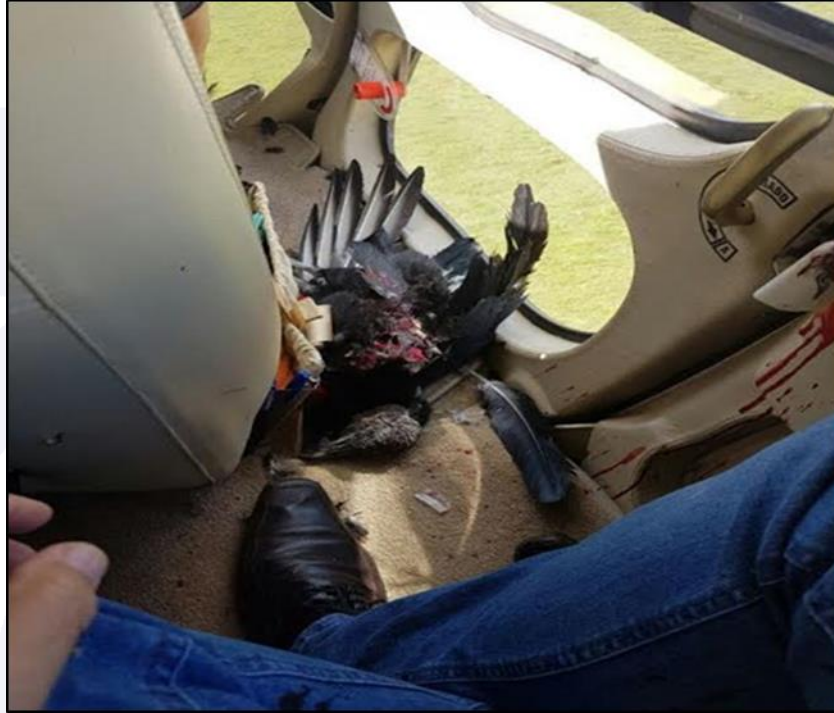
During the final approach to landing on SWNV, approximately 3nm away, the aircraft collided with a black-headed vulture (Figure 5).

(Figure 5) - Black-headed vulture.
