**FINAL REPORT**  
**A - 101/CENIPA/2020**

<b>OCCURRENCE:</b>	<b>ACCIDENT</b>
<b>AIRCRAFT:</b>	<b>PP-GMC</b>
<b>MODEL:</b>	<b>AB-115</b>
<b>DATE:</b>	<b>26AUG2020</b>

This is the Final Report of the 26AUG2020 accident with the AB115 aircraft model, registration PP-GMC. The accident was classified as “[ARC] Abnormal Runway Contact and [RE] Runway Excursion”.

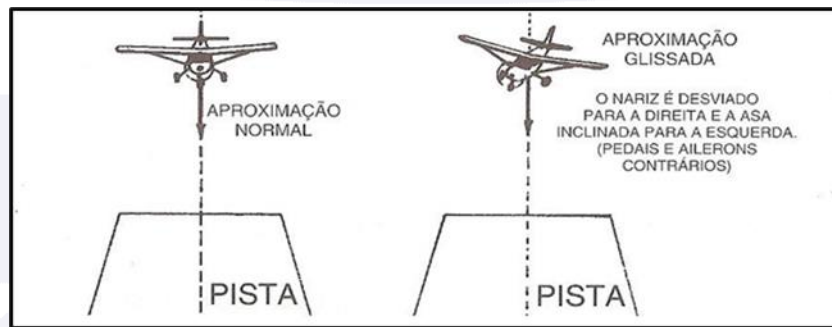
Figure 3 - Normal and "slipping" approach image.

Definition 1 - "slipping"

Loss of airplane height due to side slipping, without any change in the flight trajectory.

During a "slipping" approach, the flaps were retracted from 45° to 30°, which reduced lift and caused the plane to perform a slope lower than normal.
