**FINAL REPORT**  
**IG - 048/CENIPA/2017**

**SERIOUS INCIDENT**

**PP-PTQ**

**ATR-72-212A**

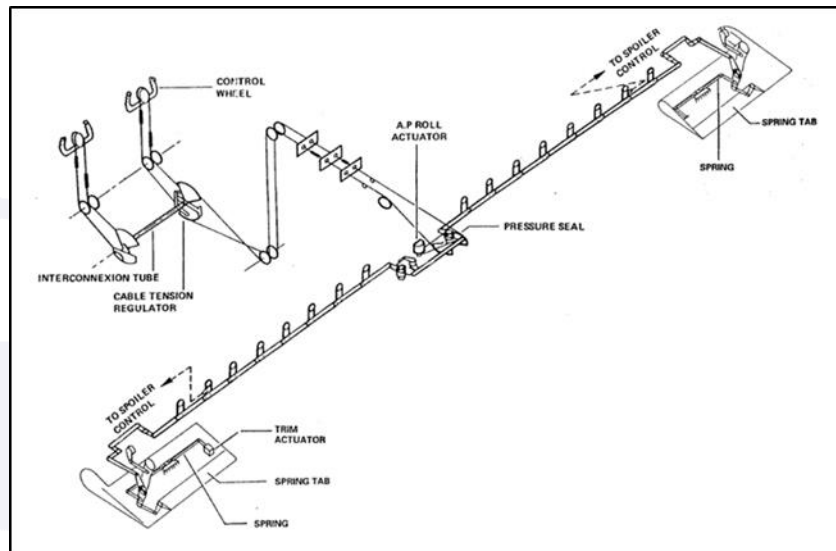
Figure 3 - Schematic of the ailerons control system.

Figure 3 shows the location of the Servo Drive in the aileron control system. In it, the component is identified as A. P. ROLL ACTUATOR.

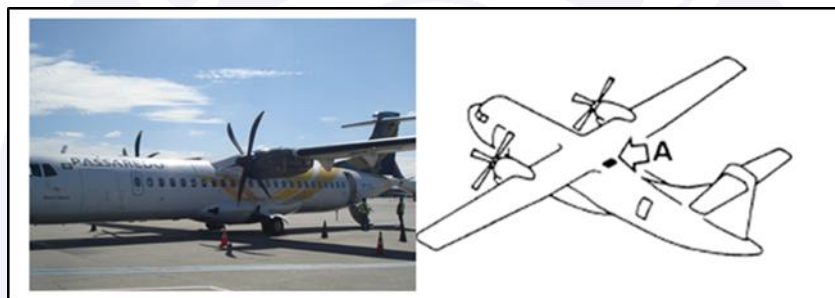
Figure 4 - General view of the aircraft and location of the Servo Drive.

Figure 4 shows the location of the Servo Drive on the aircraft (A).

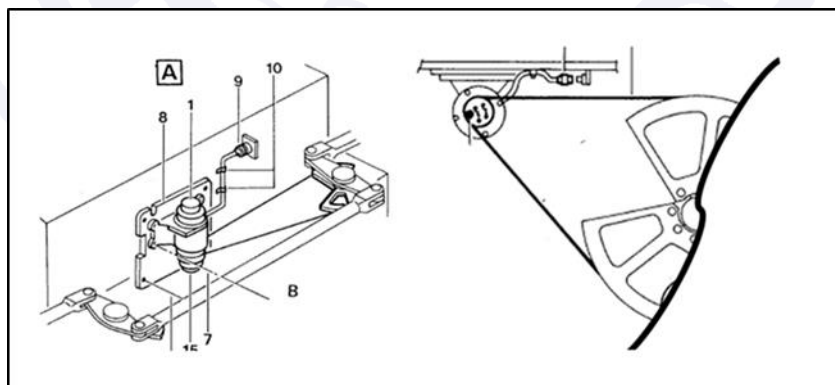
Figure 5 - Servo Drive (item 1) connected to the bellcrank using PN S2211001100000 control cables.

Figure 5 shows the Servo Drive (item 1) connected to the bellcrank, using the PN S2211001100000 control cables.

The examination of the aircraft showed that one of the control cables PN S2211001100000, which connected the autopilot's Servo Drive to the aileron control bellcranks (Quadrant Assy), was broken.

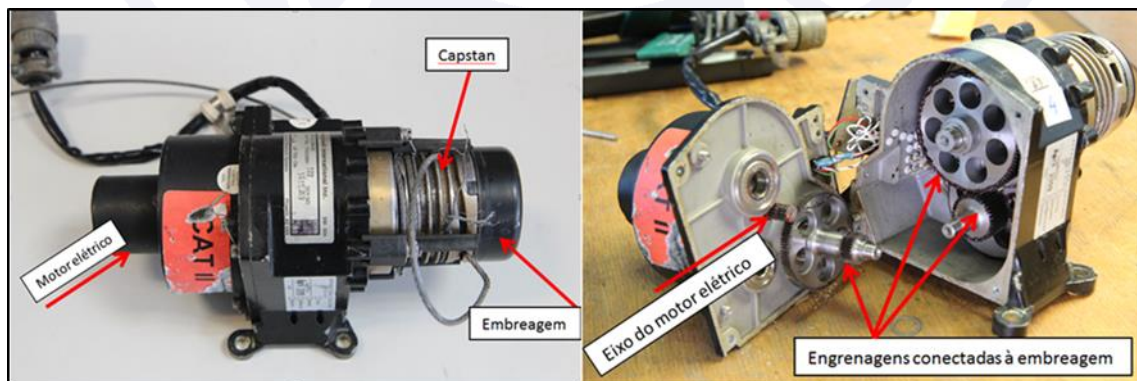
The Servo Drive had the following components: an electric engine at one end; a gearbox and a drum, called capstan, in the central body; and, at the opposite end, a mechanism that played the role of clutch. This last device had the function of mechanically connecting and disconnecting the capstan to the electric engine (Figure 7).

Figure 7 - Details of the Servo Drive components.

The partial disassembly of the Servo Drive showed that, after removing the broken control cable, the capstan could rotate freely. This free-rotation feature of the Servo Drive was what allowed the pilot to act on the flight controls when the autopilot was not engaged.

Thus, it was concluded that the capstan was locked due to the control cable becoming entangled in the drum after breaking. In turn, the restrictions on the aileron command were due to the capstan being blocked by the broken cable.

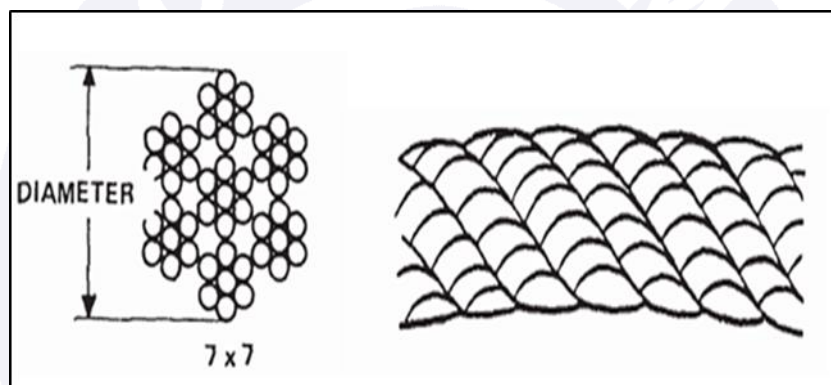
Figure 11 - Drawing of a transversal and lateral section of a cable PN S2211001100000.

The control cable PN S2211001100000 is a 7 x 7 construction wire rope. A wire rope of this construction consists of 6 outer strands of 7 wires each laid around a strand core of 7 wires.

According to ATR, in service experience shows 16 events over approximately 26 million flight cycles of AP roll cable failure amongst ATR 72-212A history. The current definition of the cable is 7x7. The AP actuator capstan diameter increases the sensitivity to internal cable friction. The definition of a cable with the same external dimensions but having a higher number of wires will decrease the relative movement of the wires during the actuation of the cable hence will reduce the internal friction as per ARP 5770. ATR has launched the development of a modification to replace the cable 7x7 by a cable 7x19.

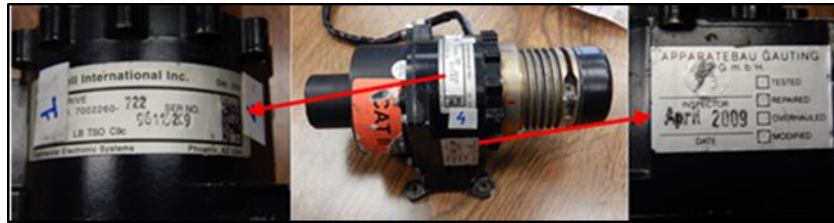
The analysis started with the identification of the Servo Drive, followed by a visual check, in order to know the condition in which the part had arrived for the analysis.

Figure 16 - Servo Drive and its identification plates.

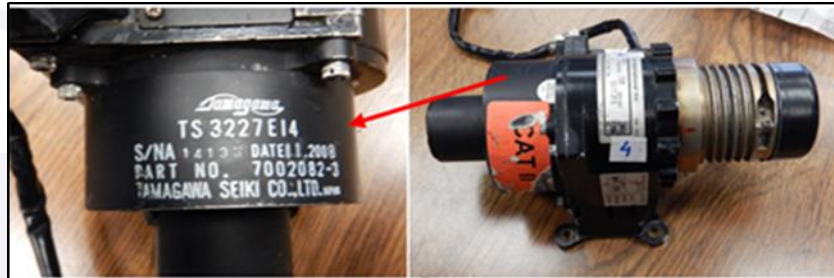
Figure 17 - Servo Drive and the identification of the electric engine.
