FINAL REPORT
A - 515/CENIPA/2021

OCCURRENCE:	ACCIDENT
AIRCRAFT:	PP-SAM
MODEL:	PC-12/47
DATE:	02MAR2012

This is the Final Report of the 02MAR2012 accident with the PC 12/47 aircraft model, registration PP-SAM. The accident was classified as “[WSTRW] Windshear/Thunderstorm”.

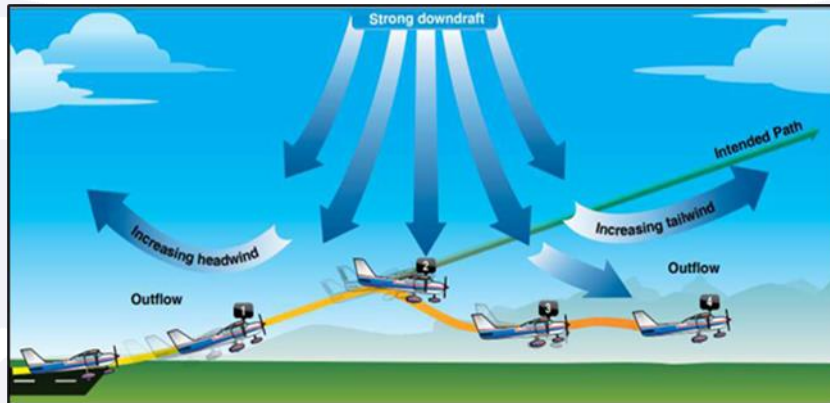
Figure 5 - Effects of the descending gust on an aircraft's take-off.
Source: FAA AC 00-6B/2016.

The strength of this air stream is enhanced by the pressure difference between the warm surface air and the cool air near the cloud base. The effects of the descending gust on an aircraft taking off can be seen in Figure 5.

Furthermore, what is described in Figure 5, when contrasted with the information displayed in the graph in Figure 4, allows visualizing typical windshear velocity gradients.
