**COMANDO DA AERONÁUTICA**  
**CENTRO DE INVESTIGAÇÃO E PREVENÇÃO DE**  
**ACIDENTES AERONÁUTICOS**

**FINAL REPORT**  
**A - 015/CENIPA/2018**

| <b>AIRCRAFT:</b> | <b>PP-HLI</b> |
| <b>MODEL:</b> | <b>R44 II</b> |

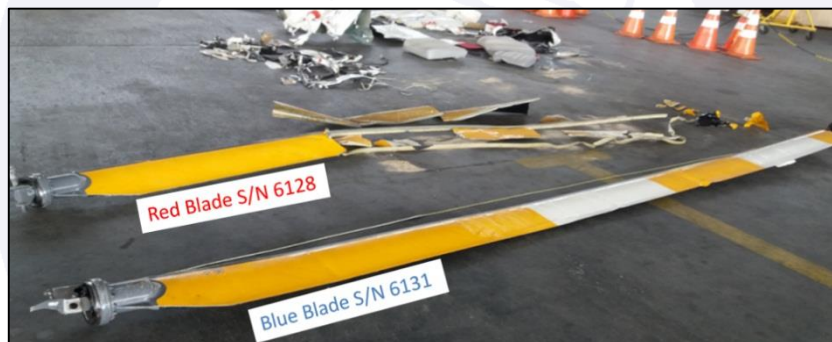
Figure 25 - General aspect of the main rotor blades.

The main rotor blades were P/N C016-5 and had S/N 6128 and S/N 6131. For maintenance control purposes, the blades were identified by a color code. The red color was assigned to the S/N 6128 blade and the blue color was assigned to the S/N 6131 blade (Figure 25).

Despite some damage and deformation, the blue blade (S/N 6131) was found entirely and in better conditions than the red blade. These characteristics indicated that the blue blade did not have an inflight failure (Figure 25).

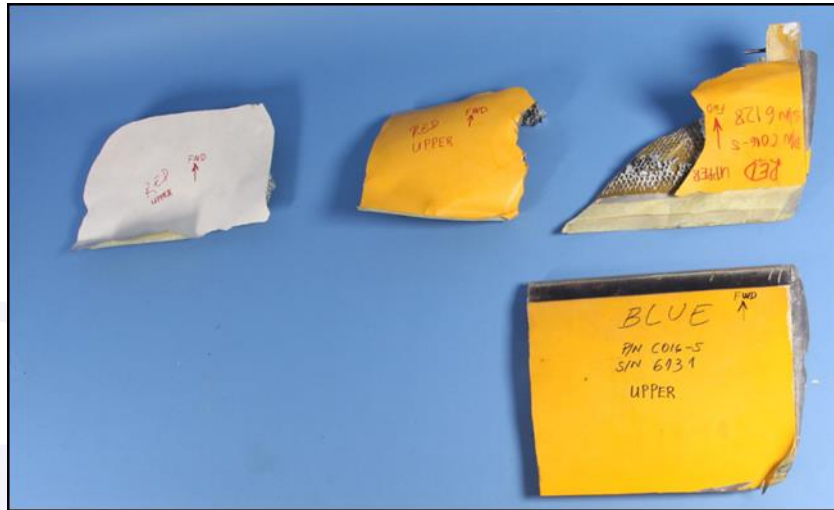
Figure 26 - Fragments of the main rotor blades sent for laboratory tests.  
(Source: Adapted from NTSB).

The red blade (S/N 6128) has been found with substantial damage from the middle section to the tip region. Some parts of the middle section were not recovered. The tip of this blade was found sectioned and separated from the rest of the structure. Red blade fragments were sent for laboratory examination at the NTSB facility in Washington, DC - USA (Figure 26).

The blue blade (S/N 6131) was found with some bents along with its structure. The tip of this blade was manually sectioned by the Investigation Team and sent for laboratory examination at the NTSB facility in Washington, DC - USA (Figure 26).

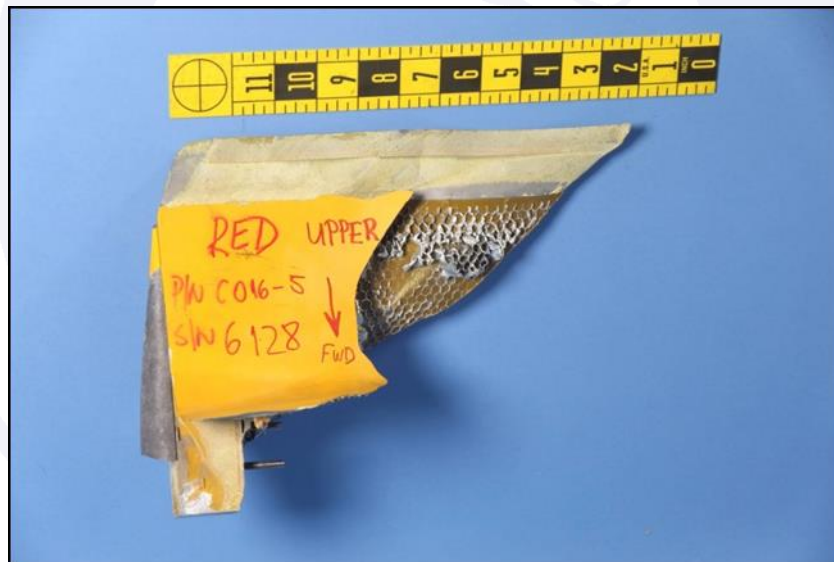
Figure 27 - Red blade fragment (S / N 6128) sent for laboratory tests.  
(Source: Adapted from NTSB).

The red blade tip (S/N 6128) was found sectioned and separated from the rest of the helicopter wreckage. Visual examinations performed at the tip of the red blade found the following (Figures 27, 28 and 29):

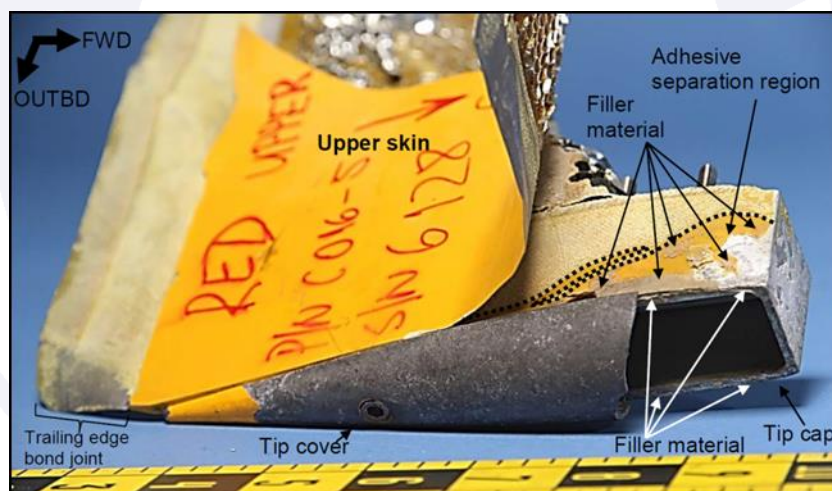
Figure 31 - Appearance of the red blade tip (S/N 6128).  
(Source: NTSB).

Visual examination of the blade revealed areas of fracture in the polymer layer used for bonding the skins. These fractures showed signs of adhesive separation, cohesive separation, and mixed adhesive/cohesive separation (Figure 31).

Cohesive separation occurs when a crack propagates within the adhesive material, while adhesive separation occurs when a crack propagates at the adhesive-metal interface.

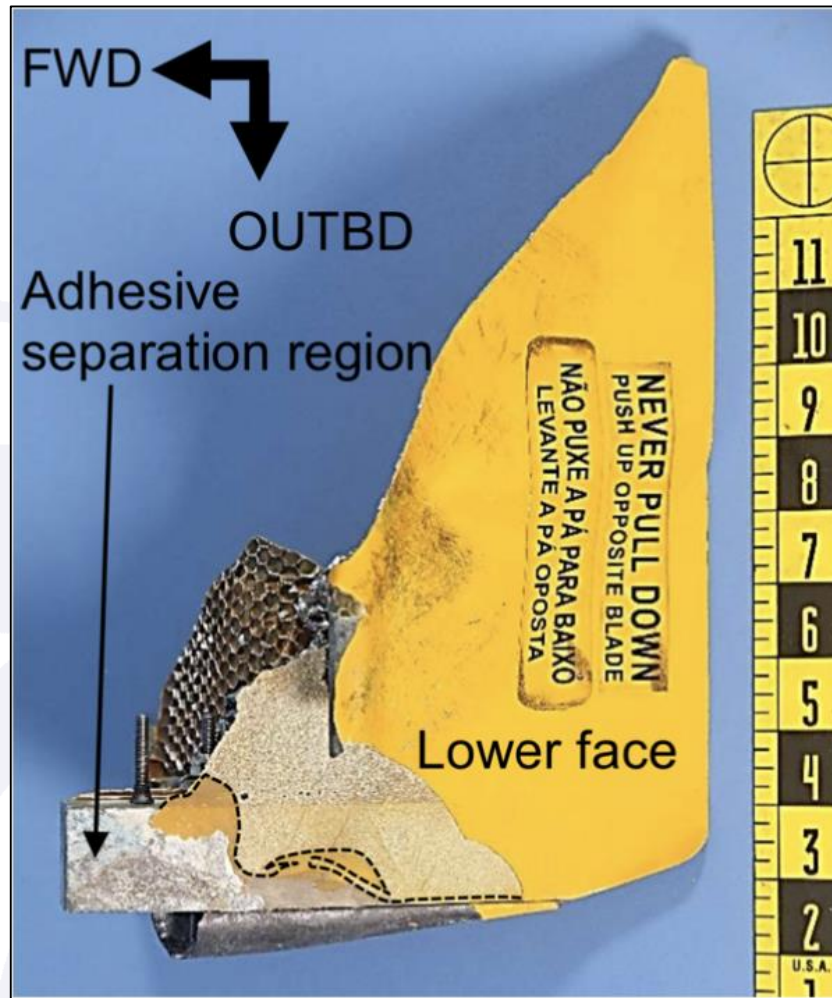
Figure 36 - General appearance of the lower surface of the red blade (S/N 6128).  
(Source: Adapted from NTSB).

Areas marked by a dashed line indicate the region where adhesive separation was noted (Figure 36).

The largest region with adhesive separation was found in the forward portion of the lower surface. In this region was also detected the presence of material with color and characteristics different from the original adhesive material used in the manufacture of the blade.

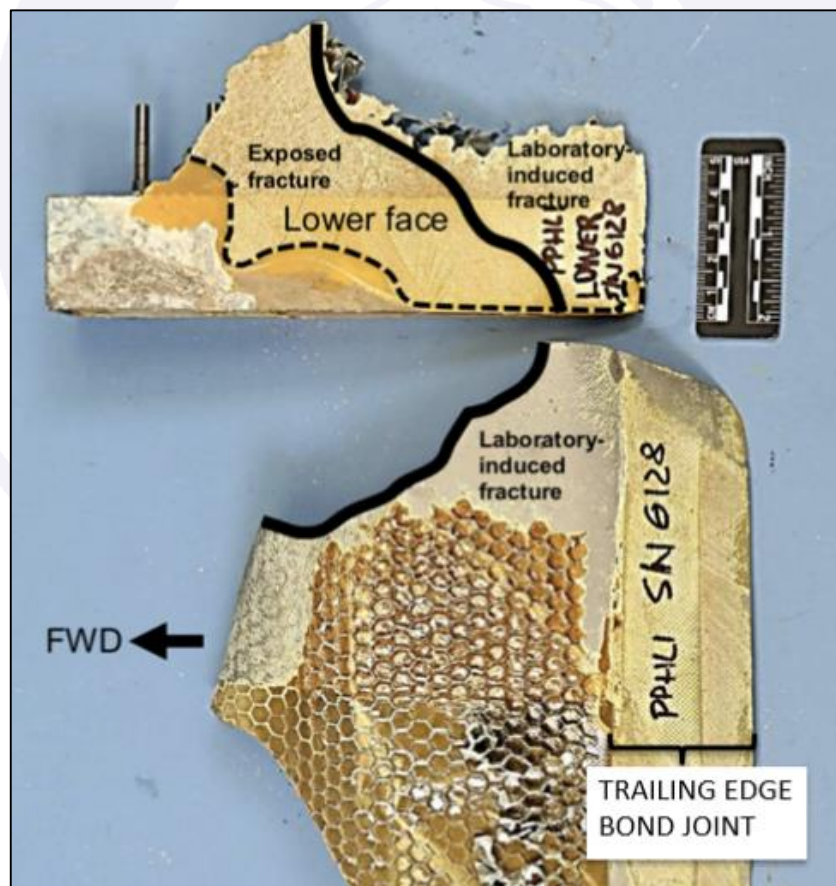
Figure 38 - Lower skin of the red blade (S/N 6128) after removal performed in the laboratory.  
(Source: Adapted from NTSB).

The lower skin was also removed with the aid of pliers. After the removal of the skin, the adhesive joints underneath the lower skin were exposed and could be examined (Figure 38).

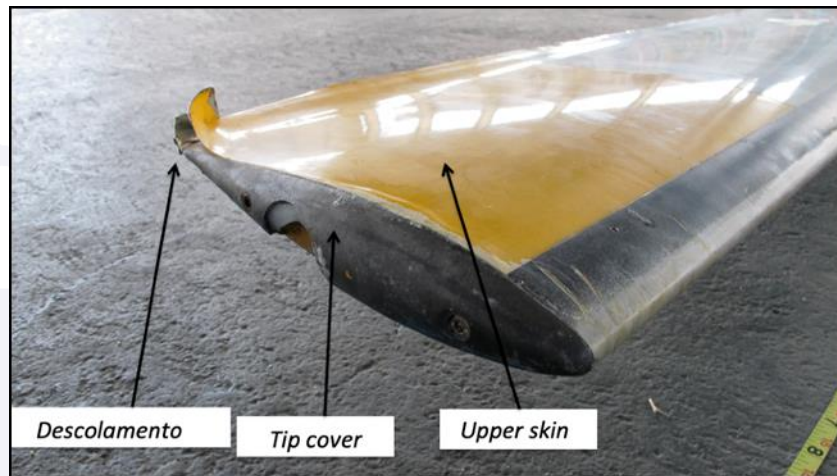
Figure 39 - General aspect of the blue blade (S/N 6131).

The blue blade (S/N 6131) was found with some bents along with its structure (Figure 39).

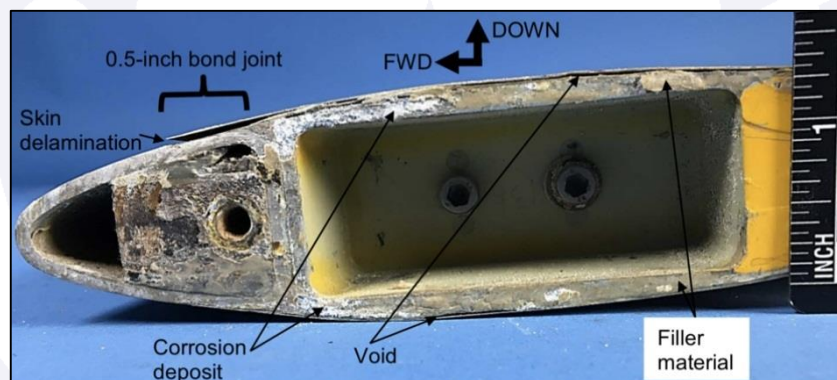
Figure 40 - Outer region of the blue blade tip cap (S/N 6131) after removal of the tip cover.

During the visual inspection, after removing the tip cover, it was possible to observe corrosion, skin delamination and the presence of filler material in the outboard region of the tip cap (Figure 40).

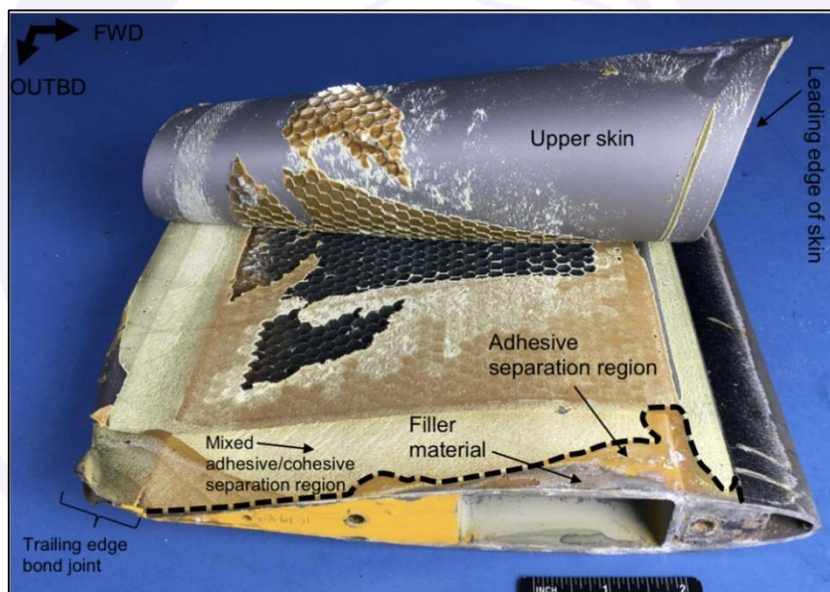
Figure 42 - Upper surface of the blue blade (S/N 6131) after removal of the upper skin.  
(Source: Adapted from NTSB).

The polymer used for blade gluing presented areas with adhesive separation more concentrated in the external region of the forward portion of the blade.

The areas where the adhesive separation was found corresponded to the areas identified with signs of debonding during the tap test (Figure 42).

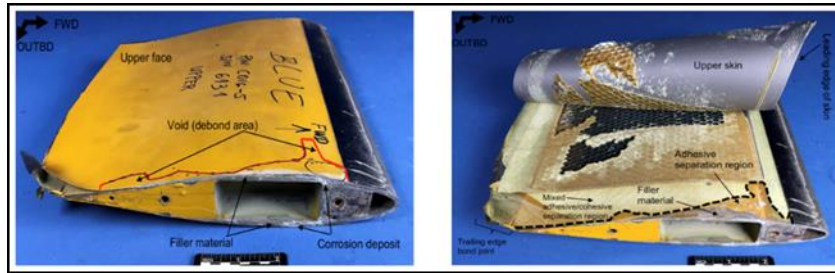
Figure 43 - Upper surface of the blue blade (S/N 6131) in two moments: Left, after the tap test; and on the right, after removing the upper skin.  
(Source: Adapted from NTSB).

Comparing the pictures in Figure 43, it is possible to notice the similarity between the area with signs of debonding, identified by the tap test, and the area where the adhesive separations were found, after the removal of the upper skin of the blue blade (S/N 6131).

After the tap test, the blue blade skins were manually removed. Examination of the inner parts of the blue blade found that in the externally demarcated areas during the tap test, there was internal debonding of the blade skin (Figure 43).

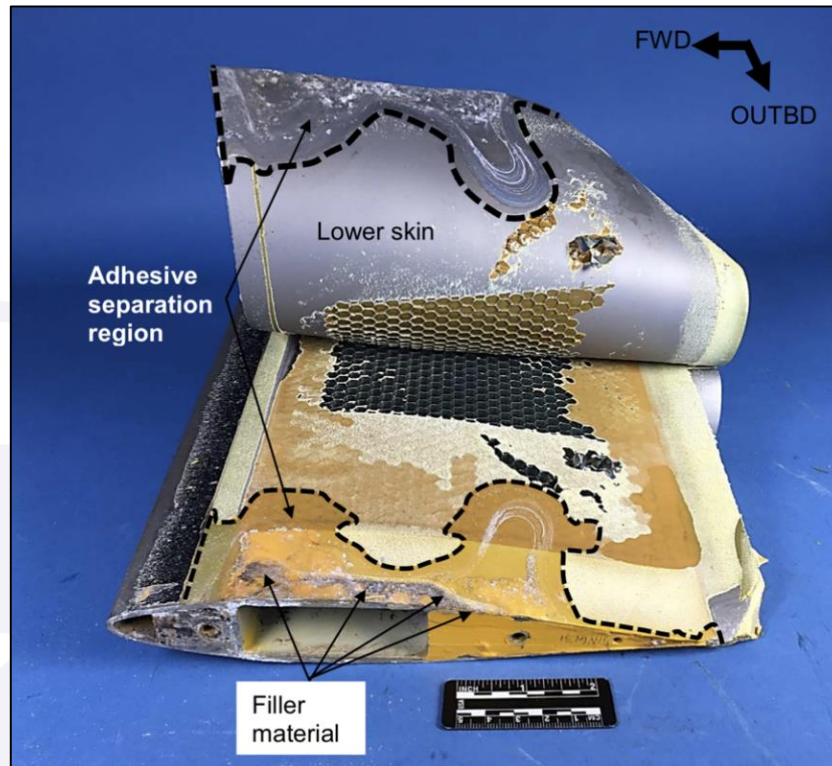
Figure 45 - Lower blue blade surface (S/N 6131) after the lower skin removal.  
(Source: Adapted from NTSB).

The area where the adhesive separation was present also contained filler material (Figure 45).

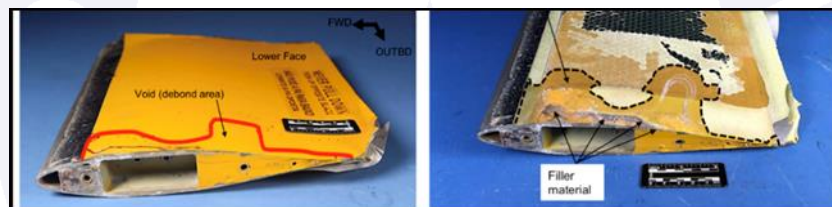
Figure 46 - Bottom surface of the blue blade (S/N 6131) in two moments: Left, after the tap test; and on the right, after removing the lower skin.  
(Source: Adapted from NTSB).

Comparing the pictures in Figure 46, it is possible to notice the similarity between the area with signs of debonding, identified by the tap test, and the area where the adhesive separation was found after the removal of the lower skin of the blue blade (S/N 6131).

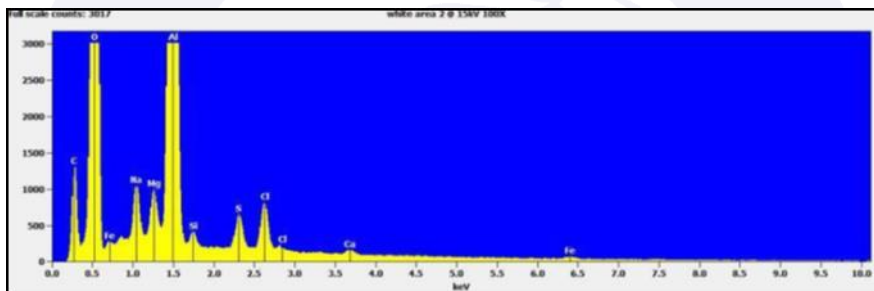
Although the collection points had different colors, the exams found out that the composition of the collected material was similar, showing that the corrosion in points “1” and “2” was of the same type (Figures 48 and 49).

Figure 48 - Chemical composition of the sample collected in point 1.

The EDS examinations identified oxygen (O) and aluminum (Al) as the main elements present in the samples. The presence of these components indicated that there was corrosion of the base metal (aluminum) of the blade. The results were compatible with the presence of aluminum oxide from the corrosion found in the tip cap.

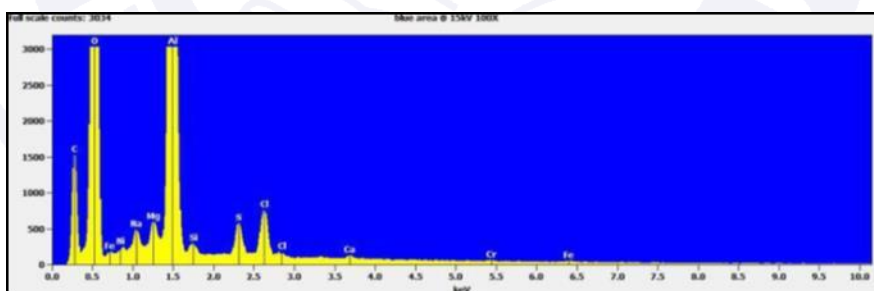
Figure 49 - Chemical composition of the sample collected in point 2.

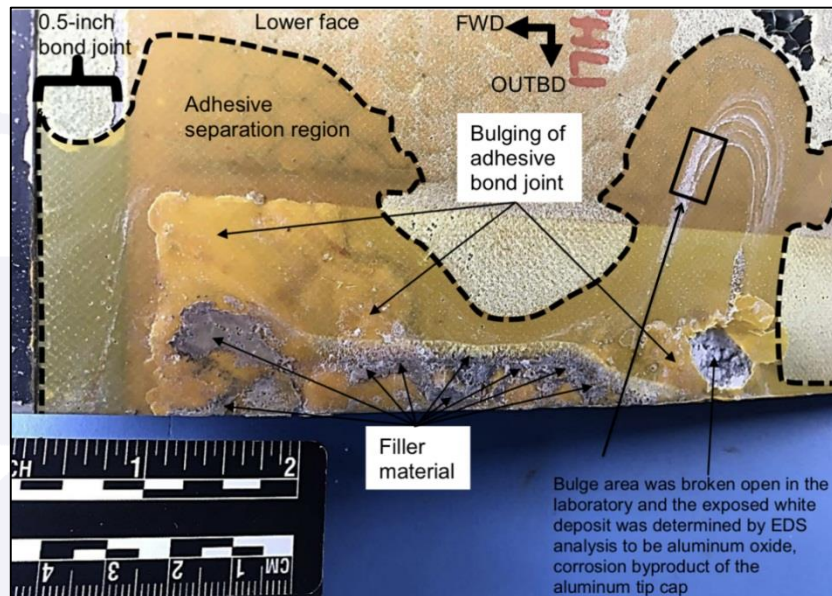
In the blue blade, regions with bulging were found under the original polymer layer used by the manufacturer to bond the blade. A cut in the polymer layer was made to access

the white material underneath the bulging regions. A thin layer of white material was also found above the original polymer (Figure 50).

Figure 50 - Points where the samples were collected in the blue blade (S/N 6131).  
(Source: Adapted from NTSB).

The EDS analysis of the material collected above the polymer layer (highlighted in the black rectangle of Figure 50) identified higher sodium (Na), chlorine (Cl) and peaks of lower intensity of calcium (Ca), potassium (K), sulfur (S), silicon (Si), aluminum (Al), magnesium (Mg), oxygen (O) and carbon (C). Larger scale substances found (sodium and chlorine) are common in saline environments.

The EDS analysis of the material collected below the polymer layer identified higher intensity peaks of aluminum (Al) and oxygen (O). The presence of these components indicated that there was corrosion of the base metal (aluminum) of the blade. The results were compatible with the presence of aluminum oxide from the corrosion found in tip cap.

Corrosion was present above and below the original polymer layer, as seen in Figures 47 and 50. The presence of corrosion below the adhesive layer compromised the skin adherence to the spar and contributed to the red blade inflight failure.

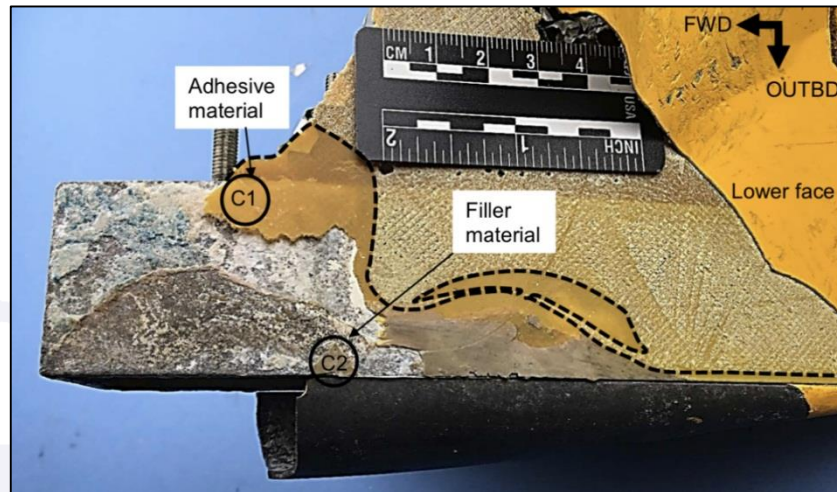
The samples, identified in Figure 51 by circles C1 and C2, were collected from the lower surface of the red blade tip cap (S/N 6128).

Figure 51 - Lower surface of the red blade indicating the areas from where samples C1 and the filler material found during the investigation were collected (C2).  
(Source: Adapted from NTSB).

The spectrum examination of the original material (C1 - adhesive smooth side) identified absorbance peaks consistent with an epoxy resin derivative, which were compatible with the original material information provided by the manufacturer (RHC).

The spectrum of the filler material (C2 - filler smooth side) examination was similar to the spectrum of the original material, indicating that the filler material was also an epoxy resin derivative. However, the absorbance peaks observed in the C2 sample examination did not have the intensity and definition as the same absorbance peaks observed in the spectrum of the original material (Figure 52).

material was found in both blades, both on the upper and lower surfaces. The substance had signs of propagation toward the inner regions of the blades, indicating that it had been inserted, or injected, from the outside. Spectrometric analyses concluded that the chemical product found was an epoxy resin derivative (Figure 51).

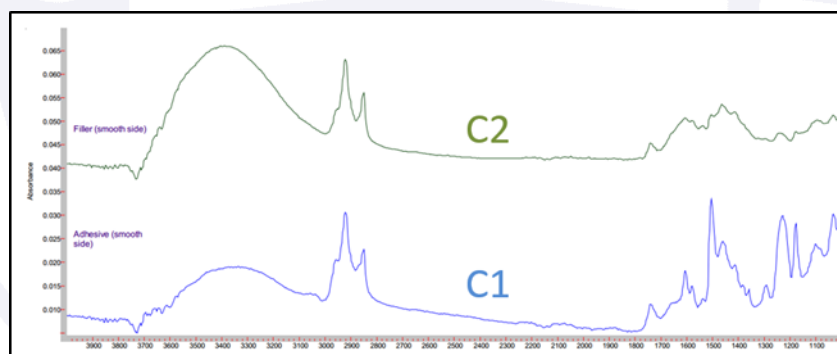
Figure 52 - FTIR spectrum of samples collected at C1 and C2.  
(Source: Adapted from NTSB).

This difference between the absorbance peaks may have occurred for several reasons, including contamination, water intrusion and lack of curing.

However, the absorbance peaks observed in the foreign material examination did not have the same intensity and definition as found in the original polymer. This showed that they were different materials with different chemical compositions. The difference between the absorbance peaks may have been caused, among other factors, by the presence of humidity (Figure 52).

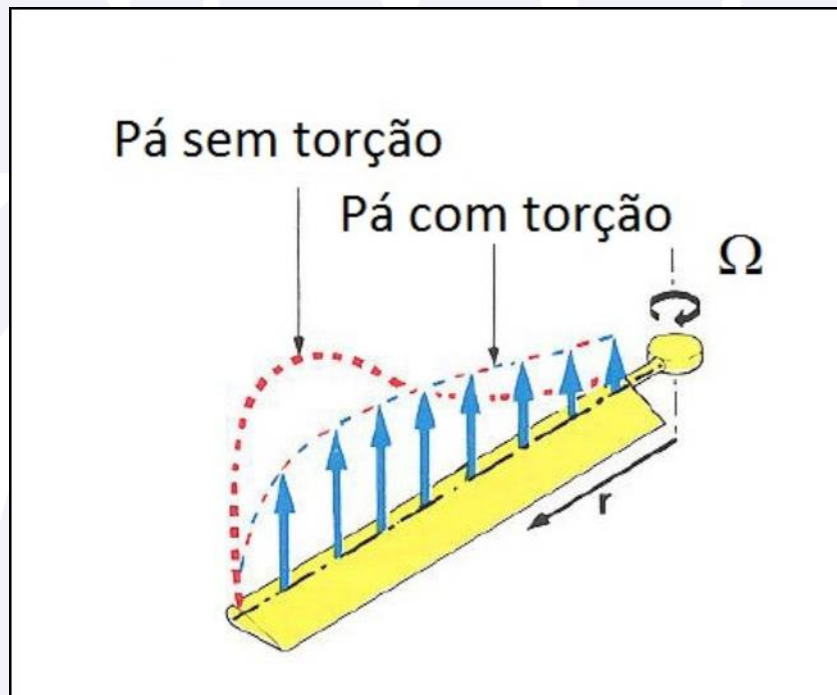
Typically, the lift distribution along the blade span of a helicopter is shown along the red dotted line in Figure 53.

Figure 53 - Lift distribution along the blade wingspan.  
(Source: IPEV).

In geometrically torsioned blades, such as the R44 blades, this torsion tends to reduce the aerodynamic load in the tip region when compared to a non-torsioned blade.

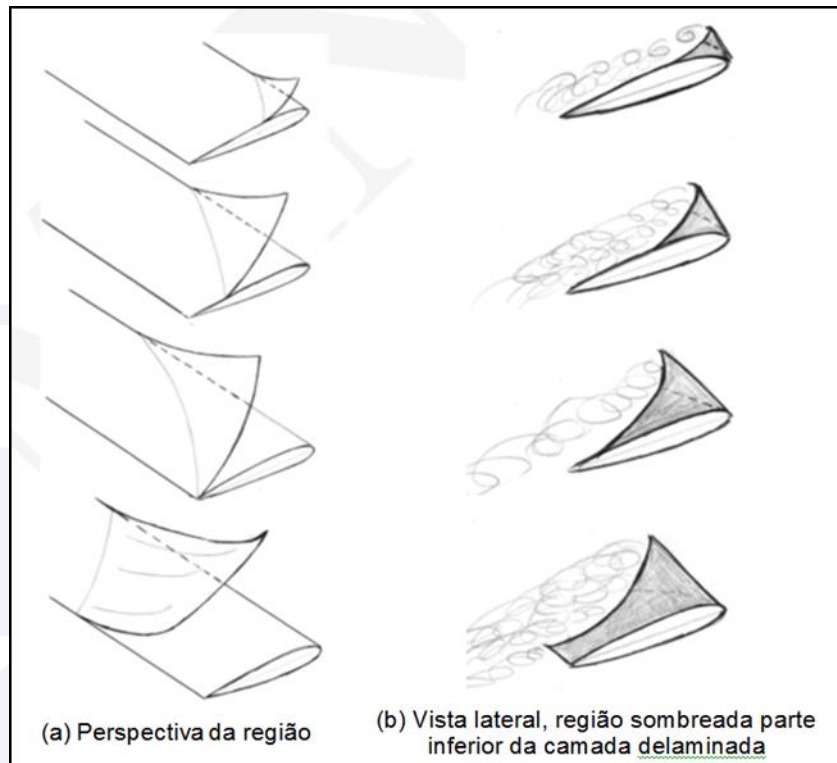
Figure 54 - Influence of the upper skin debonding on the airflow of a blade in flight.  
(Source: IPEV).

The Figure illustrates the evolution of a debonding (delamination) started at the leading edge of the blade tip.

The left column of Figure 54 illustrates the evolution of the upper skin debonding in a blade during flight. The right column demonstrates airflow behavior as it passes through the debonded area. The shaded region refers to the surface below the region where the upper skin debonding is occurring.

Figure 54 shows that even when the debonded area of the upper skin is small, the change in airflow is considerable. Initially, the disturbance in the airflow is restricted to a small region at the tip of the blade. As the debonded area of the upper skin increases, so does the disturbing region of airflow along the blade.

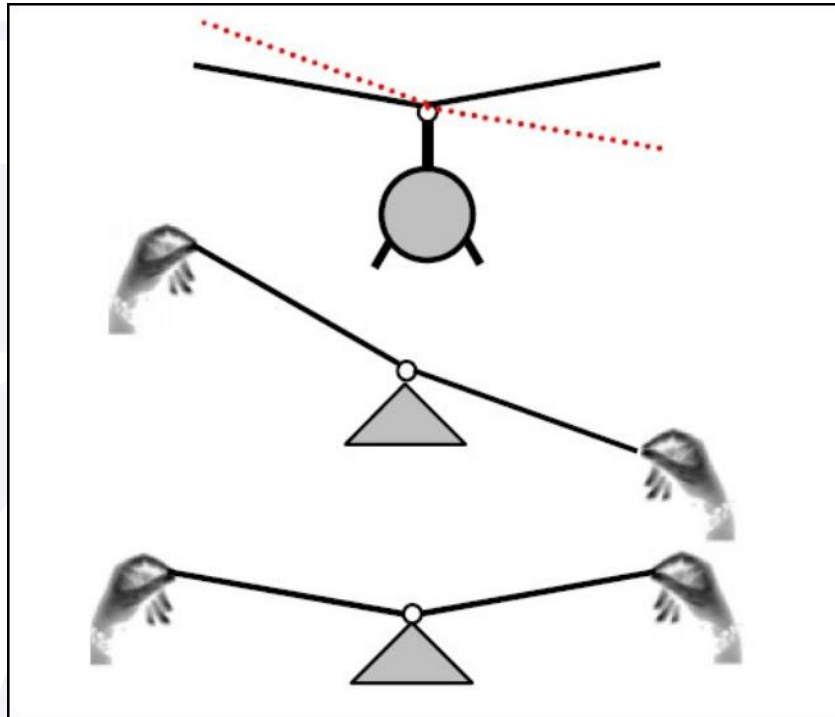
“... another effect to be considered on the dynamics of the teetering rotor-equipped aircraft is that the fuselage does not keep up with the inclination of the disc. This way, the helicopter fuselage (Figure 55) will not accompany any kind of response of the rotor in flapping derived, for example, from the skin debonding of the blade. ”

Figure 55 - Representation of the disc movement of a teetering rotor in relation to the helicopter fuselage.  
(Source: IPEV).

“... a flapping angle greater than approximately  $-16^\circ$  from the plan of the R44 rotor head could already cause the tip of the blade to touch the tailcone, considering the blade as rigid and taking into account that the fuselage does not follow the inclination of the rotor disc. With the flexibility of the blade, this angle could be even smaller. This order of magnitude could be obtained during excessive flapping oscillations. ”

According to the IPEV, these consequences could reach the point of exceeding the minimum separation limits between the main rotor and the fuselage of the aircraft and could cause a contact between the main rotor blades and the tailcone (tailcone strike).

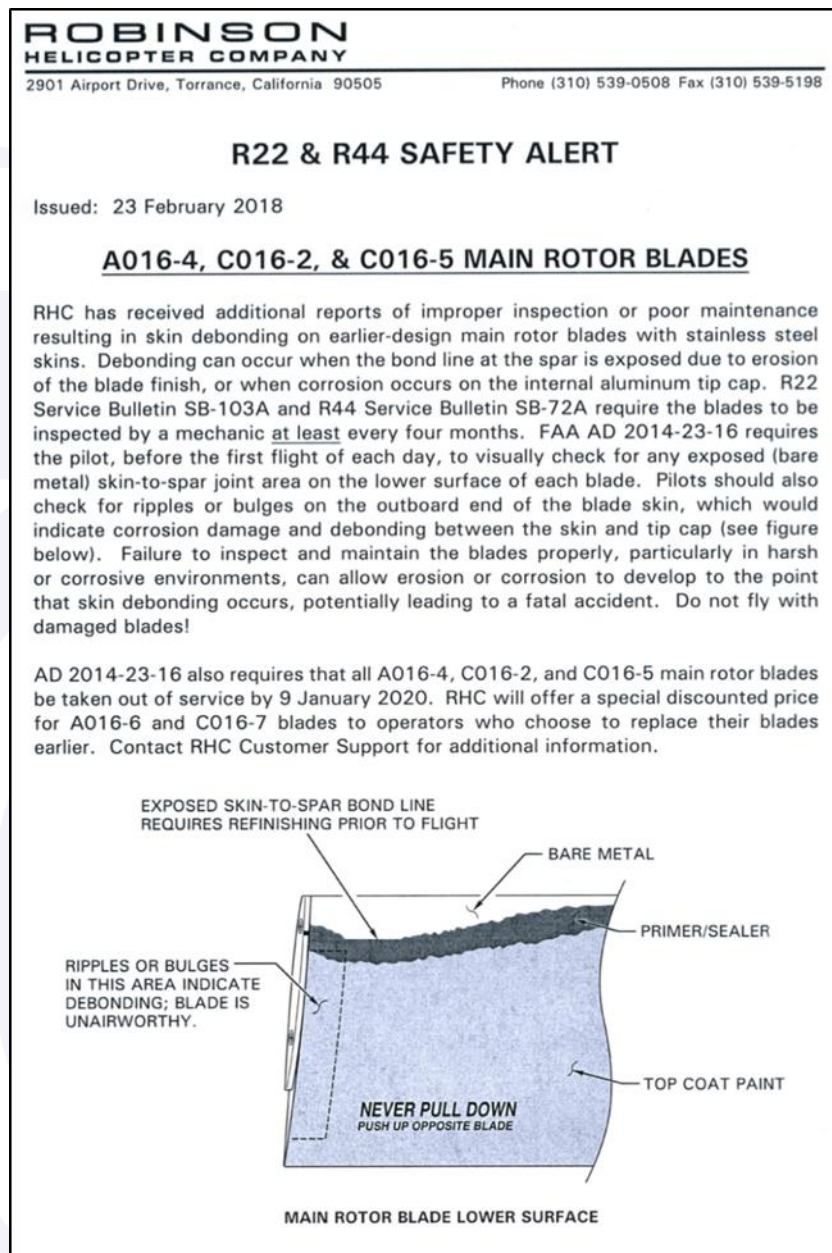
Figure 57 - Safety Alert published by the RHC on 23FEB2018.  
(Source: [www.robinsonheli.com](http://www.robinsonheli.com)).

The published document stressed the importance of the procedures set out in the AD 2014-23-16 for P/N A016-4 (R22), P/N C016-2 (R44) and P/N C016-5 (R44) main rotor blades.

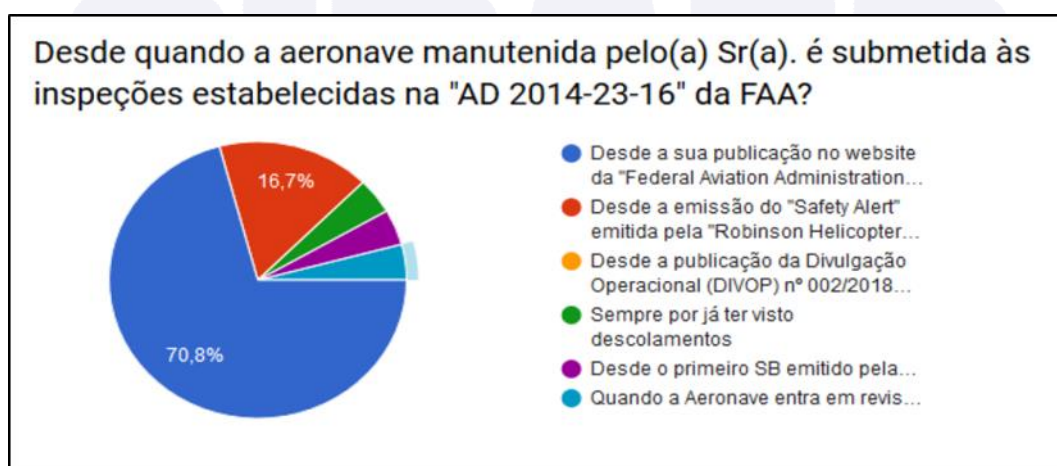
Among the maintainers, 16.7% (red slice on the graphic) answered that aircraft maintained by them were submitted to AD inspections following the issuance of the 23FEB2018 Safety Alert (Figure 59).

Figure 59 - Survey conducted with R22 and R44 maintainers.

The survey results attested that 16.7% of the interviewed maintainers responded that the aircraft they maintained were submitted to the AD inspections after the 23FEB2018 Safety Alert (Figure 59). In other words, these maintainers only heard about the AD after the accident involving the PP-HLI aircraft.

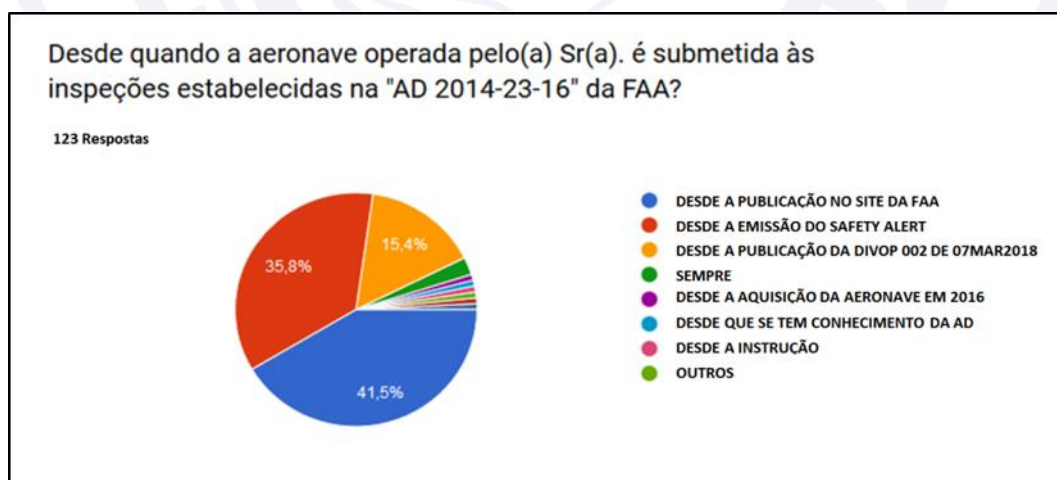
Among the pilots, 35.8% (red slice on the graphic) answered that the aircraft they operated were submitted to the inspections contained in the AD following the issuance of the 23FEB2018 Safety Alert.

Another 15.4% of the interviewed pilots answered that the aircraft they operated began to be submitted to the inspections contained in the AD after the issuance of the DIVOP published by the CENIPA, on 07MAR2018 (Figure 60).

Figure 60 - Survey conducted with R22 and R44 pilots.

Among pilots, 35.8% responded that the aircraft they operated were submitted to the AD inspections after the 23FEB2018 Safety Alert was issued and 15.4% answered that the aircraft they operated began to be submitted to the AD inspections after the issuance of the DIVOP, published by the CENIPA on 07MAR2018 (Figure 60). This means that 51.2% of the interviewed pilots said they had become familiar with the AD procedures only after the accident involving the PP-HLI.

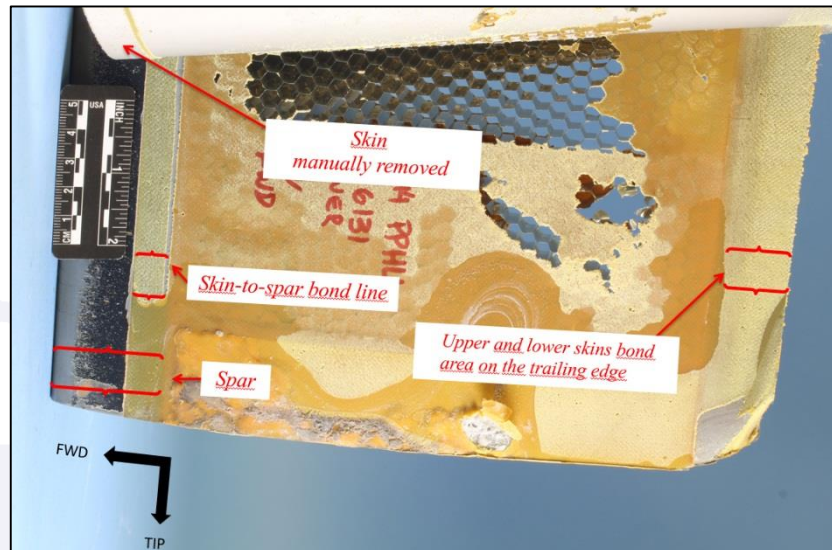
At the trailing edge of the blade, the upper and lower skins were bonded together just behind the honeycomb core (Figure 62).

Figure 62 - Blue blade (S/N 6131) lower surface. Highlighted the areas where the skin was bonded to the spar (leading edge) and where the skins were bonded to each other (trailing edge).

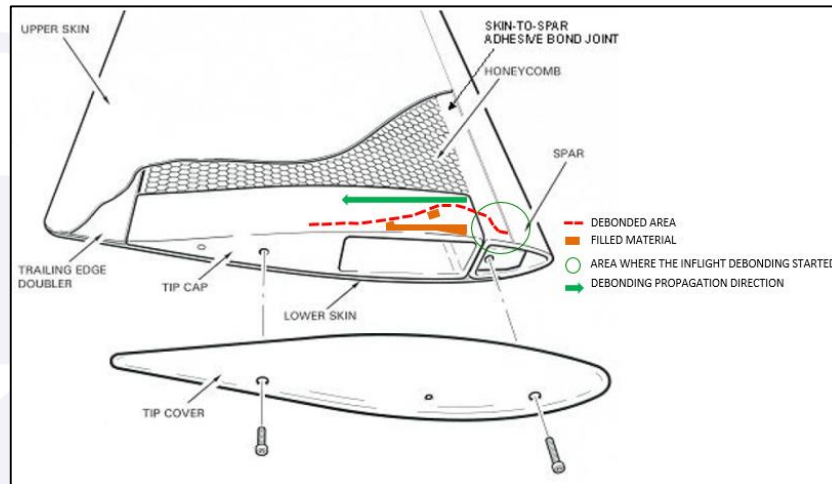
Examinations corroborated that the peeling off of the red blade upper skin (S/N 6128) occurred in flight.

The peeling off began at the leading edge of the blade, more precisely in the skin-to-spar bond line area. The relative wind incident at the leading edge, due to the blade inflight revolution, lifted up the front portion of the upper skin, causing the peeling off of approximately 50% of the skin toward the trailing edge of the blade. (Figure 64).

Figure 64 - Schematic representation of the in-flight take-off dynamics of the red blade (S/N 6128).

The debonding began at the leading edge of the blade, more precisely in the skin-to spar bond line area. The relative wind incident at the leading edge, due to the blade inflight revolution, lifted up the front portion of the debonded upper skin, causing the peeling off of approximately 50% of the skin toward the trailing edge of the blade (Figure 64).

The peeling of the lower skin began at the leading edge of the blade, more precisely in the skin-to-spar bond line area. The relative wind incident at the leading edge, due to the blade inflight revolution, lifted up the front portion of the debonded skin, causing the peeling of the skin, back toward the trailing edge of the blade (Figure 64).

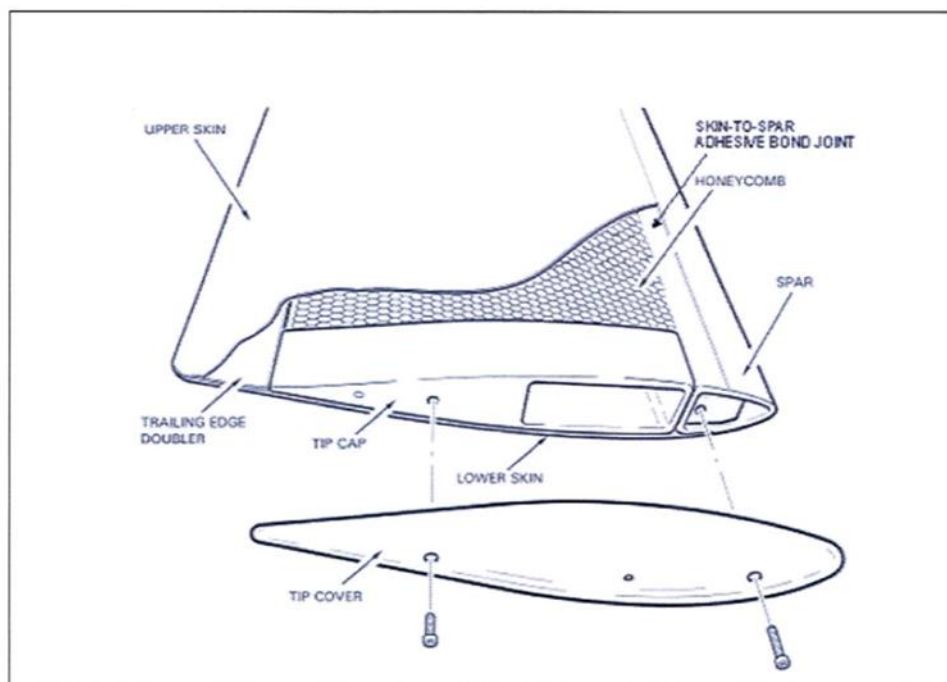
As pás do rotor principal dos helicópteros modelos R22 e R44 são compostas por um *skin* de aço inoxidável, um núcleo do tipo *honeycomb* composto por alumínio e um *spar* de aço inoxidável.

Figura 1 - Seção da ponta da pá do rotor principal da *Robinson Helicopter Company*.

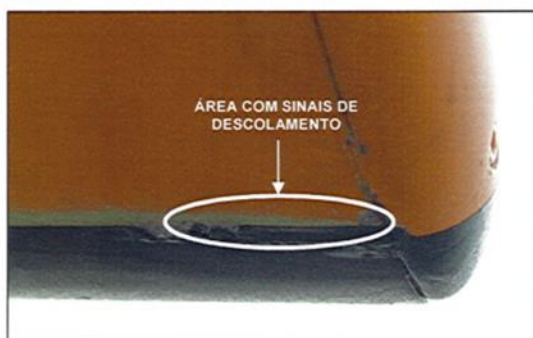
Entretanto, as verificações realizadas no Brasil constataram sinais de corrosão com descolamento em uma pá P/N C016-7, que equipava uma aeronave R44/R44II e que, em tese, não deveria apresentar problemas dessa natureza. A referida pá apresentava sinais de descolamento tanto na superfície inferior quanto na superfície superior, conforme ilustram as Figuras 4 e 5.

Figura 4 – Aspecto da área crítica na superfície inferior (*lower skin*) da pá P/N C016-7.

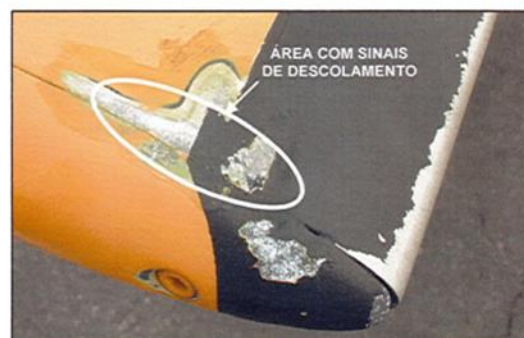
Figura 5 – Aspecto da área crítica na superfície superior (*upper skin*) da pá P/N C016-7.
