COMANDO DA AERONÁUTICA
CENTRO DE INVESTIGAÇÃO E PREVENÇÃO DE
ACIDENTES AERONÁUTICOS

FINAL REPORT
A - 094/CENIPA/2016

OCCURRENCE:	ACCIDENT
AIRCRAFT:	PR-CBB
MODEL:	407
DATE:	26JUN2016

This is the Final Report of the 26JUN2016 accident with the 407 aircraft, registration PR-CBB. The accident was classified as “[CFIT] Controlled Flight Into Terrain”.

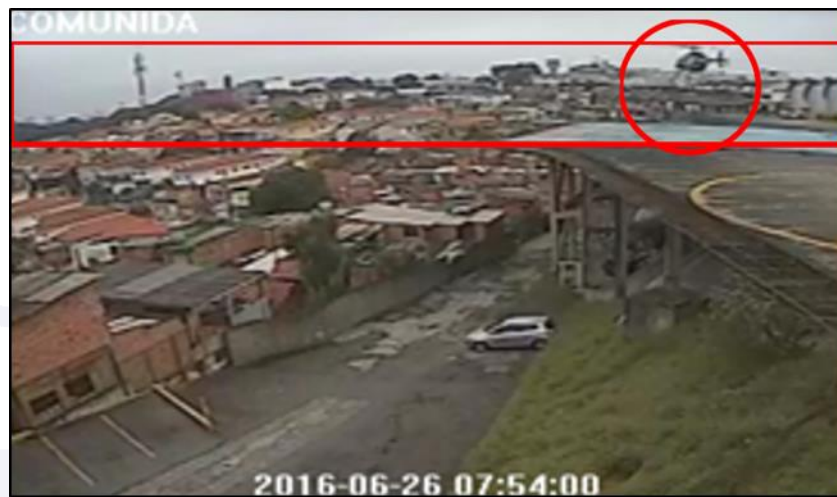
At the time of takeoff, we can verify that the images corroborate the information presented in the SBSP METAR.

Figure 6 - Images of aircraft takeoff and meteorology.

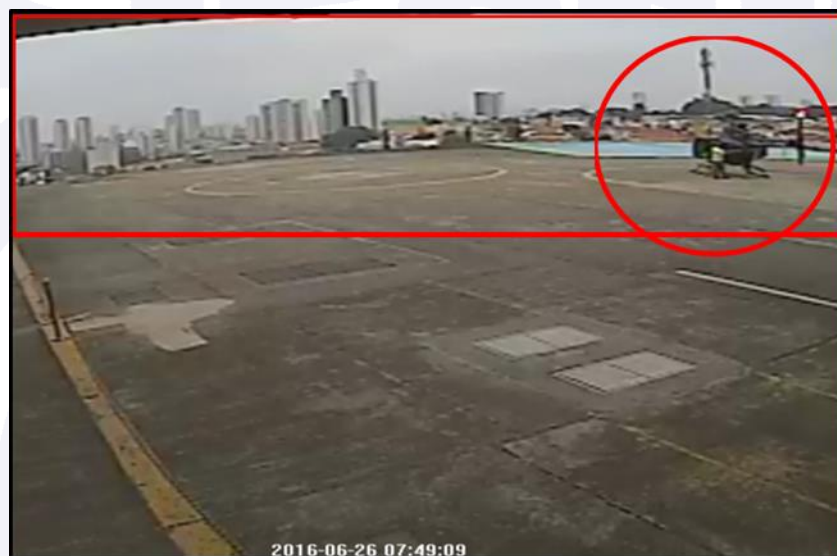
Figure 7 - Images of aircraft takeoff and meteorology.

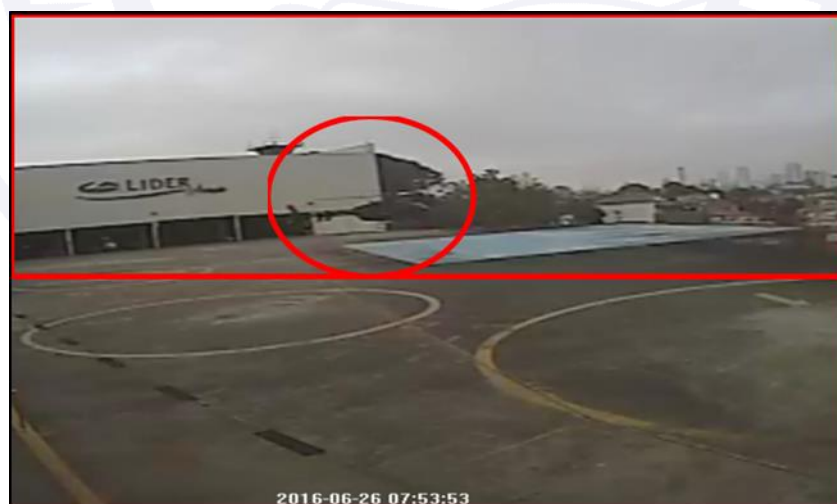
Figure 8 - Images of aircraft takeoff and meteorology.

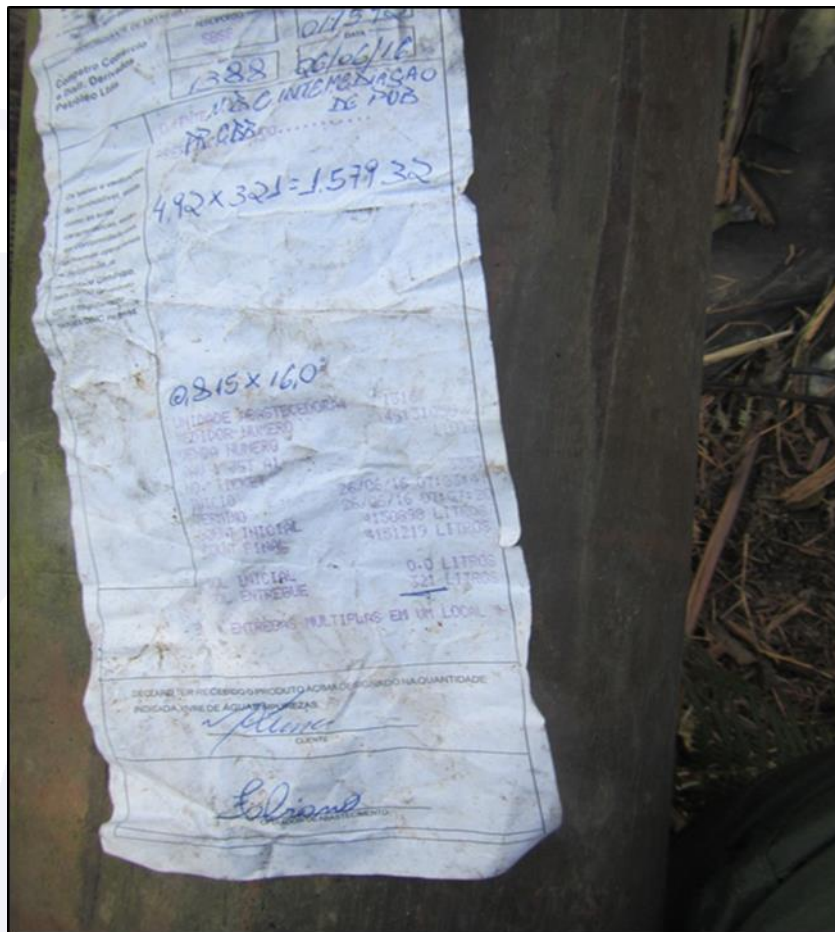
- at 1003 (UTC) the aircraft was supplied with 321 liters and had approximately 559 liters at takeoff time, as verified by the fuel voucher (Figure 17);

Figure 18 - Fuel voucher at accident site.

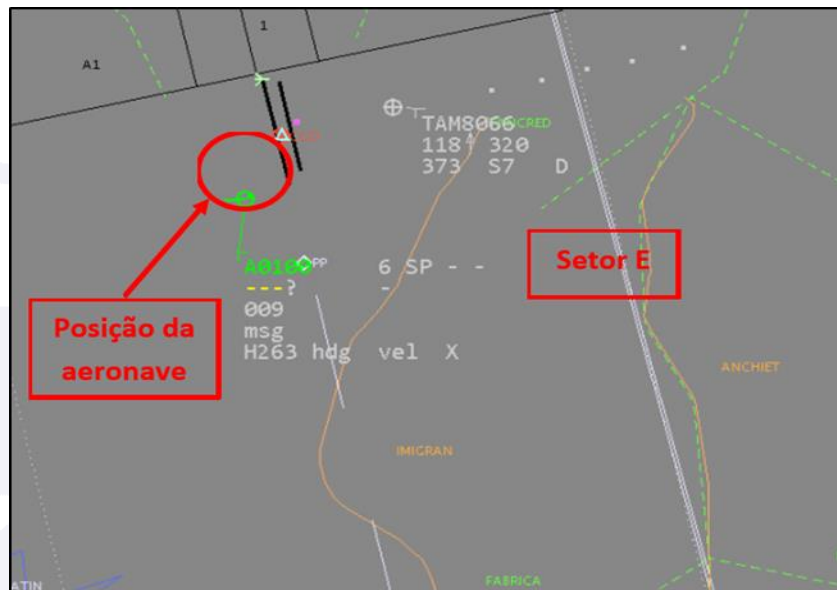
- at 10:54:22 (UTC), the pilot requested crossings to the ECHO (East) sector of the Aerodrome, being instructed by TWR-SP to cross to that sector after the passing of a traffic that was in the final approach (Figure 19);

Figure 19 - Radar image of 10h54min22s (UTC), aircraft waiting to cross to the ECHO sector.

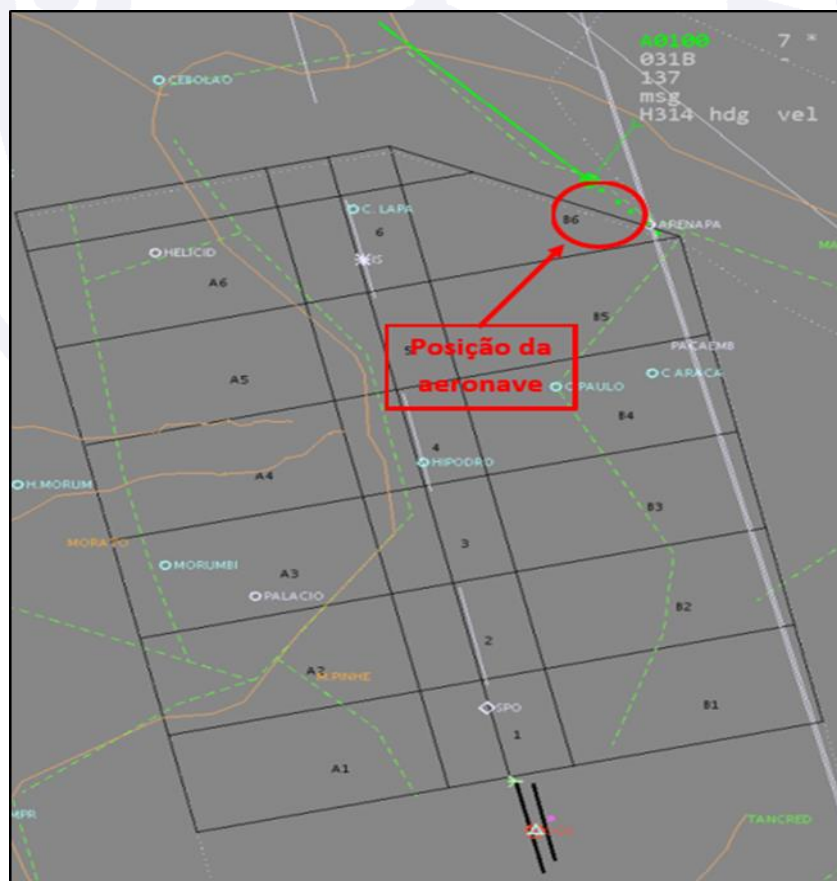
- the PR-CBB continued the flight via REH ACLIMAÇÃO and REH MARTE, according to the flight plan;

Figure 20 - Radar image of 10h59min22s (UTC), aircraft followed REH Acimação and REH Marte.

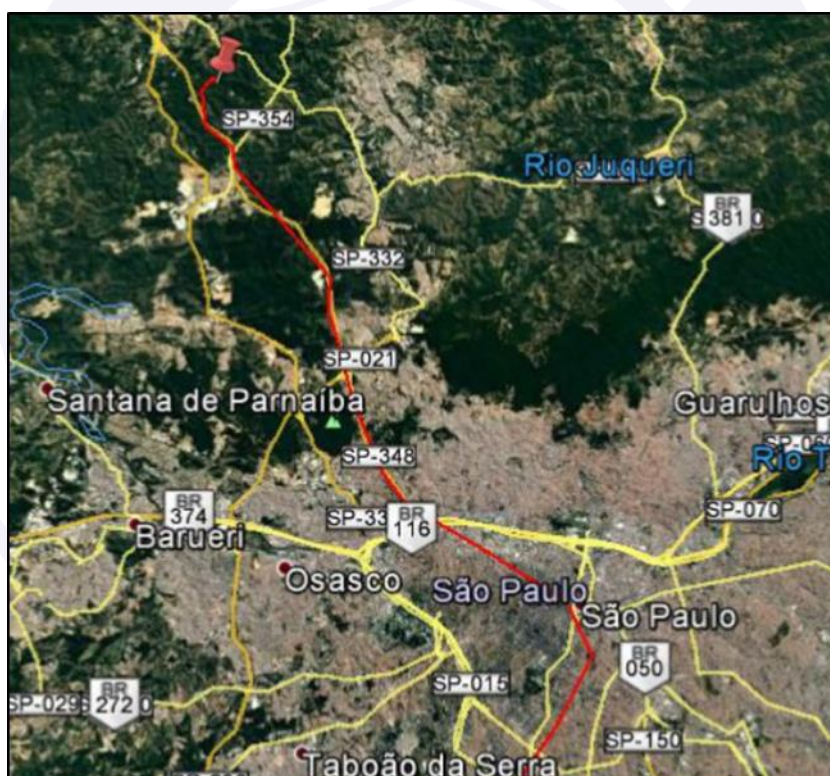
Figure 24 - Field marking of aircraft displacement.

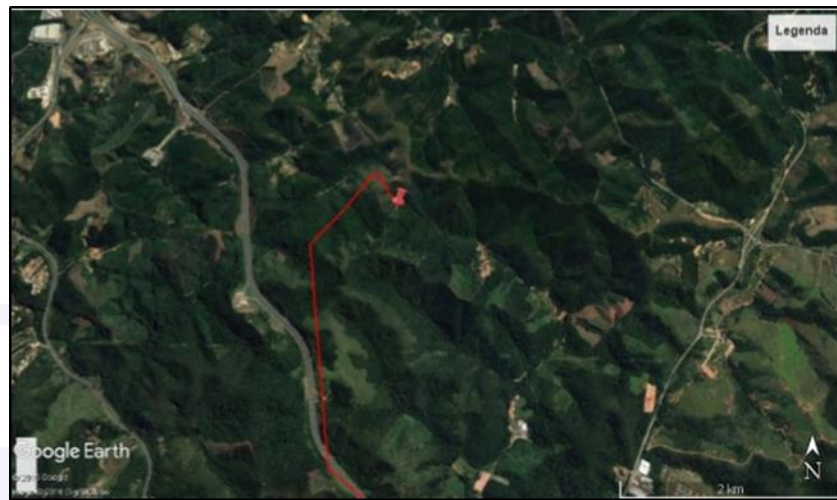
Figure 25 - Final trajectory followed by the aircraft.

The change of route did not constitute a violation of any air traffic regulations. Based on its location and altitude, PR-CBB, although within the lateral limits of the TMA-SP2 projection, was in class G airspace, since the lower limit of the TMA-SP2 was 3.600ft, according to AIP -BRASIL ENR 2.1-46.
