**COMANDO DA AERONÁUTICA**  
**CENTRO DE INVESTIGAÇÃO E PREVENÇÃO DE**  
**ACIDENTES AERONÁUTICOS**

**FINAL REPORT**  
**A - 090/CENIPA/2014**

<b>OCCURRENCE:</b>	<b>ACCIDENT</b>
<b>AIRCRAFT:</b>	<b>PR-FPL</b>
<b>MODEL:</b>	<b>EC-120B</b>
<b>DATE:</b>	<b>02MAY2014</b>

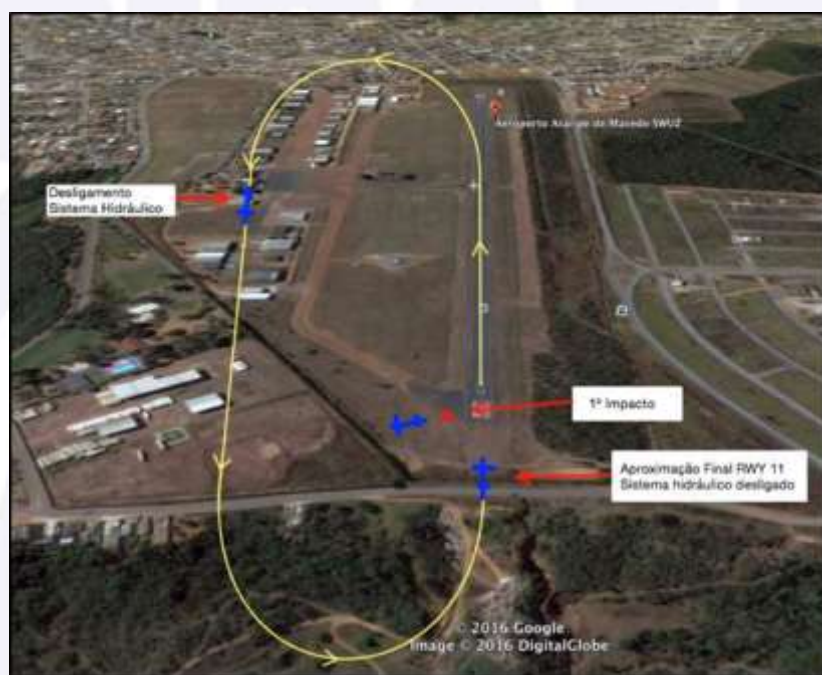
Figure 2 - Sketch of the occurrence.

The impact occurred next to the runway's threshold 11 of SWLZ, with no evidence of previous impact. Figure 2 shows the sketch of the occurrence.

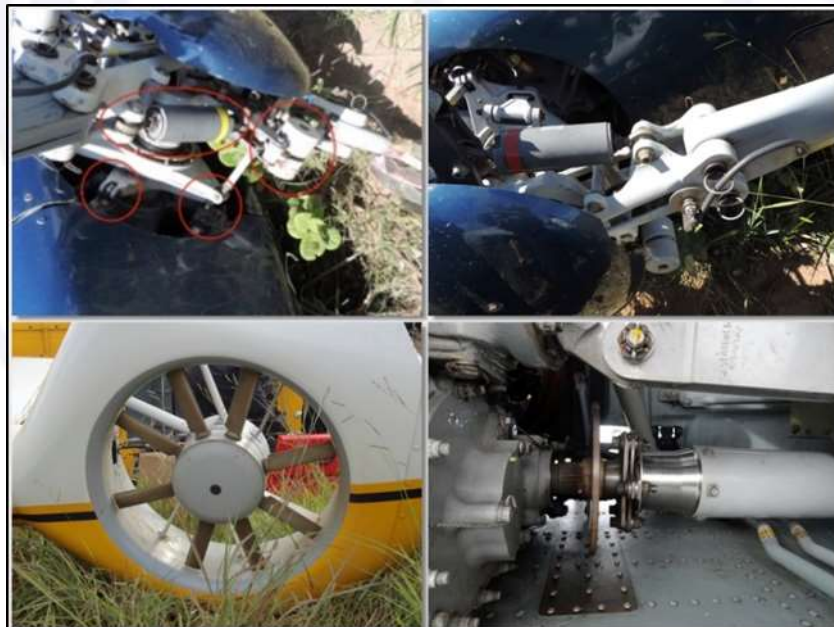
Preliminarily, at the accident site, it was not possible to identify abnormalities in the verification of the major components described above (Figure 8).

Figure 8 - Rotor head and its connections, vibration absorbers, fenestron rotor and engine connection shaft.

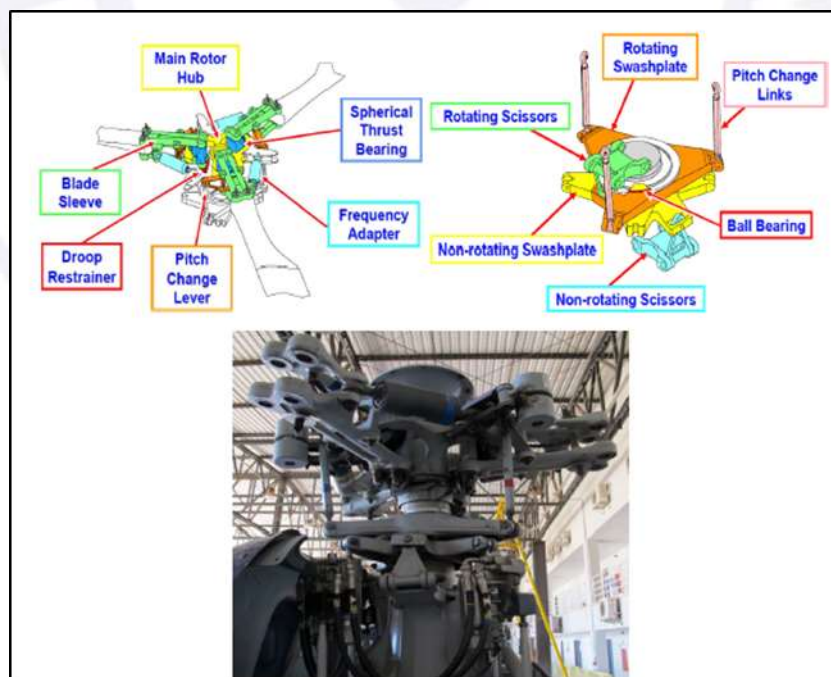
Figure 10 - Main Rotor Head (MRH) and Main Rotor Shaft (MRS).

The Main Rotor Head (MRH) and Main Rotor Shaft (MRS) showed some damage resulting from the impact of the blades on the ground with speed and power, namely:

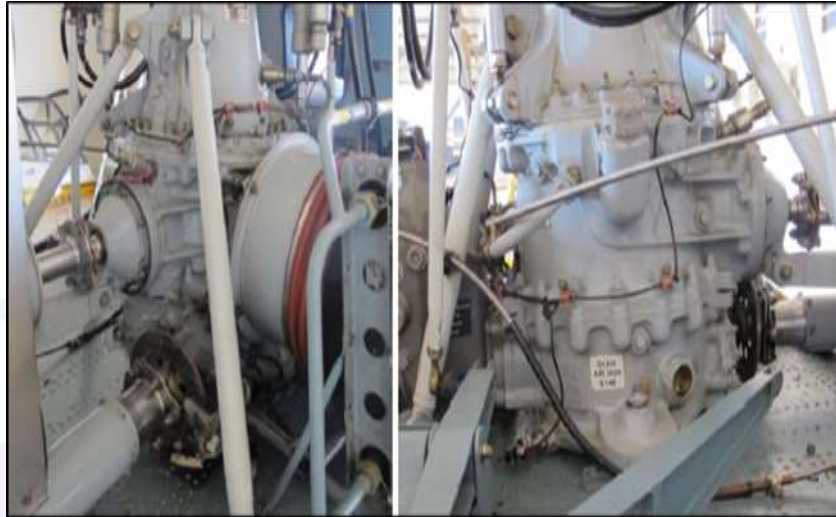
The MGB showed no external marks or damage and no particles were present in the magnetic plug (Figures 16 and 17).

Figure 16 - Overview of the good condition of the MGB.

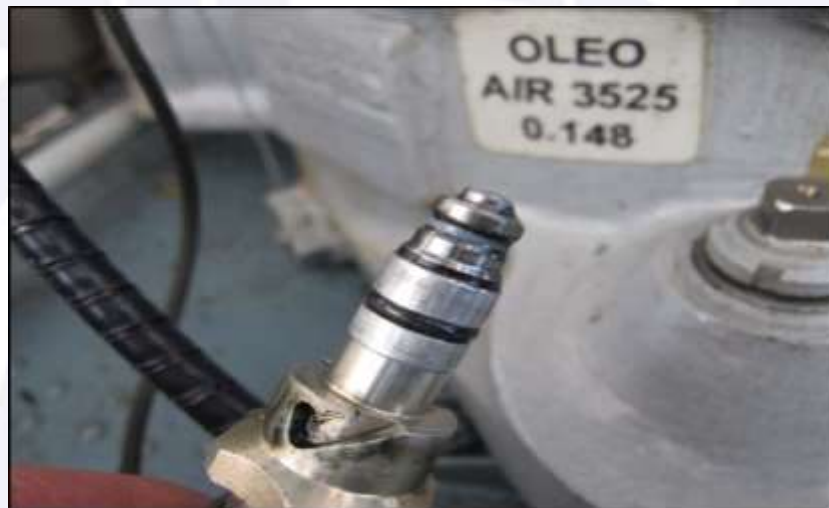
Figure 17 - Magnetic oil plug without particles or damage.

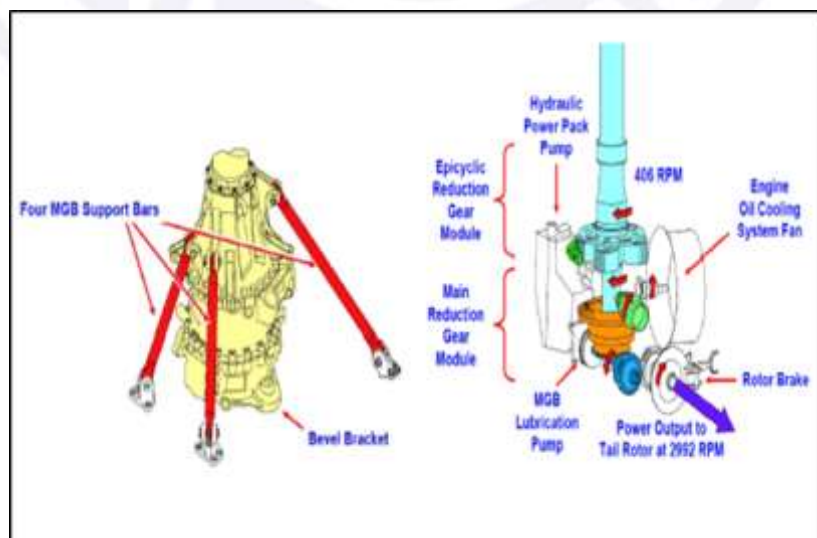
The four suspension bars of the MGB were in good condition and correctly connected to the MRH's mechanical desk and conical house (Figure 18).

Figure 18 - MGB and Suspension.

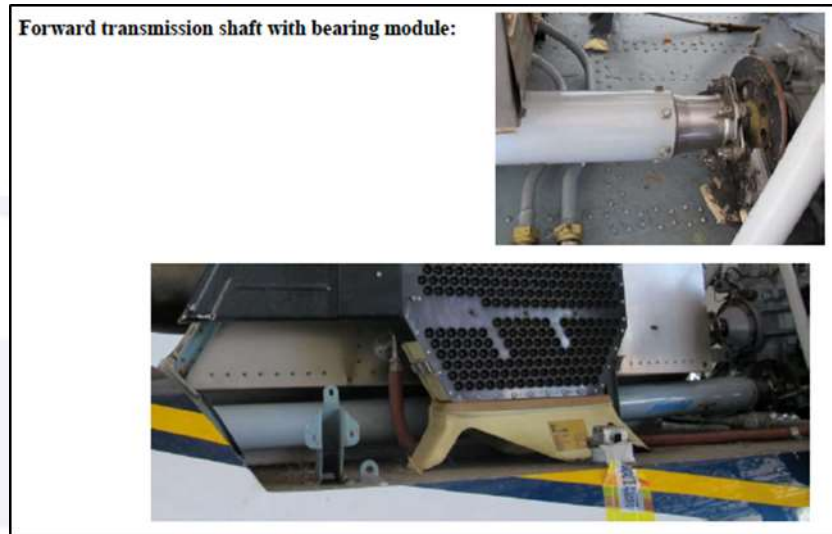
The front of the drive shaft was attached to the output of the MGB by the splined flange and it rotated freely (Figure 22).

Figure 22 - View of the transmission shaft of the tail rotor.

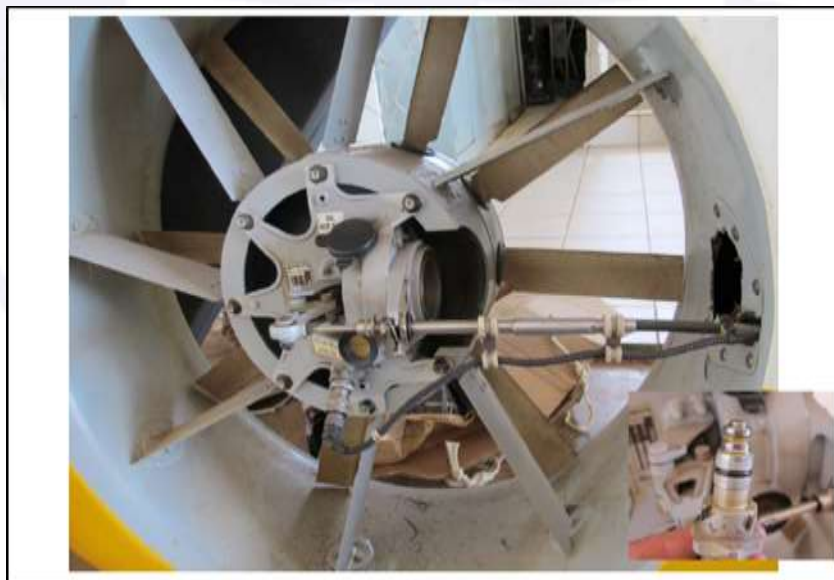
The TRH and TGB rotated freely and showed no external damage. No particle was observed on the TGB magnetic plug (Figure 26).

Figure 26 - Tail rotor and magnetic plug with no particles (highlighted).

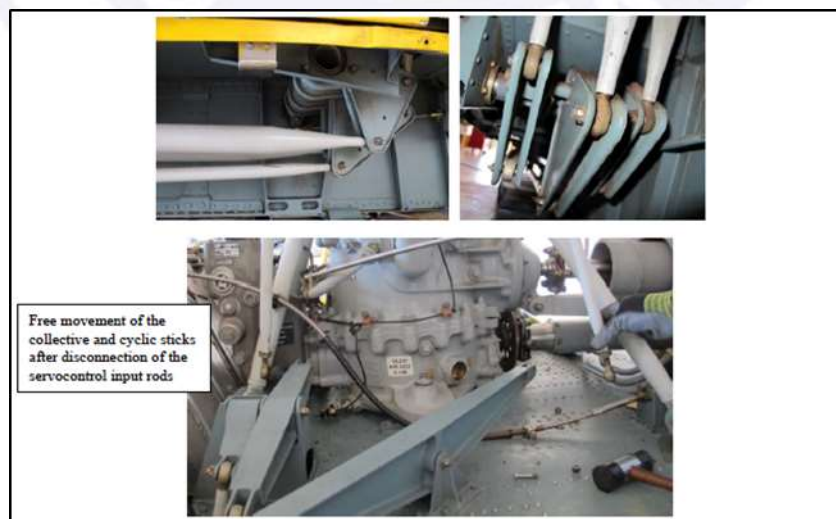
The collective and cyclic controls were hard to move because they were connected to the servocontrol input lever. After disconnecting the servocontrol input lever from the rod, it was possible to move freely and without load the collective and cyclic commands in all directions (Figure 29).

Figure 29 - Free movement of the cyclic and collective sticks.

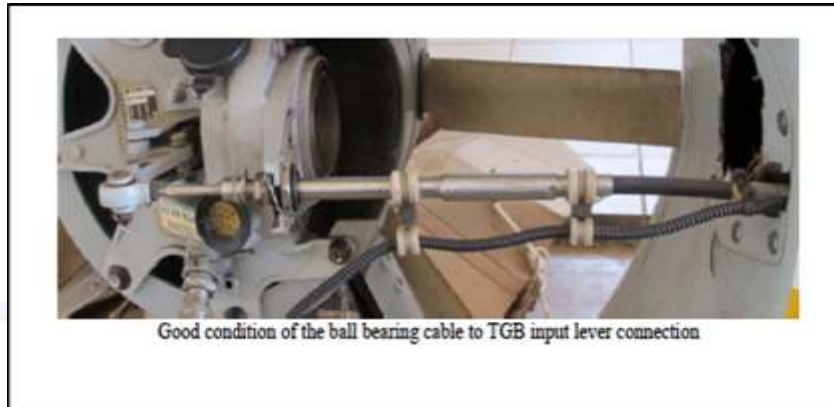
The back of the teleflex cable (ball bearing) moved freely and acted at the entrance of the TGB resulting in the movement of all the blades of the tail rotor (Figure 35).

Figure 35 – Good condition of the connection of the teleflex cable to the TGB.

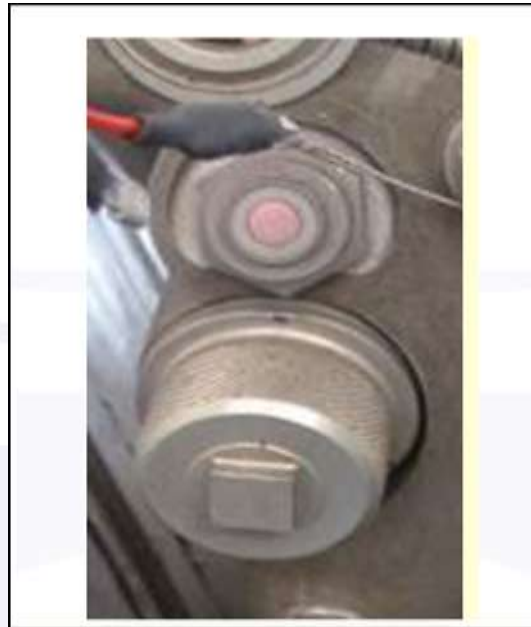
All servocontrols were visually in good conditions on the outside, with no rod bent. The hydraulic compact unit was visually in good conditions on the outside. The hydraulic filter indicator was not triggered (Figure 38).

Figure 38 - Hydraulic filter indicator not triggered.

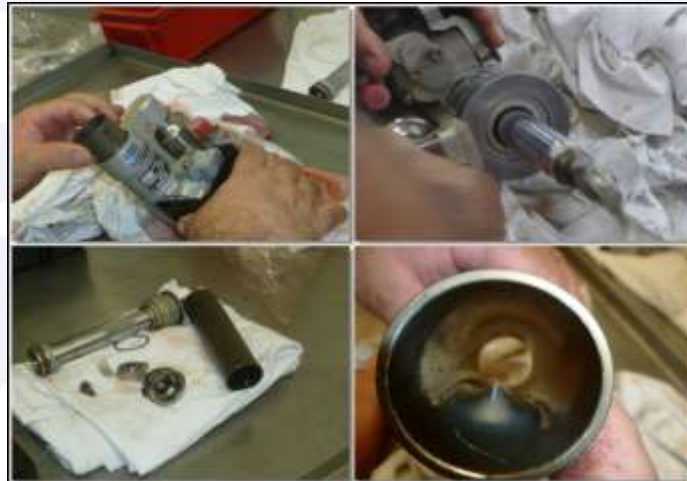
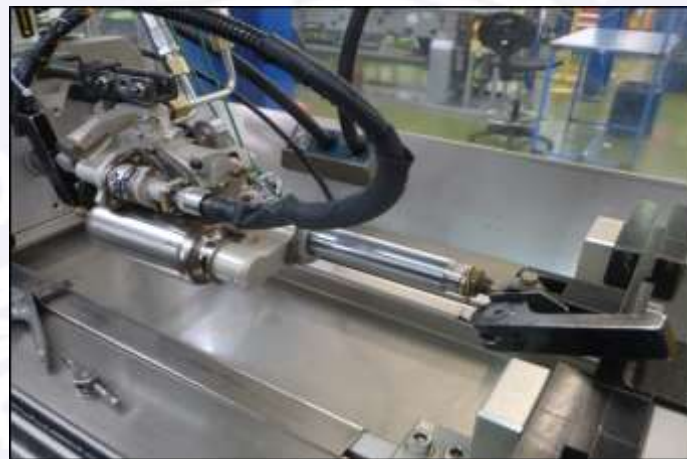
Figure 42 - Servocontrols disassembly and analysis.

Figure 43 - Functional test in the servocontrols.

The servocontrols with serial numbers (S/N) 952 and (S/N) 943 presented characteristic damages resulting from the impact, due to the overpressure generated at the actuator. The polyurethane protection was deformed by this overpressure and the displacement of the piston rod was limited, due to the deformation (Figures 44 and 45).

The S/N 958 servocontrol was in good conditions and without indications that it could show abnormalities just before impact.

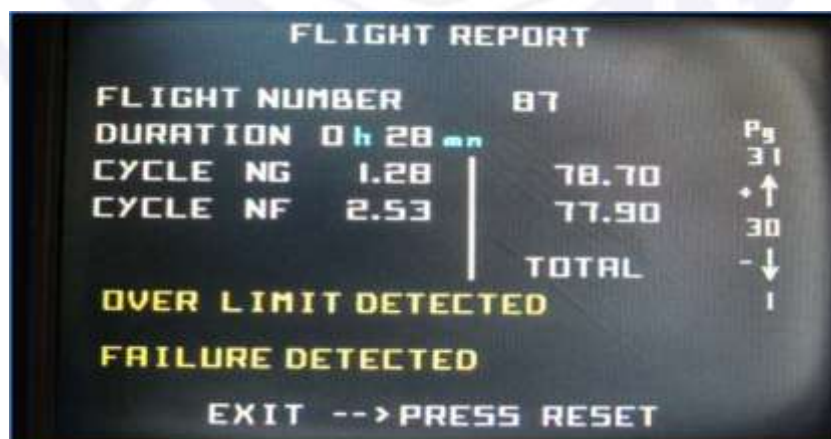
The flight of the accident was identified as Flight No. 87 (Figure 46).

Figure 46 - Flight of the accident recorded in the VEMD as n° 87.
