COMANDO DA AERONÁUTICA
CENTRO DE INVESTIGAÇÃO E PREVENÇÃO DE
ACIDENTES AERONÁUTICOS

FINAL REPORT
A-119/CENIPA/2018

OCCURRENCE:	ACCIDENT
AIRCRAFT:	PR-GGD
MODEL:	737-8EH
DATE:	16JUL2018

This is the Final Report of the 16JUL2018 accident with the 737-8EH aircraft model, registration PR-GGD. The accident was classified as “[SCF-NP] System/Component Failure or Malfunction Non-Powerplant – with Landing Gear”.

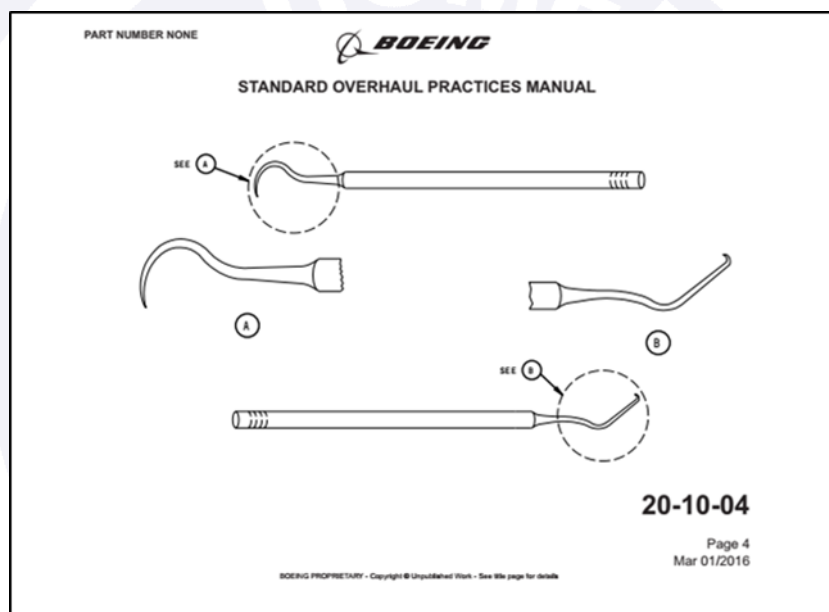
Figure 8 - Inspection and quality control instrument for chrome grinding.
Source: SOPM 20-10-04 from the Boeing Company.

In addition to the other inspections, an examination can be performed using an inspection instrument for crack detection (Figure 8).

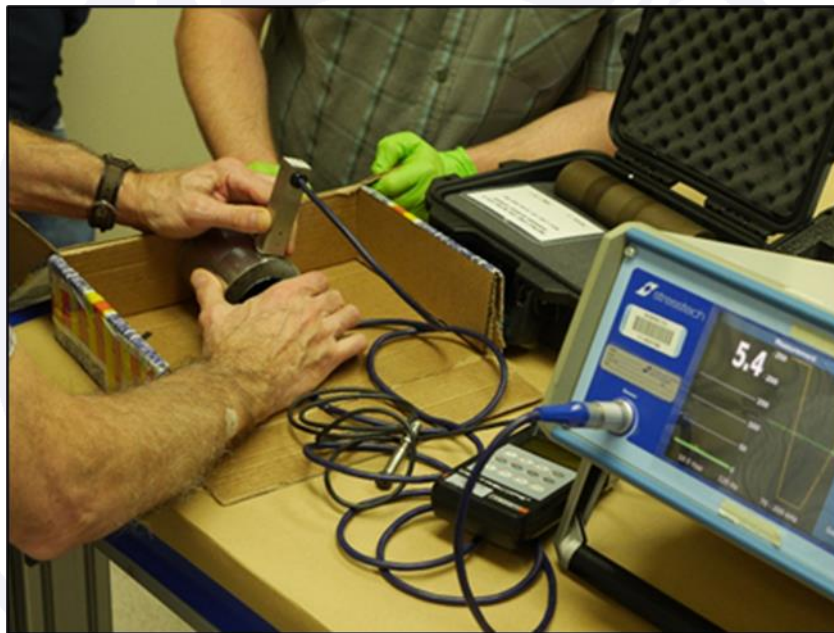
Figure 21 - Barkhausen inspection.

Initially, an inspection by the Barkhausen method was carried out on the two portions of the aft trunnion pin. This examination uses equipment that generates a magnetic pulse capable of identifying changes in the crystalline structure of the part caused by thermal damage.

The Barkhausen inspection was performed using a portable device shown in Figure 21, however, the results were considered inconclusive.

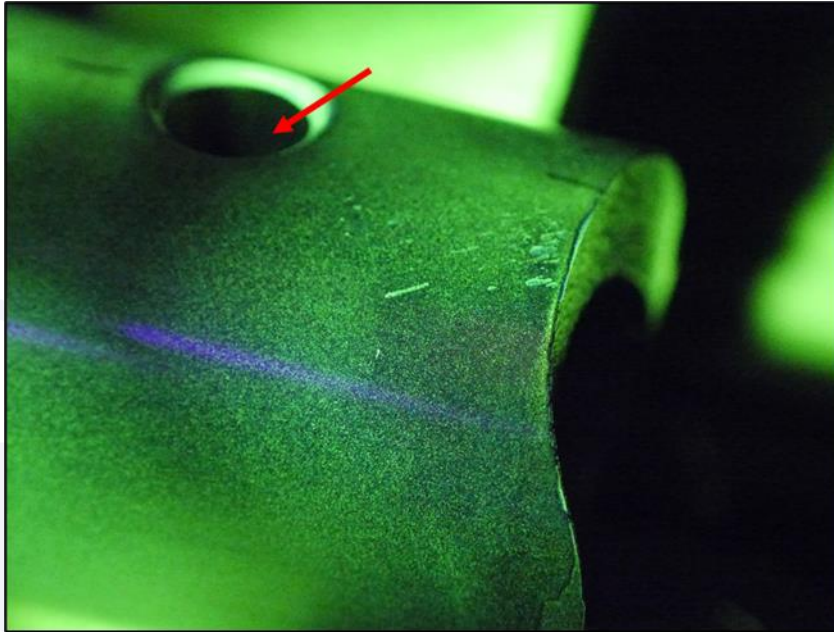
Figure 22 - Inspection by Magnetic Particles.

No significant cracks were found in the inspection by magnetic particles in the two halves of the analyzed pin.

The presence of coverage by non-magnetic material (chromium), which limits the effectiveness of the inspection by magnetic particles, and the existence of the transversal wall plug (red arrow in Figure 22) can alter the magnetic flux, making it difficult to identify cracks.

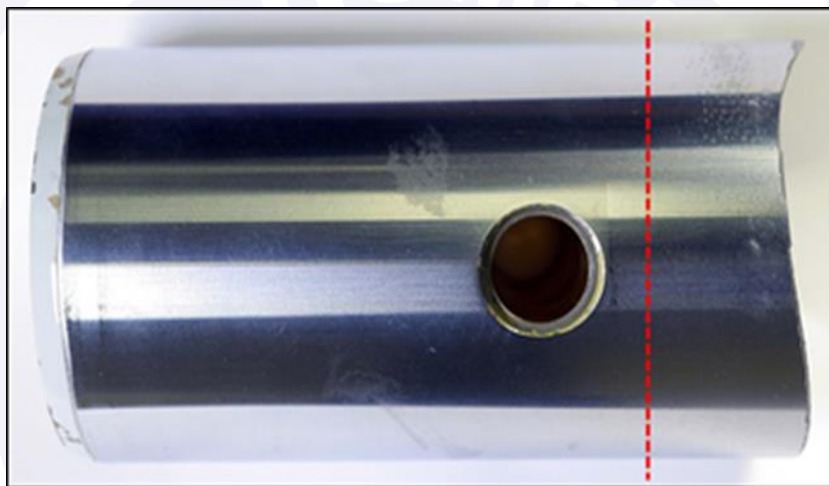
Figure 25 - Section of the major portion of the aft trunnion pin.

The larger part of the aft trunnion pin was cut (Figure 25), in order to allow analysis in the Stereoscope and in the MEV or SEM.

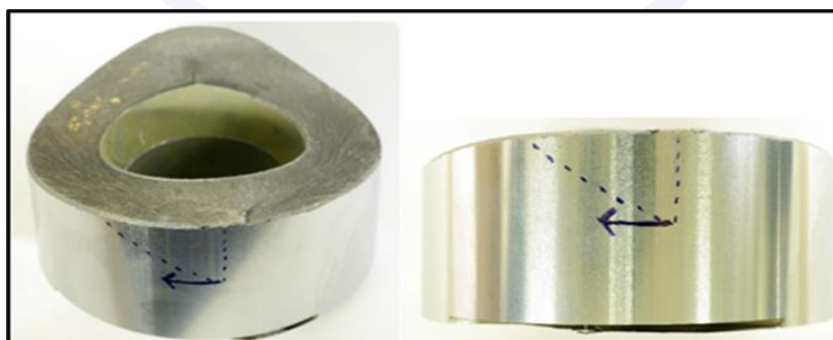
Figure 28 - Cut performed for metallographic examinations.

A new cut was made in the sectioned portion, in order to conduct metallographic examinations in the fracture region, as shown in Figure 28, below.

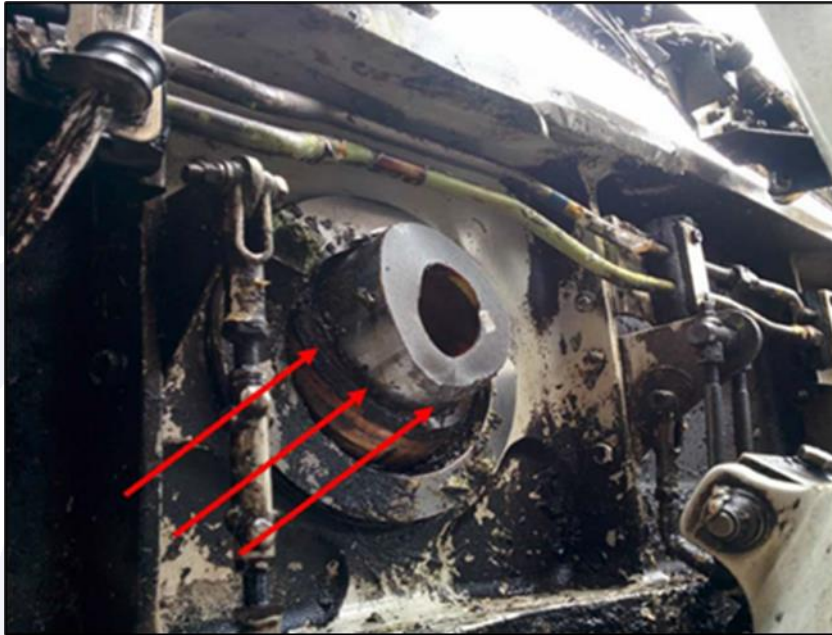
Figure 34 - Detail of the aft trunnion pin on the left landing gear of the VT-JGA aircraft.
Source: Final Investigation Report on Accident to M/s Jet Airways (Pvt.) Ltd. Boeing B 737-800 Aircraft VT-JGA at Khajuraho Airport.

The first event took place on 13APR2015, at the Khajuraho Aerodrome, involving the VT-JGA aircraft (B737-800). In this occurrence, about fifteen seconds after the touch, during the post-landing run, the aft trunnion pin of the aircraft's left landing gear broke, causing subsequent damage, highlighted in Figures 34 and 35, obtained from the Final Report issued by the Indian investigative authority, the Directorate General of Civil Aviation (DGCA).
