COMANDO DA AERONÁUTICA
CENTRO DE INVESTIGAÇÃO E PREVENÇÃO DE
ACIDENTES AERONÁUTICOS

FINAL REPORT
A - 131/CENIPA/2017

OCCURRENCE:	ACCIDENT
AIRCRAFT:	PR-MPE
MODEL:	208 AMPHIBIAN
DATE:	17OCT2017

This is the Final Report of the 17OCT2017 accident with the 208 Amphibian aircraft, registration PR-MPE. The accident was classified as “[ARC] Abnormal Runway Contact”.

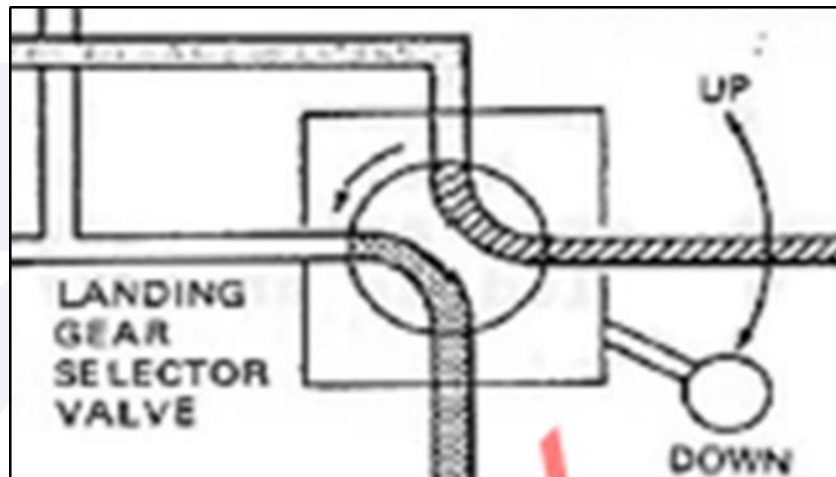
Figure 2 - Landing gear command lever layout.

The landing gear control lever controlled a hydraulic selector valve within the control unit on the instrument panel (Figure 2) and had two positions (UP WATER and DOWN LAND), providing a mechanical indication of the selected landing gear position.

From any position, the lever should be pulled toward the pilot to release the safety lock, before it could be repositioned.

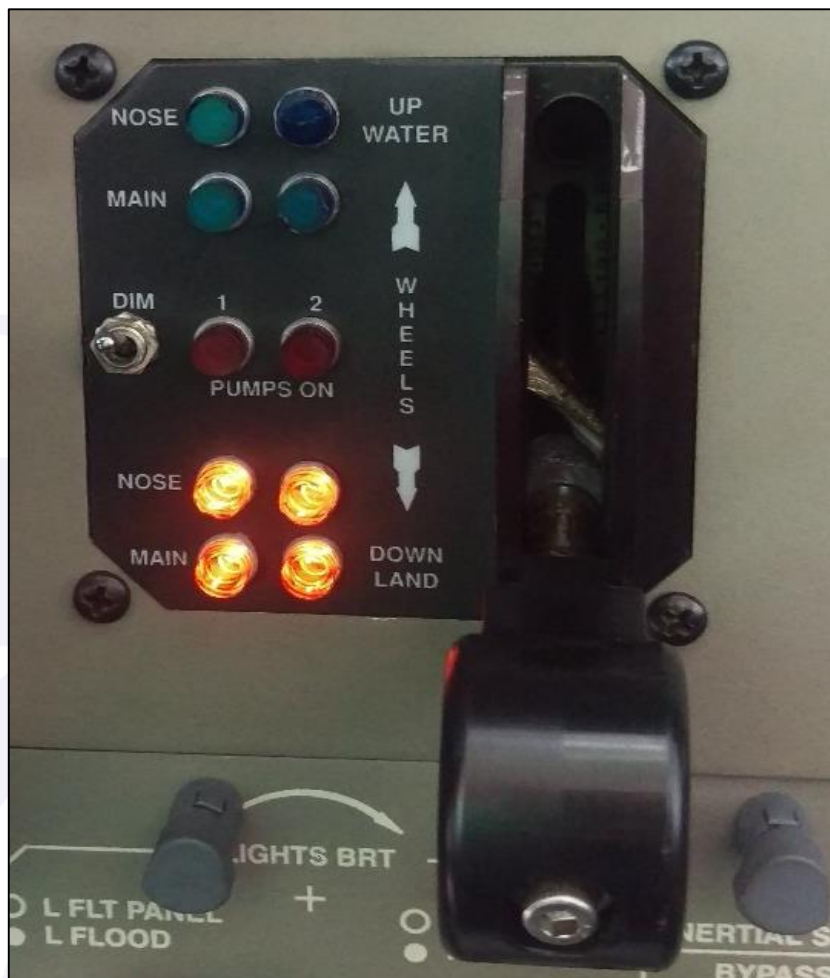
Figure 3 - Amphibian landing gear control and light system.

The lights were tested by pressing the Lamp Test switch. Four blue lights, named NOSE and MAIN (lights from the left to the left float and lights from the right to the right float), indicated by their ignition that the landing gear was up and locked.

The four amber lights, named NOSE and MAIN (lights from the left to the left float and lights from the right to the right float), indicated by their illumination that the landing gear was down and locked. None of the lights remained ON when the landing gear was in transit (Figure 3).

In this new test, both the aural alert system and the landing gear system worked normally. However, the illumination of the landing gear lights and hydraulic pumps worked partially, as some lamps did not light up. However, it could not be stated whether this condition occurred before or after the impact.

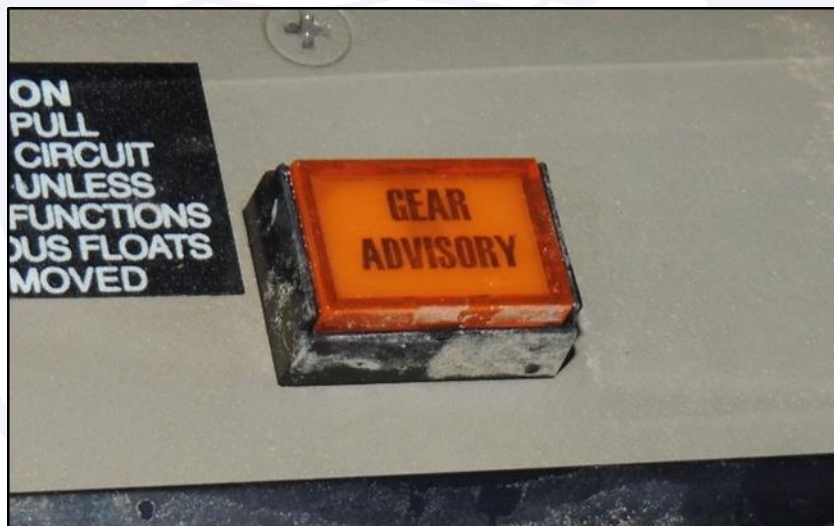
Figure 4 - Gear Advisory button installed on the PR-MPE aircraft.

Sensors that detected the condition of the landing gear indication lights and read the airspeed in the pitot system operated the system. Thus, it alerted the pilot, through the GEAR ADVISORY button light, located on the panel (Figure 4), in a prominent position.

In addition, the audio message sounded in the audio system (headphones or speakers) "GEAR IS UP FOR WATER LANDING" or "GEAR IS DOWN FOR RUNWAY LANDING".

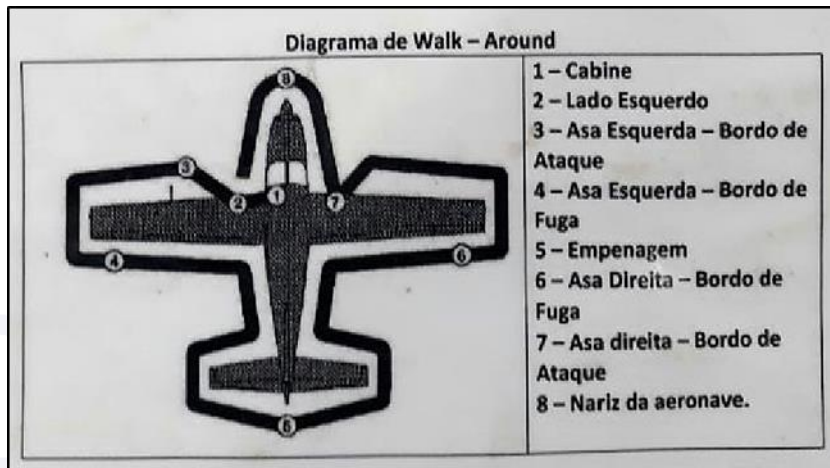
Figure 11 - Walk around diagram.

At the inspection, there was a sequence that started from the cabin and continued clockwise from the outside of the aircraft (Figure 11).

For the inspection of the cabin, it was prevised in the Pre-Flight Inspection Form to comply with item 7 - Circuit Breakers - IN. This action required the operator to check the breaker panel and check if all circuit breakers were in the IN position, that is, armed.
