COMANDO DA AERONÁUTICA
CENTRO DE INVESTIGAÇÃO E PREVENÇÃO DE
ACIDENTES AERONÁUTICOS

FINAL REPORT
A - 143/CENIPA/2014

OCCURRENCE:	ACCIDENT
AIRCRAFT:	PR-NEO
MODEL:	EC-130B4
DATE:	23AUG2014

This is the Final Report of the 23AUG2014 accident with the EC-130B4 aircraft, registration PR-NEO. The accident was classified as “[CTOL] Collision with Obstacle during Take-Off and Landing”.

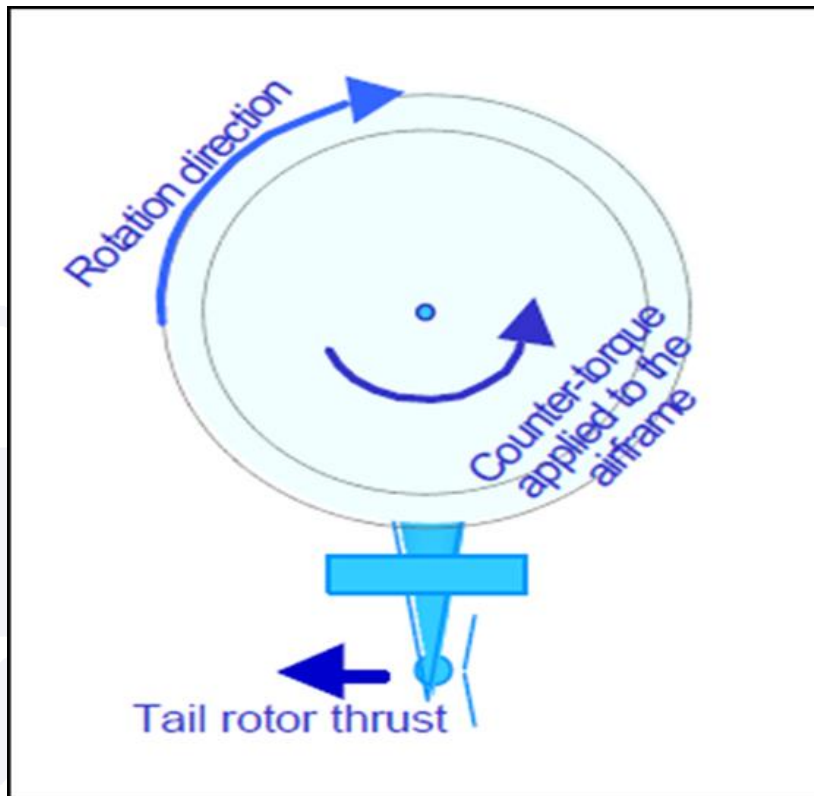
In hover flight or in a very low speed flight, the pilot counteracts the leftward aircraft rotation by applying the right yaw pedal (Figure 9).

Figure 9 - Representation of the aircraft from above, without wind component.
Source: Service-Letter 1673-67-04.

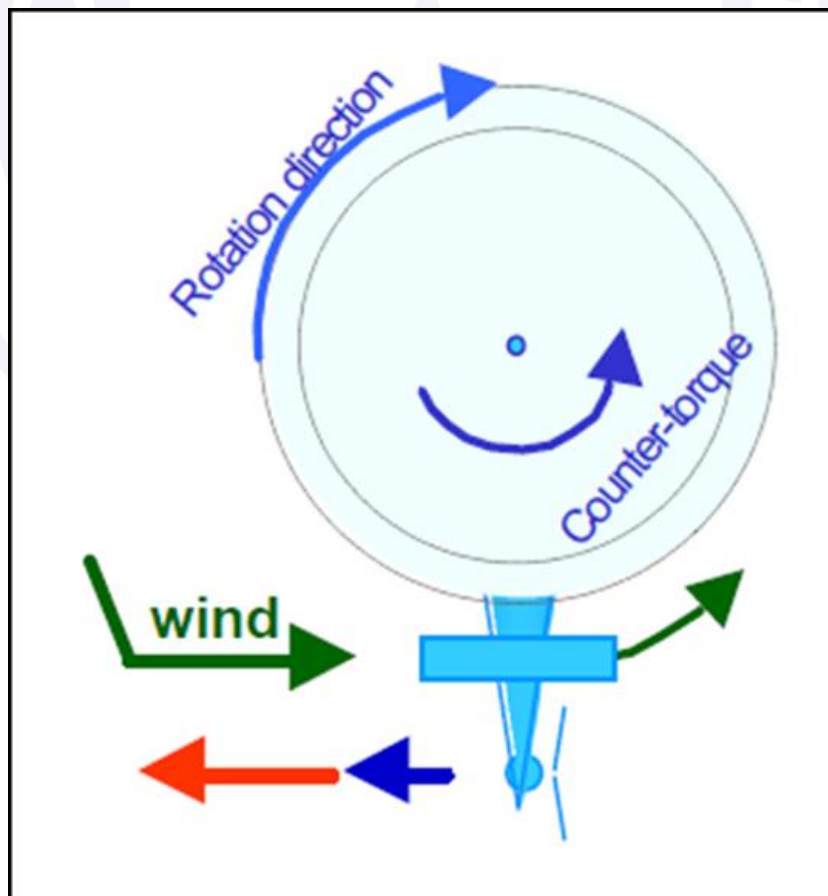
When adding a light unfavorable wind (Figure 10), a leftward rotation departure can result in the aircraft's initiating a high rotation rate, if no adequate and additional action is immediately applied to the yaw pedals.

Figure 10 - Representation of the aircraft from above, added a component of left crosswind. Source: Service-Letter 1673-67-04.

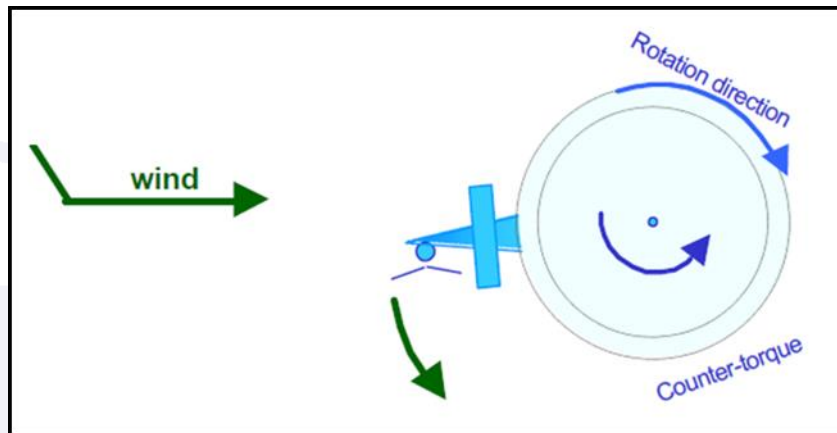
A tail wind component, upon departure would worsen the problem (Figure 11).

Figure 11 - Representation of the aircraft viewed from above, added a component of tail wind. Source: Service-Letter 1673-67-04.

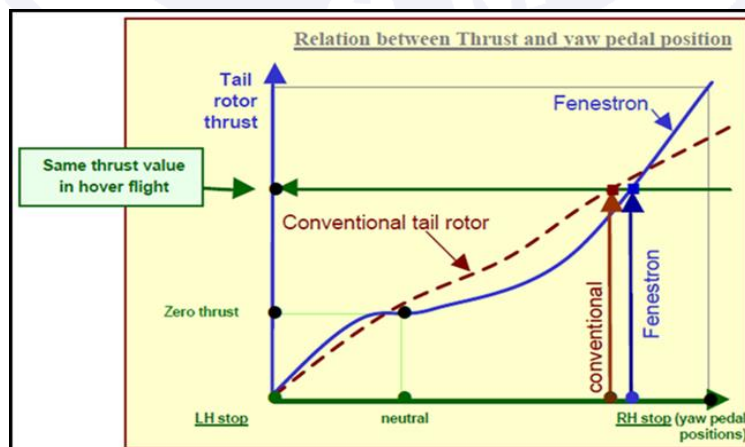
- The yaw pedal position / tail rotor thrust law curve shape is not the same for a « conventional rotor and a Fenestron. (Figure 12).

Figure 12 - Relation between thrust and the yaw pedal position, in hover flight.

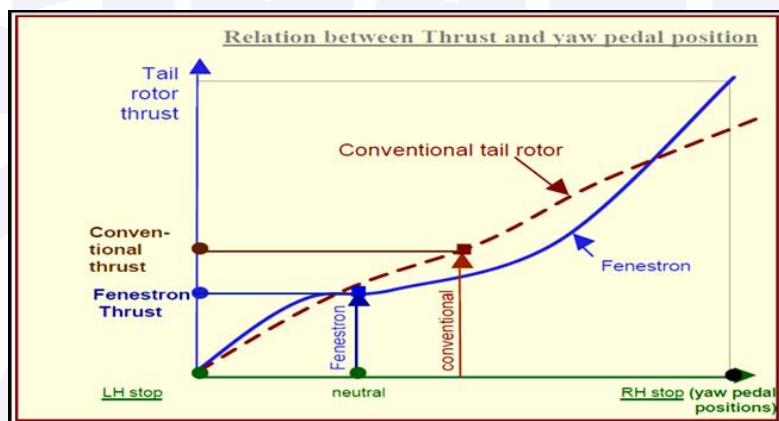
As regards the Fenestron, since the fairing effect is higher due to its large surface, the thrust to be applied by the tail rotor is lower. (Figure 13).

Figure 13 - Relation between thrust and position of the yaw pedal position on the cruise flight.

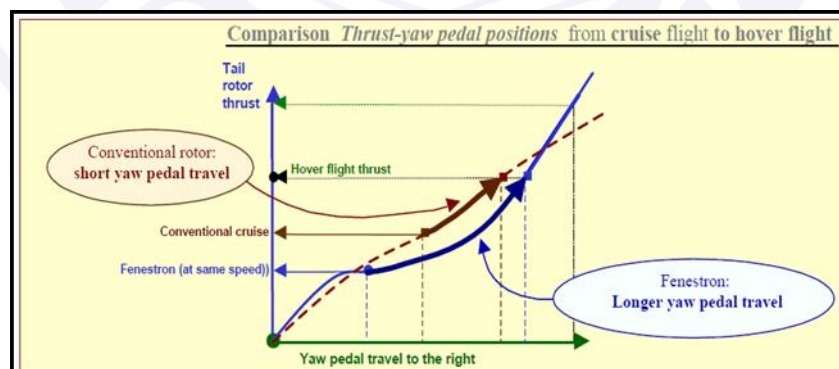
With a Fenestron, when changing from cruise flight to hover flight, be prepared for a significant movement of the foot to the right.

Insufficient application of pedal would result in a leftward rotation of the aircraft during the transition to hover.

Figure 14 - Comparison between thrust and the yaw pedal position, in the transition from cruise flight to hover flight.

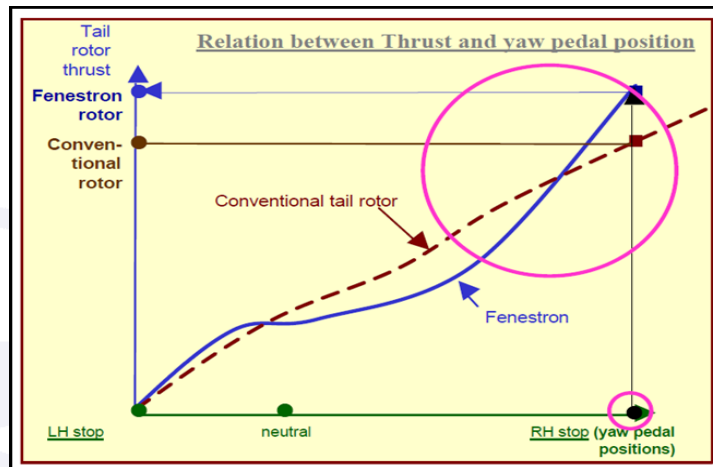
It can be noticed that near the right stop, the Fenestron efficiency is very high (slope of the curve - Figure 15).

Figure 15 - Comparison between thrust and the yaw pedal position, with maximum power.
Source: Service-Letter 1673-67-04.

To stop rotation to the left, whether it is intentional or not, never hesitate to go up to yaw pedal right stop.
