**COMANDO DA AERONÁUTICA**  
**CENTRO DE INVESTIGAÇÃO E PREVENÇÃO DE**  
**ACIDENTES AERONÁUTICOS**

**FINAL REPORT**  
**A-157/CENIPA/2016**

<b>OCCURRENCE:</b>	<b>ACCIDENT</b>
<b>AIRCRAFT:</b>	<b>PR-TUN</b>
<b>MODEL:</b>	<b>R44 II</b>
<b>DATE:</b>	<b>04DEC2016</b>

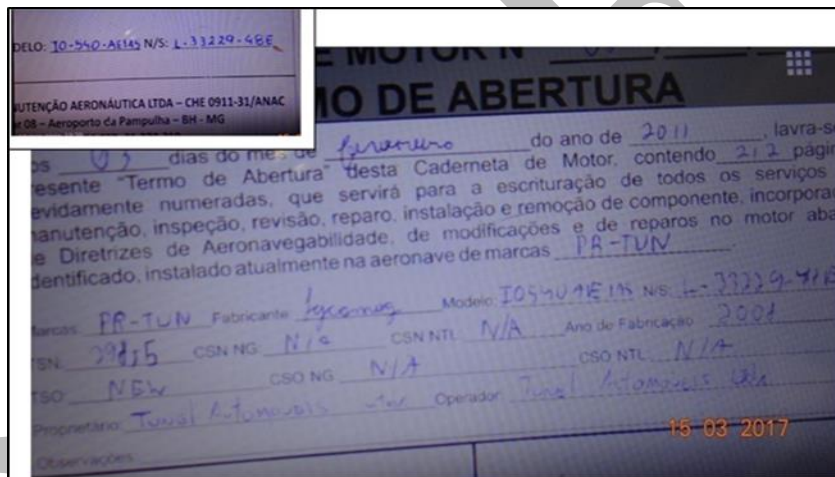
The engine had major breakdowns due to the collision with the ground. One of the consequences was the loss of the nameplate. Its identification was performed through the engine Logbook opening Sheet (Figure 9).

Figure 9 - Identification of the Lycoming IO-540-AE145 engine, S/N 33229-48E.

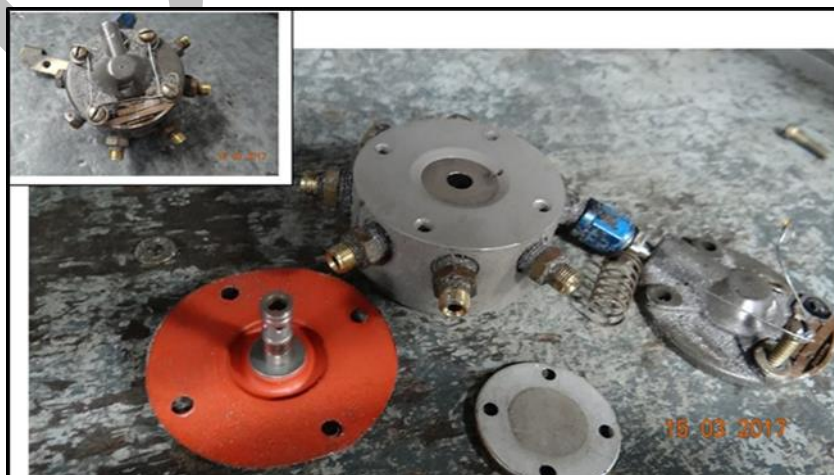
9 Figure 13 shows the fuel distributor and its components.

10  
11 Figure 13 - Disassembled distributor view. Highlighted the distributor assembled.

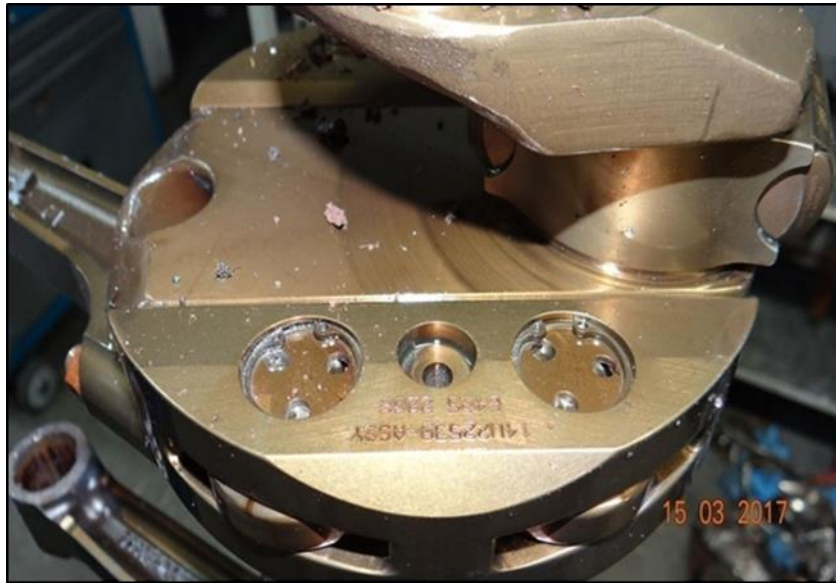
- 10 Figure 29 shows the dynamic counterweights of the crankshaft. They were normal and  
11 the pins were assembled correctly.

Figure 29 - Highlight for identification of the counterweight of the crankshaft.

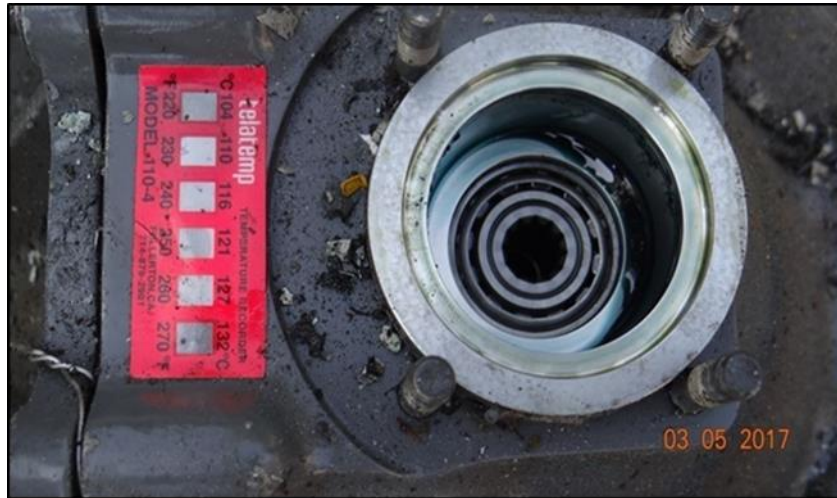
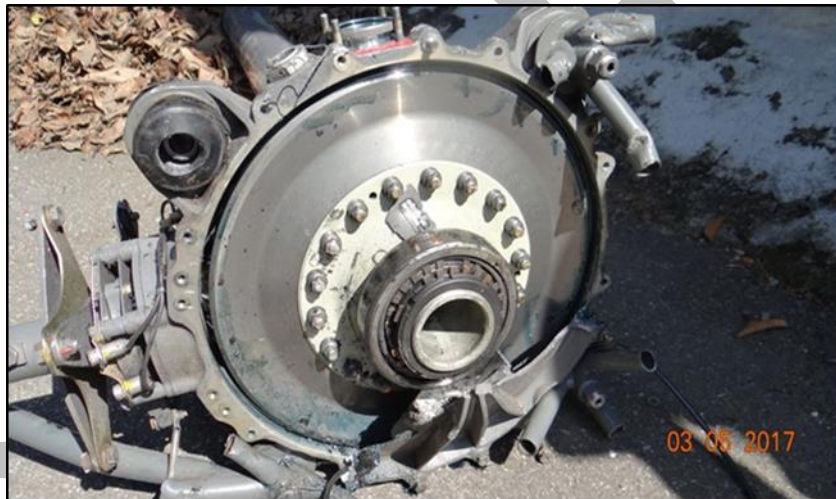
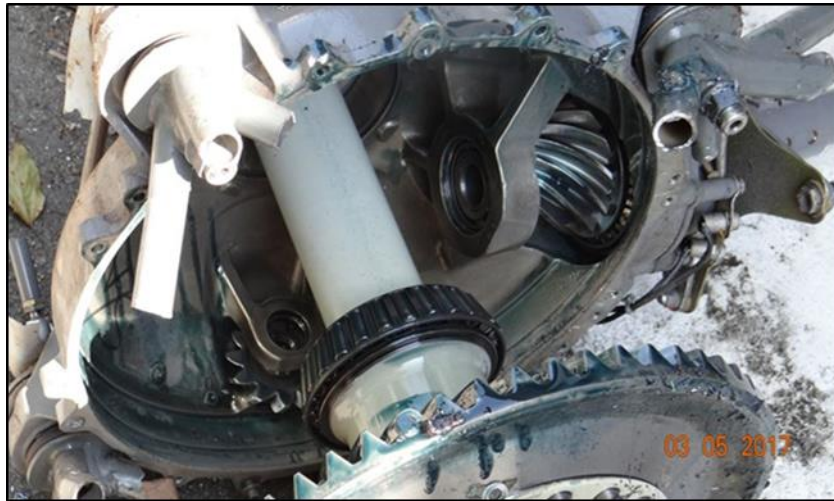
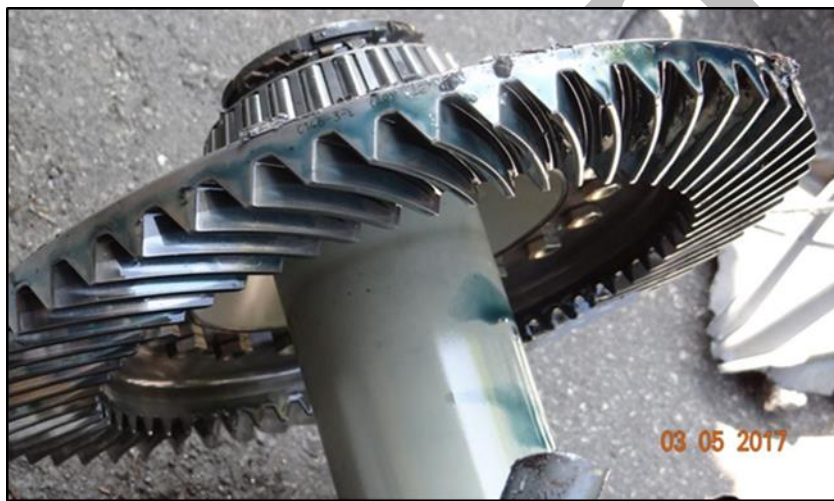
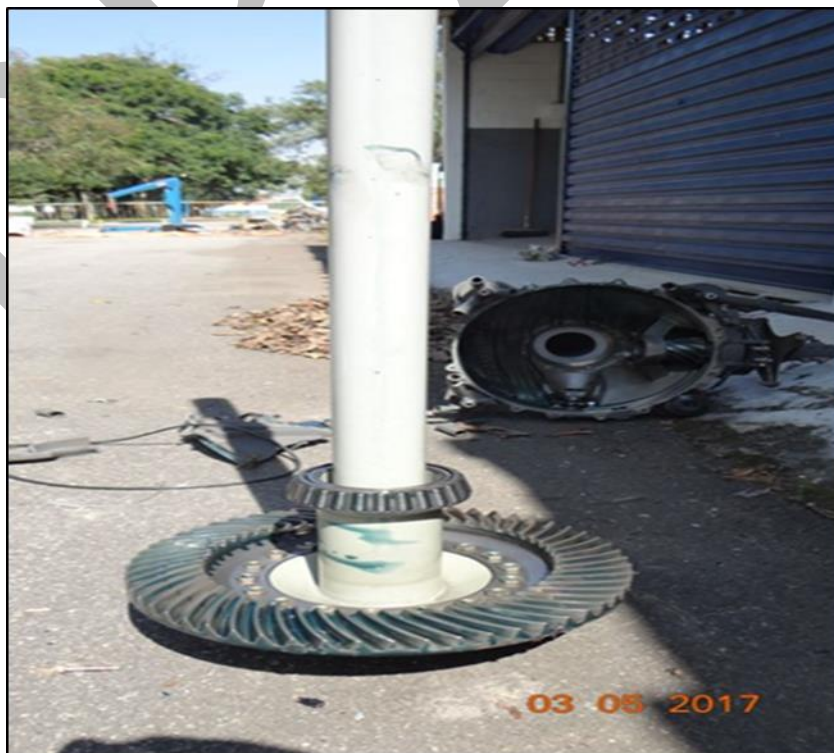
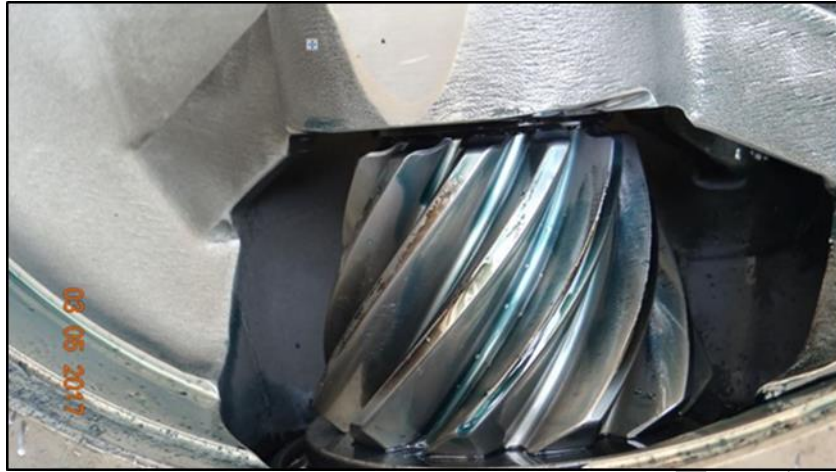
1 The interior of the transmission case and its components (rack, pinion, hydraulic pump  
2 gear, pump housing and bearings) did not present scratches and signs of overheating, due  
3 to lack of lubrication (Figures 38 to 46). No evidence of failure was found to compromise its  
4 operation.

5  
6 Figure 38 - Housing of the hydraulic pump in the gearbox.

7  
8 Figure 39 - Bottom view of the rack and bearing of the transmission box.

Figure 41 - General view of the rack, the upper bearing and the gearbox pinion.

Figure 42 - Main gearbox rack.

Figure 43 - Top rack and top bearing of the main gearbox.

No abnormality was observed. Thus, it has been observed that the temperature excess observed in Telatemp was probably the result of heat irradiated by the engine after the accident.

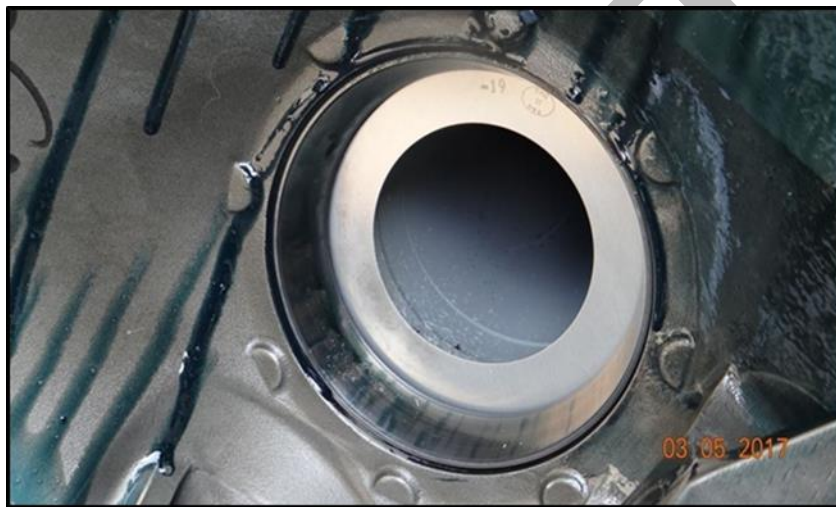
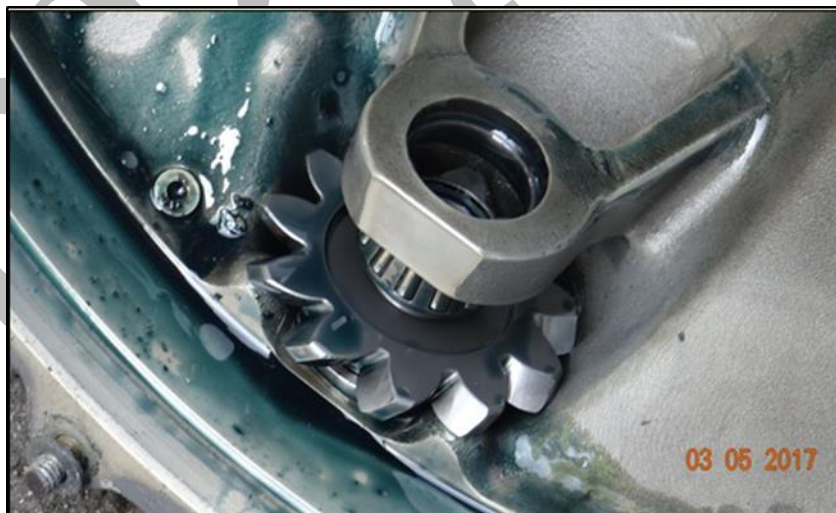
Figure 45 - External track of the upper gearbox bearing.

Figure 46 - Gearbox hydraulic pump drive gear.

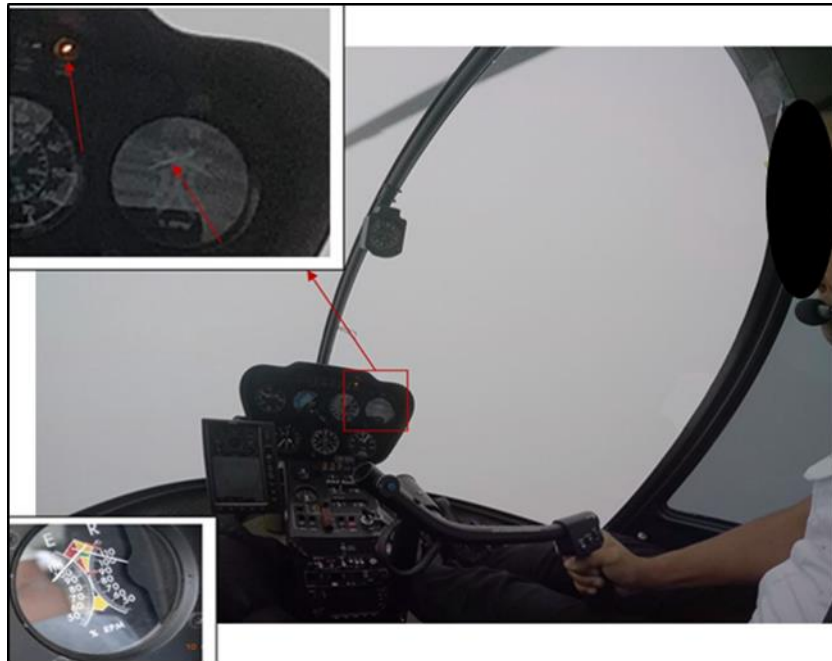
The image of the camera on board the aircraft made it possible to observe the low-rotating light of the main rotor on (Figure 47) and, in the upper display, the indication that the engine was powered.

The lower highlight (Figure 47) shows an instrument similar to that of the aircraft panel. It was included, so that the reader could clearly observe the information provided by that instrument, that is, the engine and main rotor rotations in percentage.

Figure 47 - Low RPM Main Rotor Indicator Light. In the lower highlight, an indicator similar to that of the aircraft. In the top highlight, indication that the engine was powered.

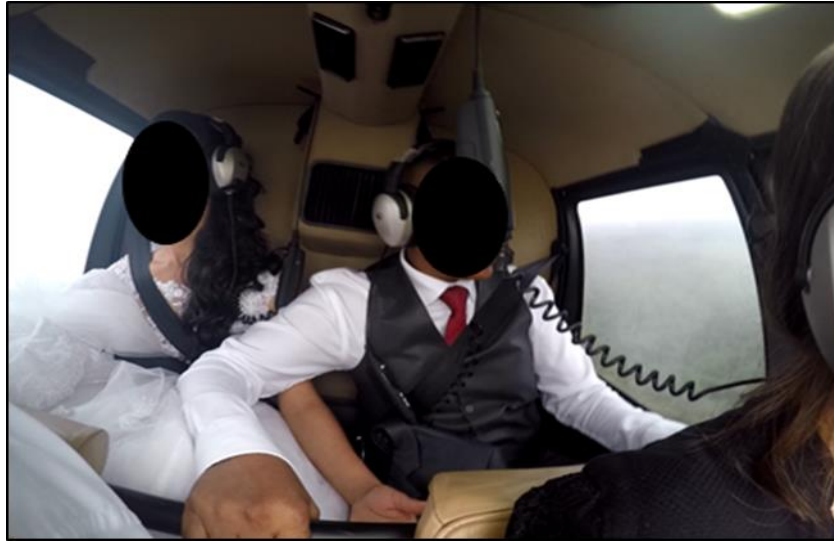
1 At 18:25:59 (UTC), the aircraft flew over the southern region of São Lourenço da Serra.  
2 The pilot turned to the left and began to fly through the clouds, with low visibility and in  
3 instrument meteorological conditions (IMC), but it was possible to observe that he still had  
4 visual contact with the ground (Figure 55).

5  
6 Figure 55 - 18:25:59 (UTC), low visibility flight and under IMC conditions.

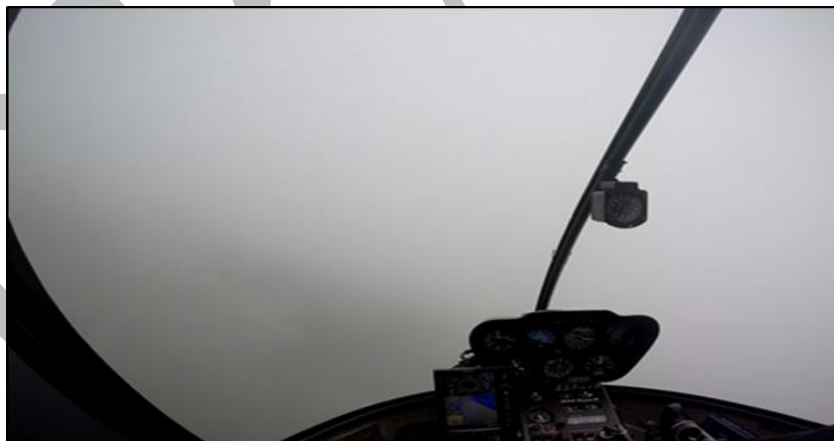
7 At 18:26:13 (UTC), the weather deteriorated. There was no visual contact with the  
8 ground and the visibility ahead was zero. The flight conditions were IMC and it was not  
9 possible to define the exact position of the aircraft.

10 The aircraft turned to the left with 25° inclination, 5° pitched up, 52kt of indicated speed,  
11 was passing through 2,940ft, with a rate of ascent of 800ft / min. The Manifold Pressure was  
12 21.5inHg, the Rotor Tachometer was 100% and the Engine Tachometer was 101% (Figure  
13 56).

14  
15 Figure 56 -18:26:13 (UTC), there was no visual contact with the ground and the visibility  
16 ahead was zero.

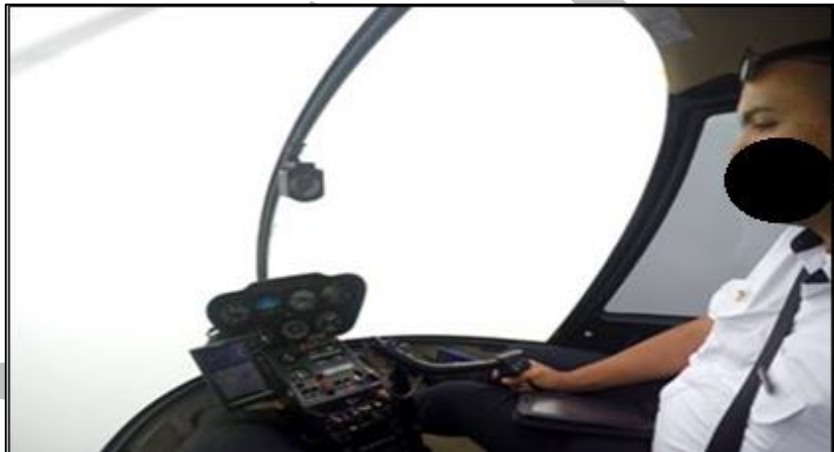
- 6 The image recorded at 18:27:32 (UTC) shows that the pilot appeared to be staring only  
 7 at the aircraft's GPS equipment (Figure 58), but the attitude information from the GPS and  
 8 the aircraft's original instrument were conflicting, as shown in Figure 59.

9  
 10 Figure 58 - Fixed look, apparently, in the GPS at 18:27:32 (UTC).

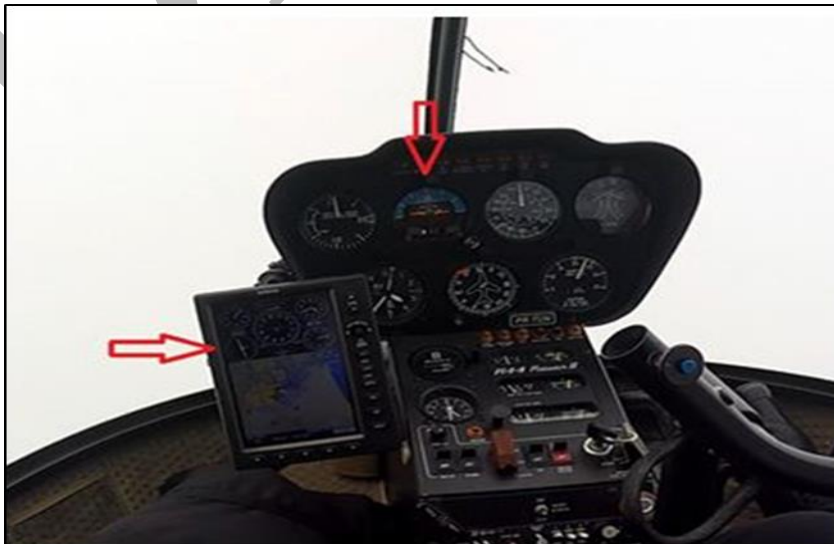
11  
 12 Figure 59 - 18:29:40 (UTC), aircraft attitude indicator and GPS with different indications.

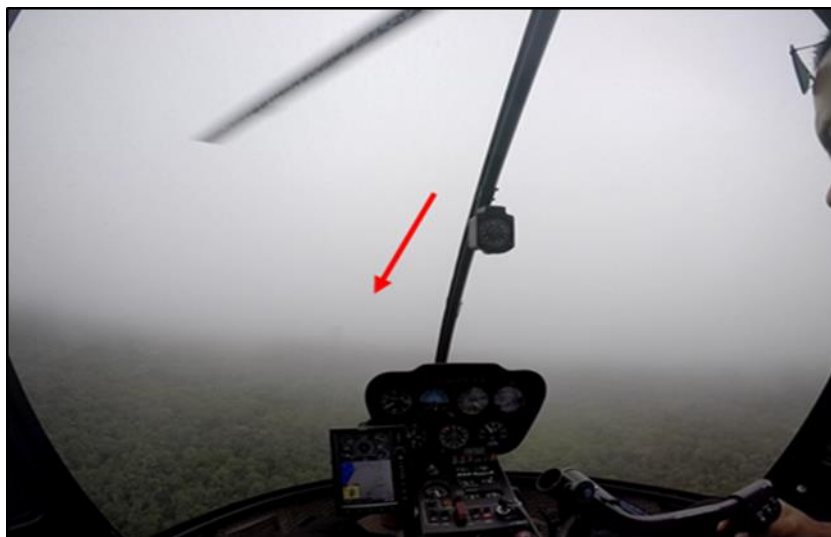
4 The pilot started a 30° turn to the left. The power was increased to 21inHg, the speed  
5 was decreased to 35Kt and the rate of climb reached 400ft / min. The conditions remained  
6 IMC, but there was visual contact with the terrain (Figure 60). The following dialogue was  
7 established between the passenger and the pilot:

10  
11 Figure 60 - 18:27:47 (UTC), flight conditions IMC (arrow indicates the power grid).

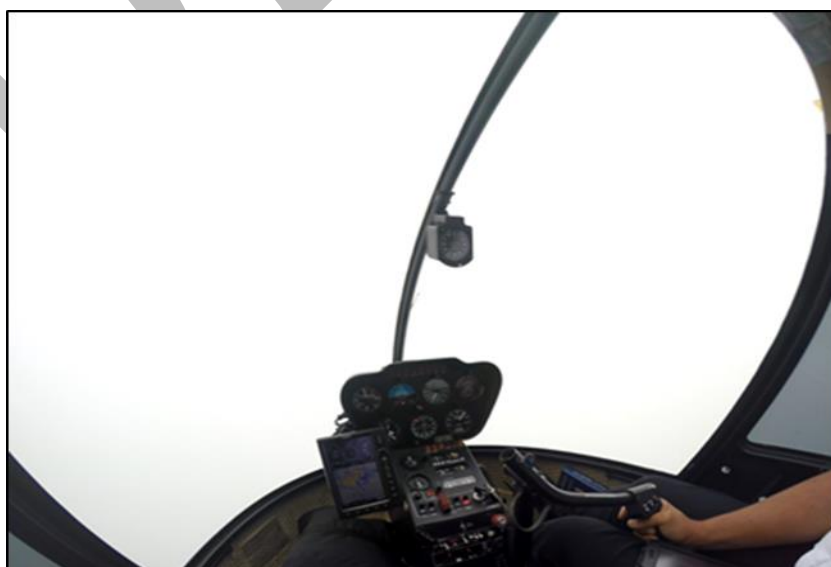
14 At 18:28:58 UTC, conditions remained IMC and visibility was zero, the pilot constantly  
15 looked at the instrument panel (there were no external references). The aircraft had 90kt of  
16 indicated speed, passing through 3.500ft of altitude with rate of climb of 800ft / min. The  
17 Manifold Pressure was at 25.5inHg, the Rotor Tachometer at 100% and the Engine  
18 Tachometer at 101% (Figure 61).

19  
20 Figure 61 – 18:28:58 (UTC), the visibility was zero.

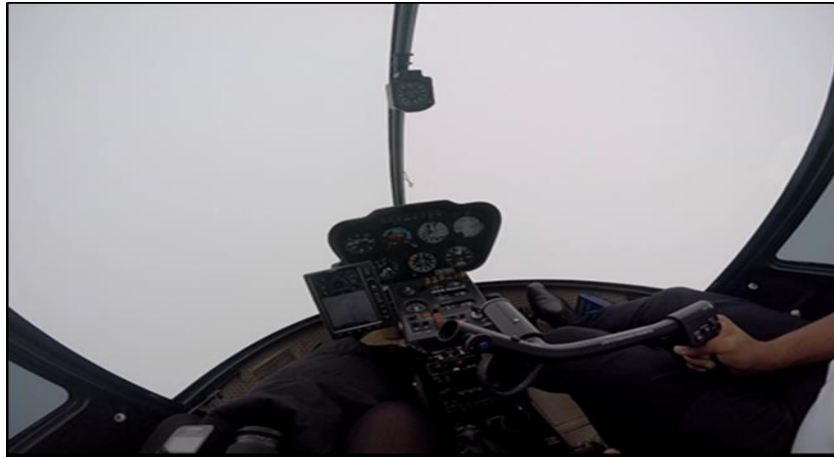
5 The pilot increased the movements of the cyclic. The aircraft tilted to the right, then to  
 6 the left and reversed again to the right. There were variations in the pitch angle from +30°  
 7 to -10° and around 45° of banking for each side (Figure 62).

8  
 9 Figure 62 – 18:30:05 (UTC), high pitch and bank angles.

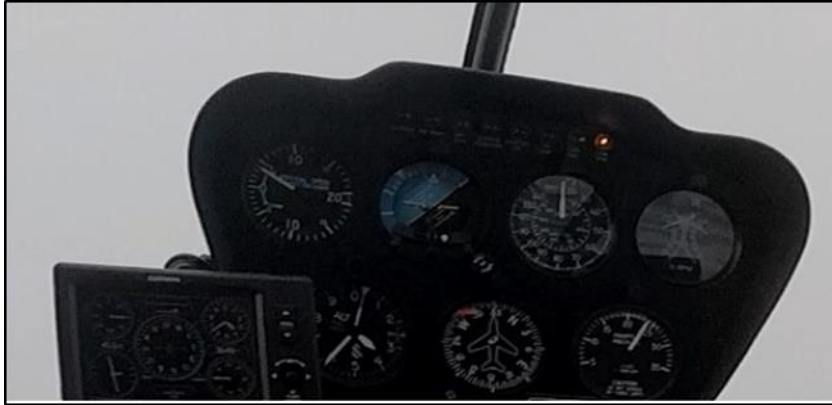
3 The transmission failure would be indicated by unusual noise and vibration, nose to  
4 the right or left, decrease of the main rotor rotation (NR) with increase of the engine RPM.  
5 In Figure 64, it was found that engine (Engine RPM) and rotor (NR) rotations were  
6 synchronized.

7  
8 Figure 64 – 18:30:13 (UTC), engine RPM and rotor synchronized (NR).

25 The illumination of the LOW RPM light in the present case was motivated by an excess  
26 load factor caused by the maneuver performed. In Figure 64, it was found that the engine  
27 (Engine RPM) and rotor (NR) rotations were synchronized.

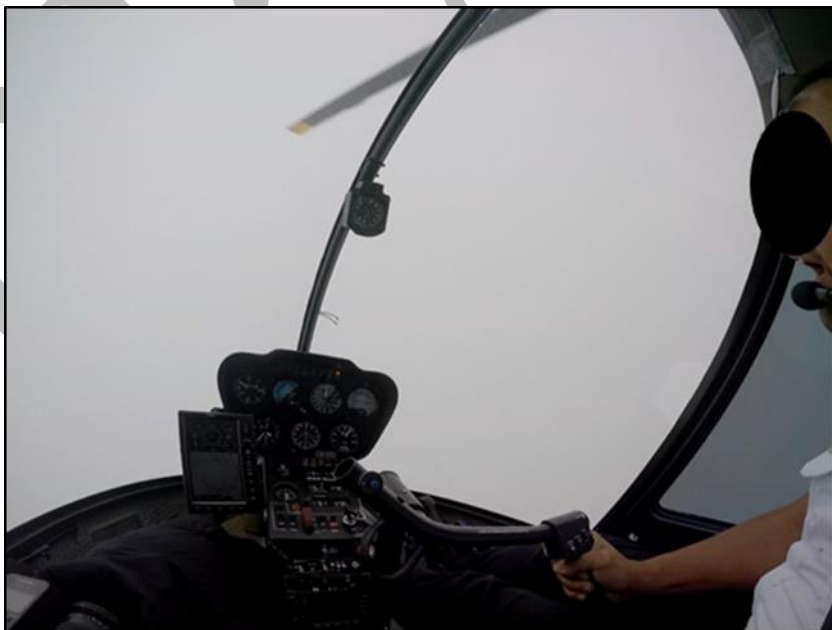
14 The aircraft entered an abnormal attitude, with an indicated speed of 0kt, a 50° bank  
15 to the right, Manifold Pressure was at 24inHg, Rotor Tachometer at 94% and Engine  
16 Tachometer at 96% (Figure 65).

17  
18 Figure 65 - 18:30:13 (UTC), aircraft in a 50° bank to the right.

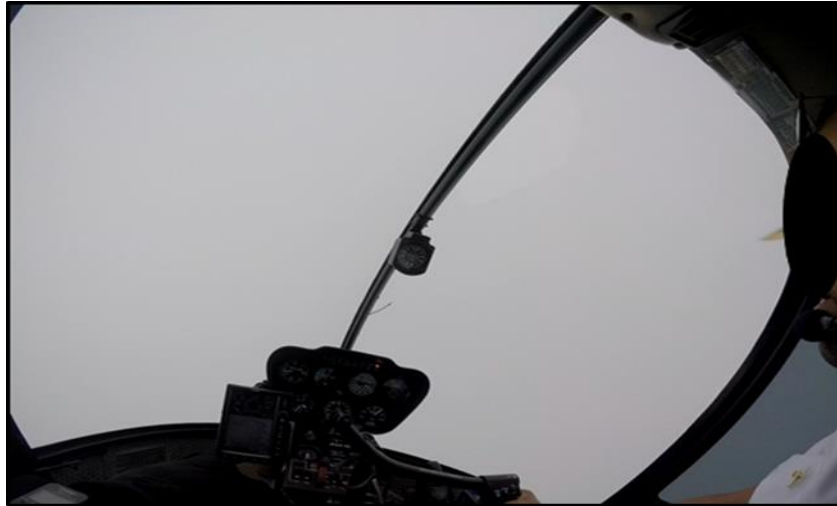
19 At 18:30:15 (UTC), the aircraft was out of control. The LOW RPM light was still on. The  
20 aircraft had an indicated speed of 54kt, in a 75° bank to the right and a 25° pitched down  
21 attitude. The altitude was of 3.560ft, the Manifold Pressure was 25inHg, the Rotor  
22 Tachometer was 92% and the Engine Tachometer was 94% (Figure 66).

1  
2  
3  
Figure 66 - 18:30:15 (UTC), aircraft with a 75° bank to the right and a 25° pitched down attitude.

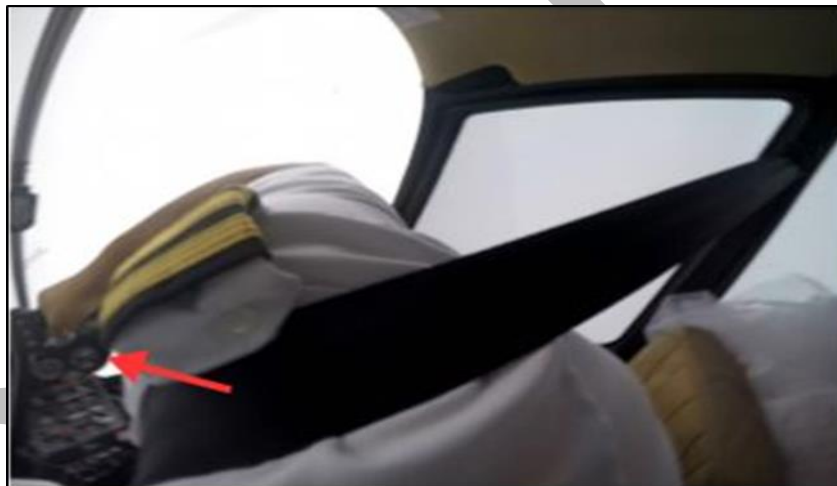
7 Until that moment, the engine has been in normal operation (Figure 67).

8  
9  
Figure 67 – 18:30:18 (UTC), indication that the engine was still running.

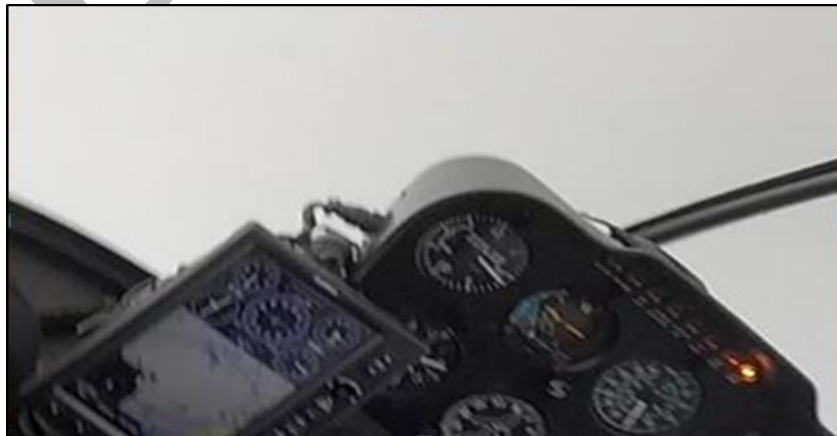
10 There are indications that the helicopter has reached 140° of bank and 30° of pitch  
11 down, already with a high rate of descent (Figure 68).

12  
13  
Figure 68 - Uncontrolled aircraft at 18:30:19 (UTC).

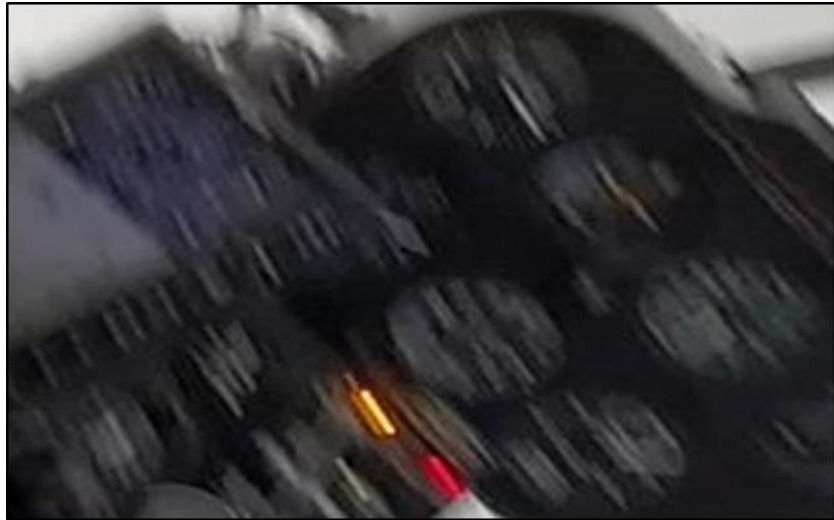
1 At this time, the OIL PRESSURE and AUX FUEL PUMP alarm lights came on (Figure  
2 69).

3  
4 Figure 69 - Alarm lights on at 18:30:19 (UTC).

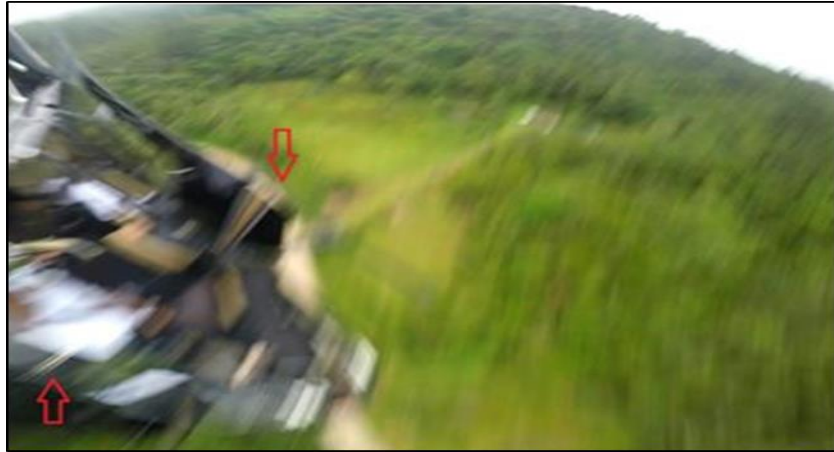
10 The camera was launched into the air and recorded the image (even if blurred) of the  
11 damaged aircraft in the air (Figure 71). In the highlight, one could see the detail of the  
12 external painting (three golden bands).

Figure 71 - View of external parts of the aircraft still in the air at 18:30:22 (UTC).

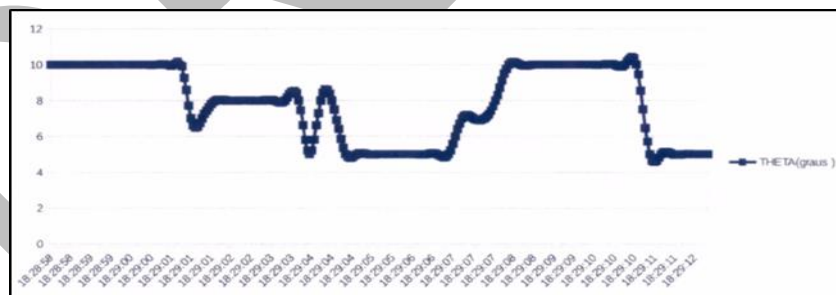
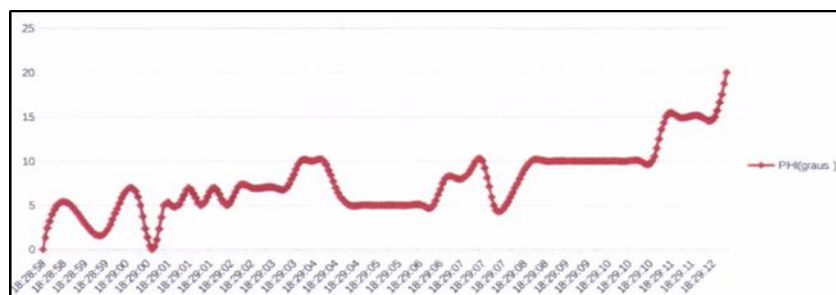
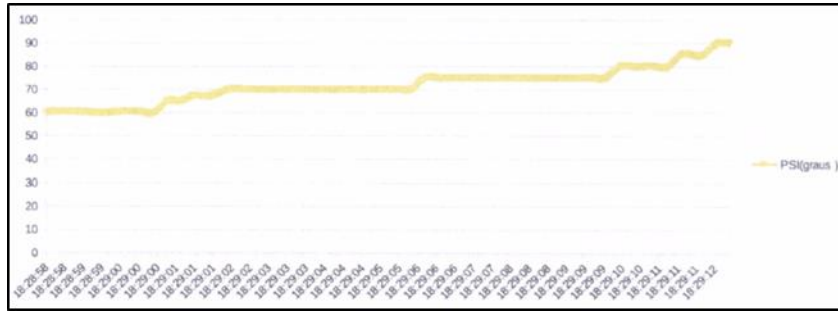
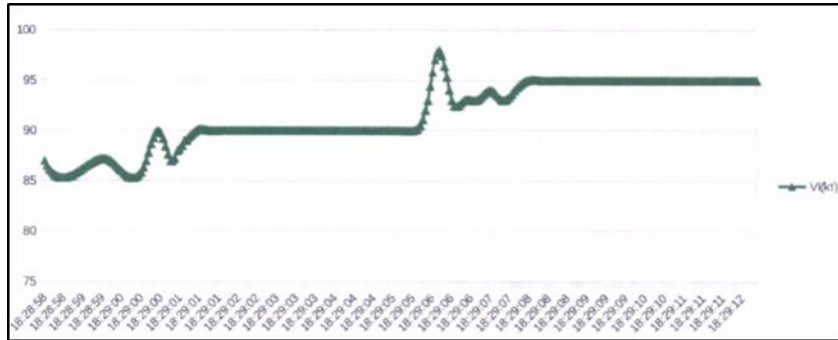
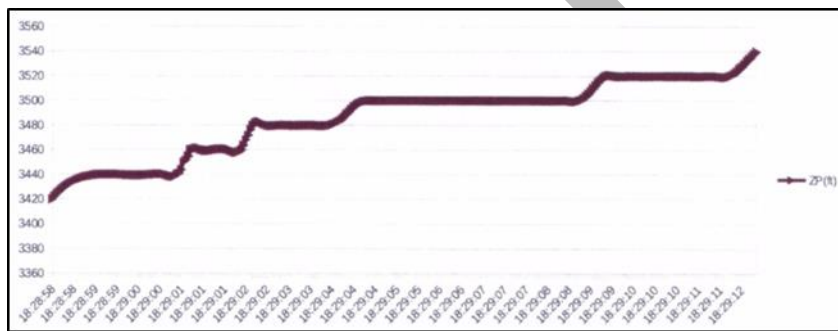
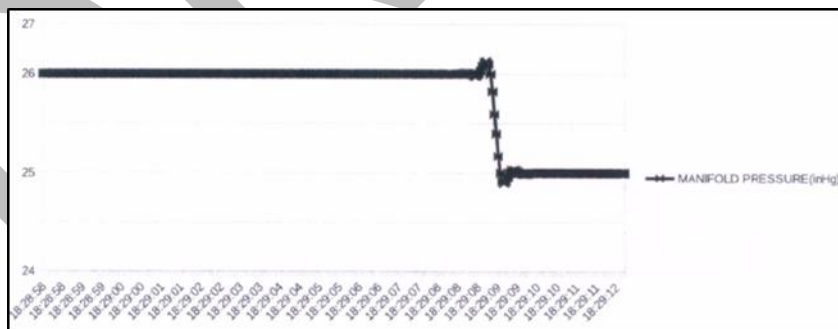
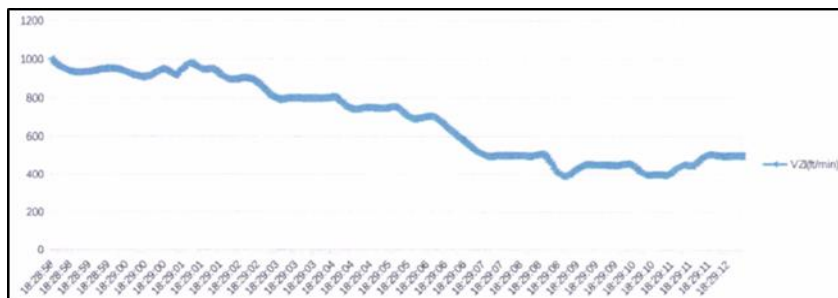
11 As shown in the graphs (Figures 72 to 78), the pilot kept high engine power (Maximum  
12 Takeoff Power - PMD) and the aircraft kept climbing (Figure 76).

13 On this first moment, the attitude variation in relation to the horizon (Figure 72) and the  
14 bank (Figure 73) suggest that the pilot was already showing signs of spatial disorientation,  
15 since the parameters were not kept stabilized.

9 As observed in Figures 72 to 76, when the forward speed was kept close to 90Kt, the  
10 stability of the helicopter favored the flight without catastrophic control loss.

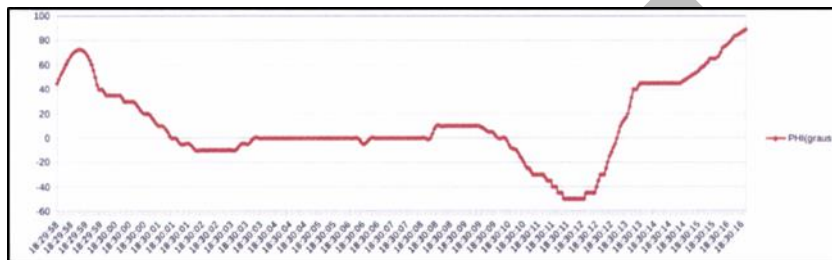
5  
 6 Figure 80 -Phi (bank in °) final moments.

15 As shown in Figure 80 the pilot commanded the cyclic on the right, reaching 75° of  
16 bank at 18:29:59 (UTC). Realizing it, he reversed the command to the left, but in an overly  
17 pitched down attitude (-15 ° to -25 °) and finally precipitated an aggressive 90° banking right.

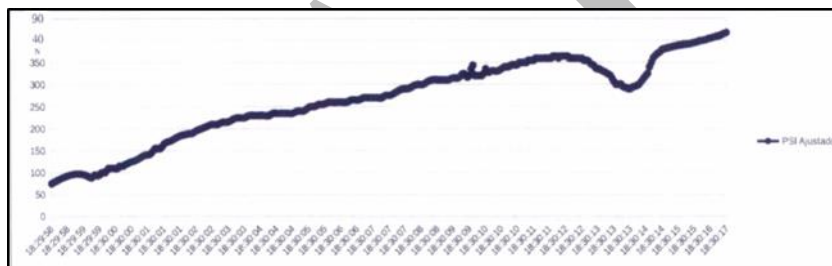
7  
 8 Figure 81 -Psi (Heading in °) final moments.

31 Figure 81 shows the helicopter's headings at the final moments. If there was a loss of  
32 the yaw command there would be no tendency to reverse the heading, which occurred at  
33 least twice: at 18:30:09 (UTC) very quickly and at 18:30:12 in a more smooth and clear  
34 manner.

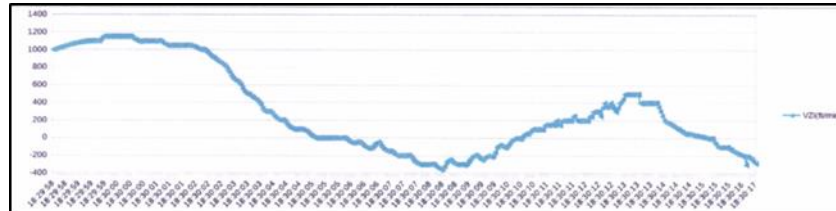
Figure 85 - Vzi (Rate of climb/descent in ft./min) final moments.

37 Vortex stalls occur in vertical descents with applied power. In Figure 85, it is seen that  
38 there has not been a steady descent, but rather an upward sequence interspersed with a  
39 rapid descent.
