COMANDO DA AERONÁUTICA
CENTRO DE INVESTIGAÇÃO E PREVENÇÃO DE
ACIDENTES AERONÁUTICOS

FINAL REPORT
IG - 155/CENIPA/2017

OCCURRENCE:	SERIOUS INCIDENT
AIRCRAFT:	PR-MBG
MODEL:	A320-232
DATE:	30NOV2017

This is the Final Report of the 30NOV2017 serious incident with the A320-232 aircraft model, registration PR-MBG. The serious incident was classified as “[OTHR] Other / Caused by in-flight weather phenomenon and [RE] Runway Excursion”.

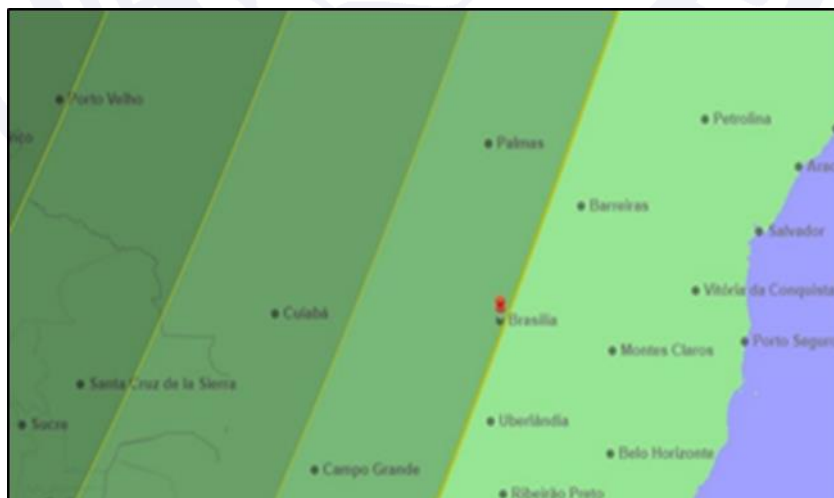
The event took place about seven minutes after the calculated sunrise time in Brasilia - DF, which corresponded to the sun in the direction of 112° and at an angle of 1° above the horizon line (Figure 1).

Figure 1 - Sun position at the time of the event.
(Source: in-the-sky.org).

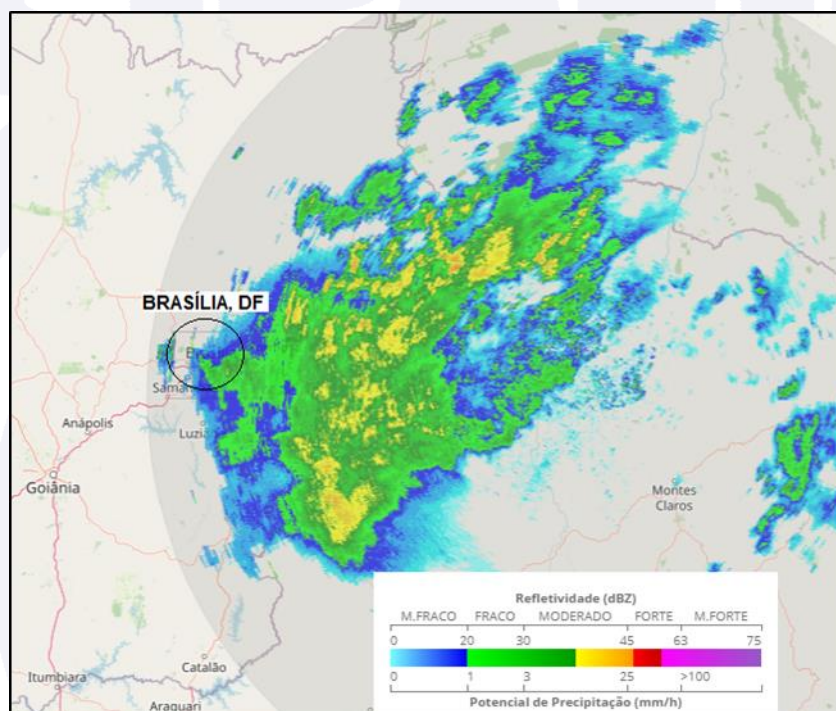
The images obtained in the REDEMET, of the MAXCAPPI, from the weather radar of São Francisco - MG, from 30NOV2017, at 0837 (UTC), showed, in the Brasilia region, the presence of precipitation in shades that varied from blue (very light rain) to green and yellow (light and moderate rain) (Figure 2).

Figure 2 - MAXCAPPI image of Brasília - DF, from 0837 (UTC), on 27NOV2017.

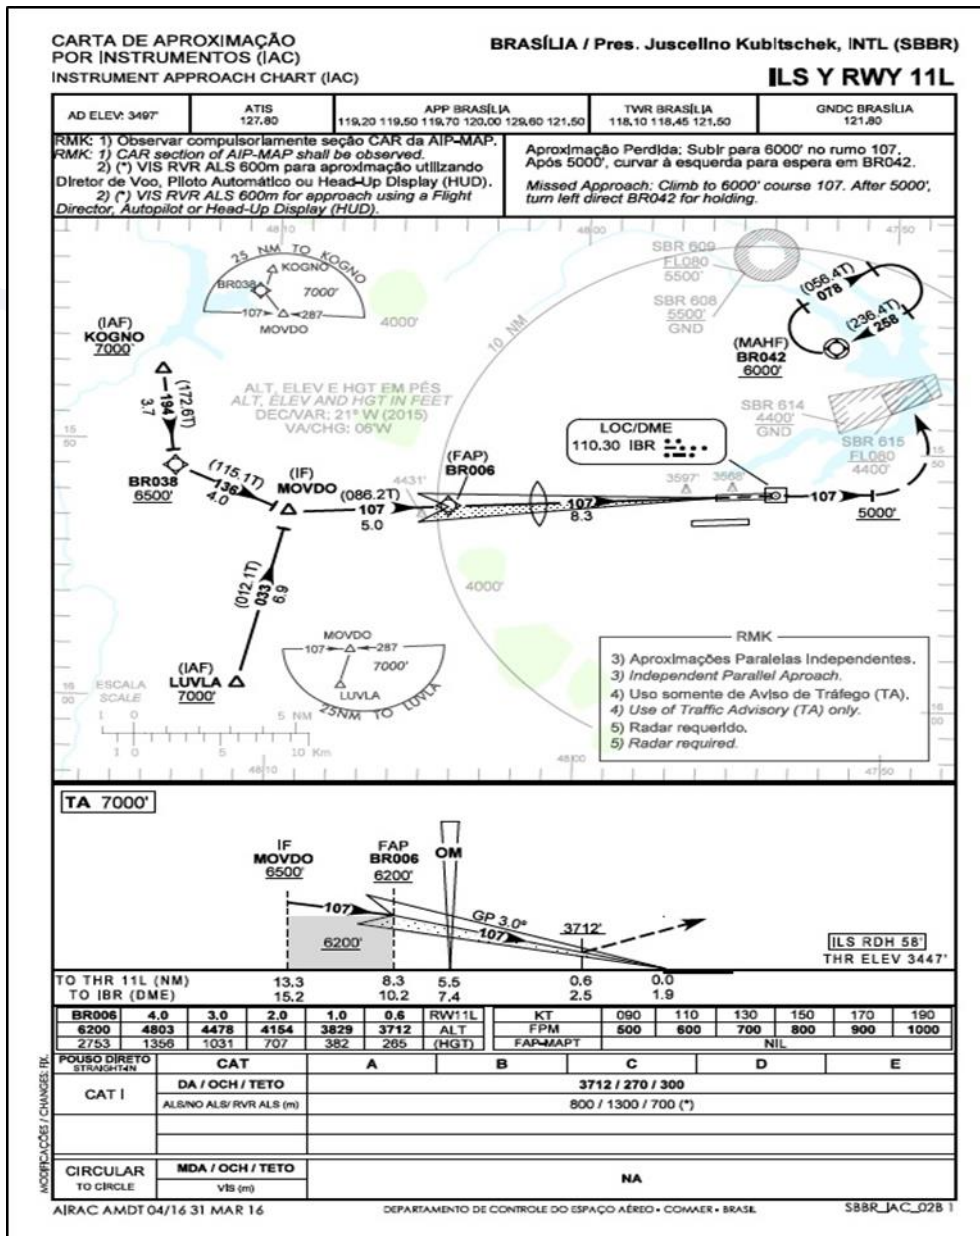
All navigation and landing aids operated normally when the aircraft was approaching, including instrument approach, Instrument Landing System (ILS) Y RWY 11L, used during approach (Figure 3).

Figure 3 - ILS Y RWY 11L chart from SBBR.

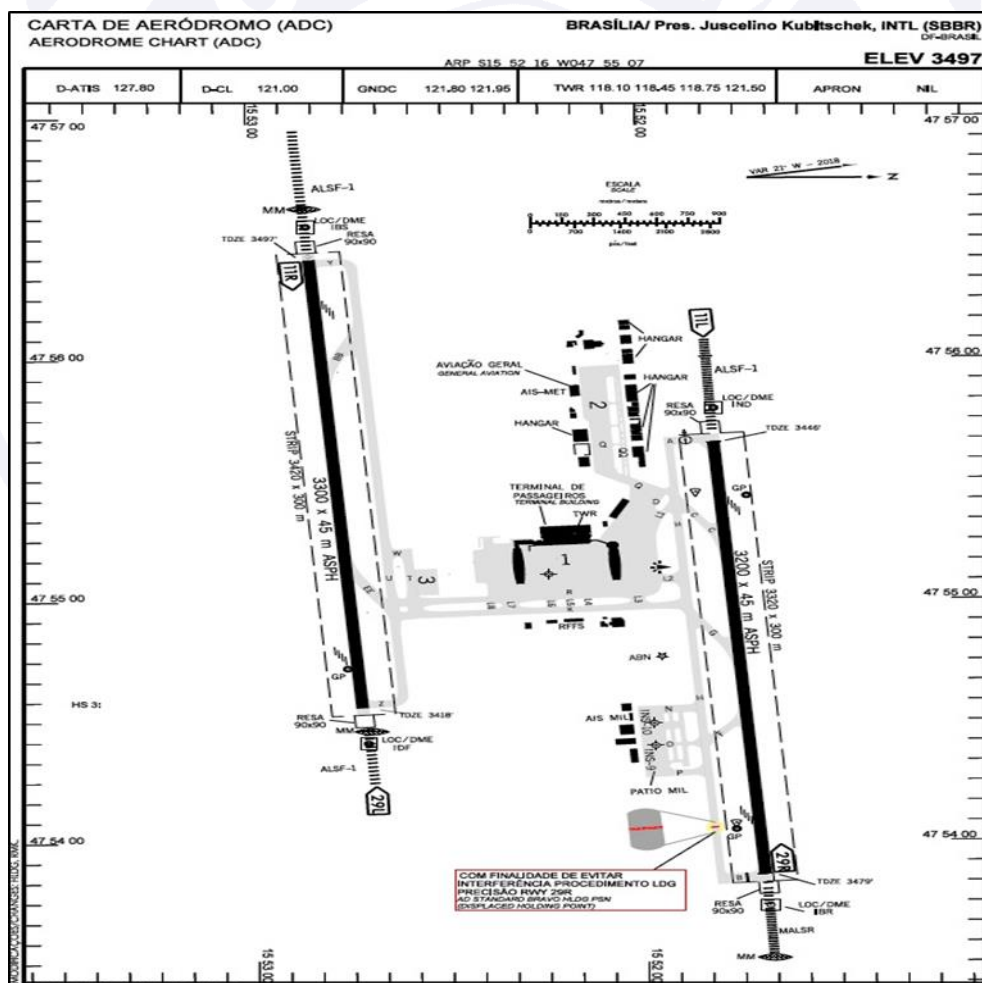
The runways were made of asphalt, with thresholds 11L / 29R and 11R / 29L, dimensions of 3,200m x 45m and 3,300m x 45m, with an elevation of 3,497ft (Figure 4).

Figure 4 - SBBR Aerodrome Chart (ADC).

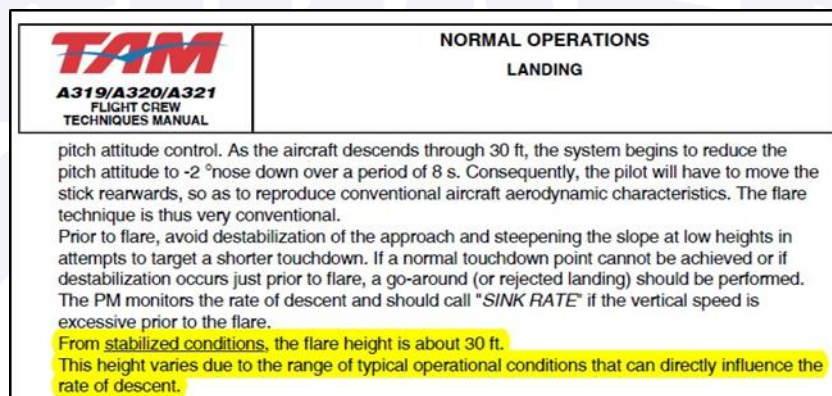
The FCTM of the Airline Company prevised that, in stabilized conditions, the reference height for performing the FLARE would be around 30ft, and that height could vary depending on the operational conditions that directly influenced in the descent rate (Figure 13).

Figure 13 - TAM A319/A320/A321 FLEET FCTM NO-170 P 2/14.

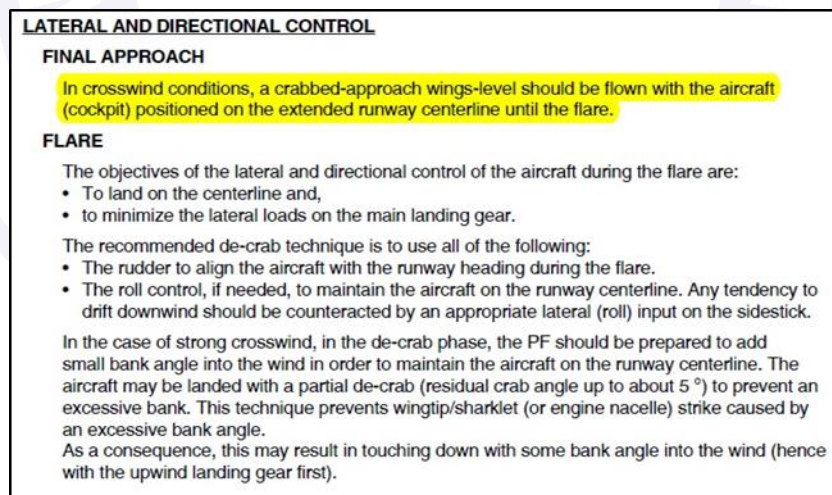
The same manual also prevised that, to compensate for the side wind component, the crabbed-approach technique was used until FLARE, then use the technique of lowering the wing to the wind side and utilize the rudder to align the fuselage with the runway axis (Figure 14).

Figure 14 - TAM A319/A320/A321 FLEET FCTM NO-170 P 3/14.
