COMANDO DA AERONÁUTICA
CENTRO DE INVESTIGAÇÃO E PREVENÇÃO DE
ACIDENTES AERONÁUTICOS

FINAL REPORT
A - 144/CENIPA/2019

OCCURRENCE:	ACCIDENT
AIRCRAFT:	PT-LTJ
MODEL:	550
DATE:	14NOV2019

This is the Final Report of the 14NOV2019 accident with the 550 aircraft model, registration PT-LTJ. The accident was classified as “[USOS] Undershoot / Overshoot – Undershoot”.

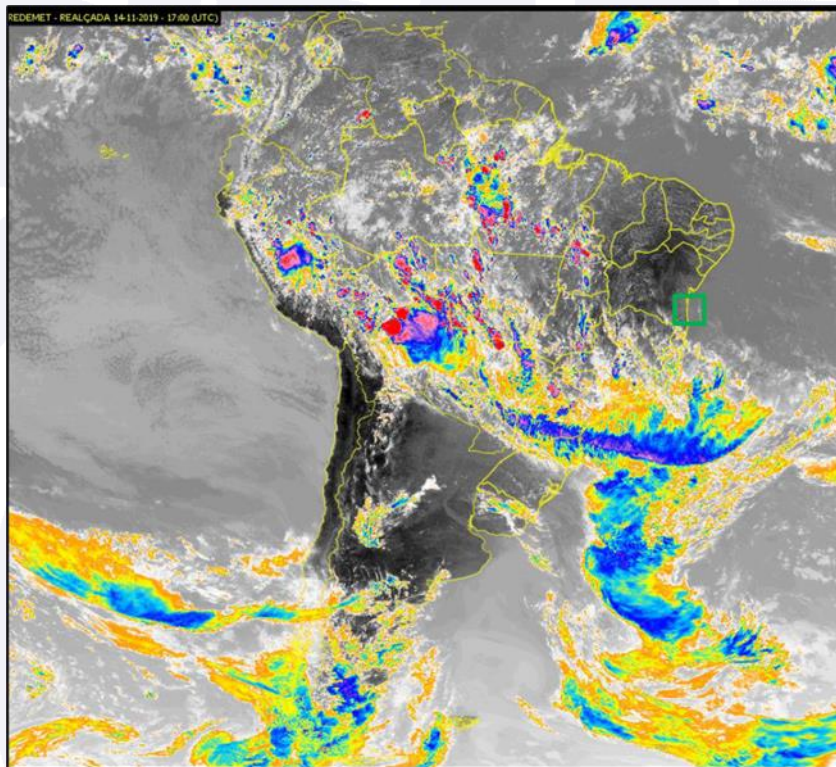
The satellite image highlighted at 1700 UTC, on 14NOV2019, made available by the REDEMET, shows that, over the accident region, there was no cloudiness with vertical development and that the cloudiness associated with the region of the study corresponded to *cumulus humilis*, that is, cloudiness with little vertical development and characteristic of good weather (Figure 4).

Figure 4 - Enhanced satellite image, from 14NOV2019, at 1700 UTC.

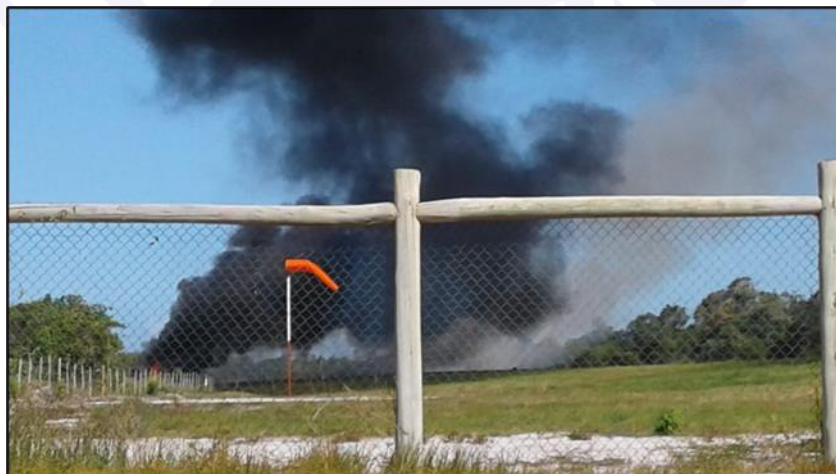
Based on the position of the Aerodrome windsock, it was estimated that the wind speed at the time of the accident was 06kt and the direction was 070° (Figure 5).

Figure 5 - Windsock indicating the wind condition at the time of the accident.

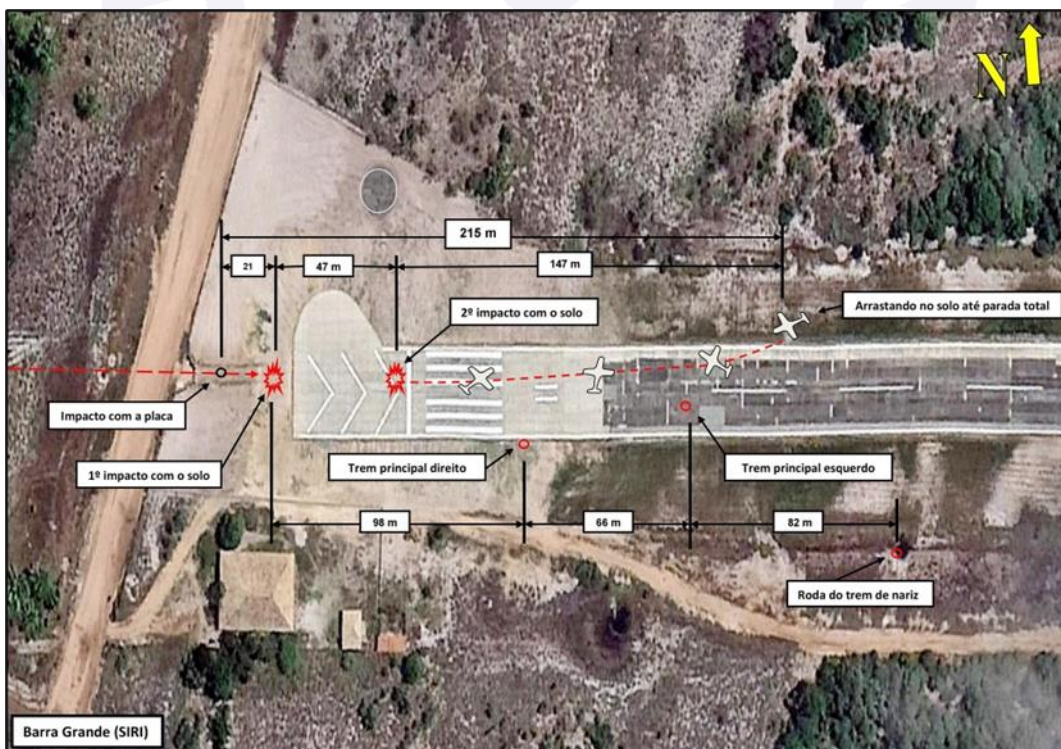
The aircraft dragged for 147 meters, catching fire. During this displacement, he left a trail of fire, turned left, leaving the runway by its left side (Figure 13), stopping with the heading lagged approximately 210° from the landing path (Figure 14).

Figure 14 - Sketch of the accident.

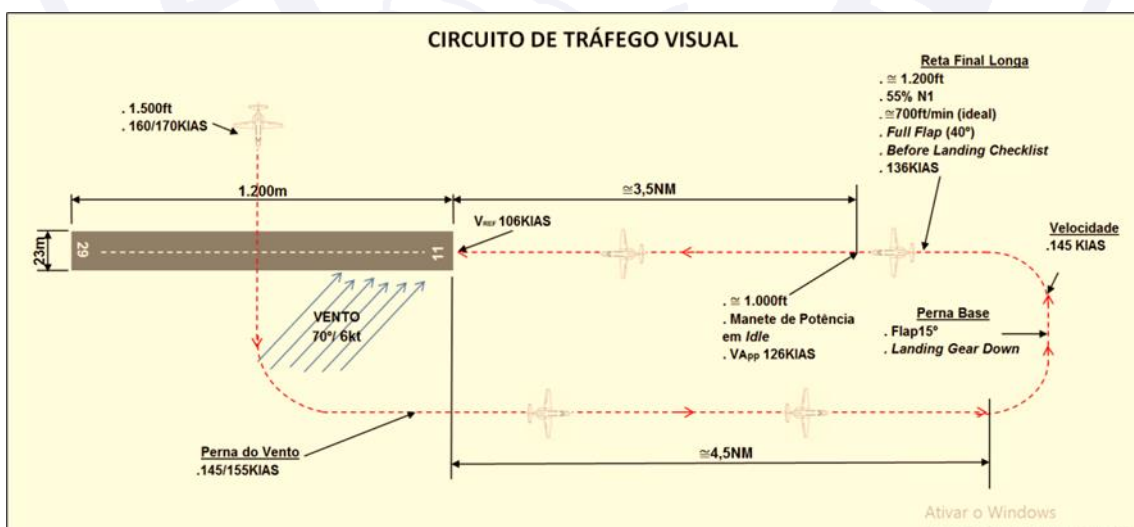
Upon crossing 1,000ft AGL, according to the commander's initial report and, with an approximate speed of 126 KIAS, the PF commanded the power levers to the Idle position (minimum power), as he realized that the aircraft was above the ideal ramp (Figure 17).

Figure 17 - Profile of the traffic circuit according to the commander's initial declaration.

The fact that the PF decided to prolong the wind leg (approximately 4.5NM), may have influenced his judgment of the approach ramp, since the beginning of the final approach segment took place on a long final straight (Figure 17).

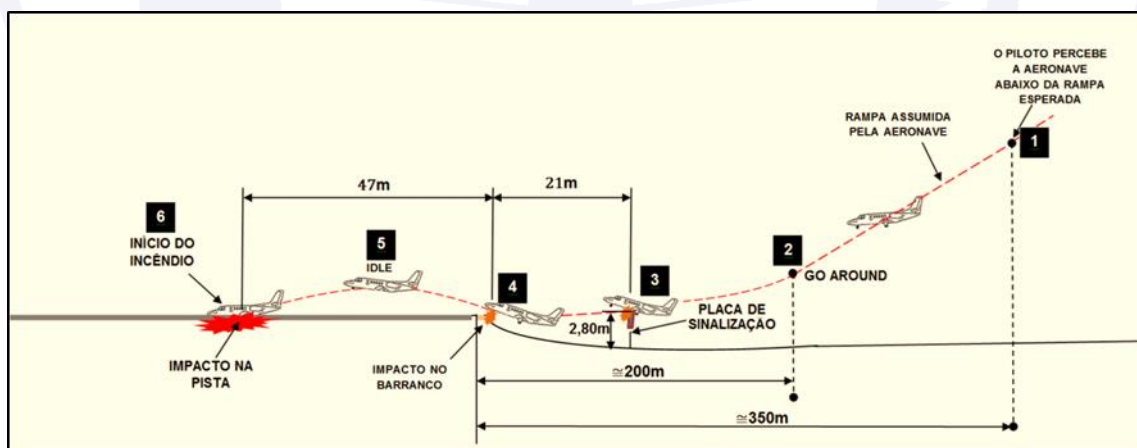
The decision to interrupt the go-around procedure came after the PF's distrust of the severity of the aircraft's impact against the ravine, and of the possible damage caused to the landing gear.

The profile of the final approach and the attempted go-around procedure, based on the commander's report, is described in Figure 18.

Figure 18 - Profile of the final approach and attempted go-around procedure, based on the commander's report.
