FINAL REPORT
IG-032/CENIPA/2017

OCCURRENCE:	SERIOUS INCIDENT
AIRCRAFT:	PT-MZY
MODEL:	A320-232
DATE:	22FEB2017

This is the Final Report of the 22FEB2017 serious incident with the A320-232 aircraft, registration PT-MZY. The serious incident was classified as “[SCF-PP] System/Component Failure or Malfunction Powerplant / Engine Failure on the Ground”, “[LOC-G] Loss of Control – Ground and [RE] Runway Excursion.”

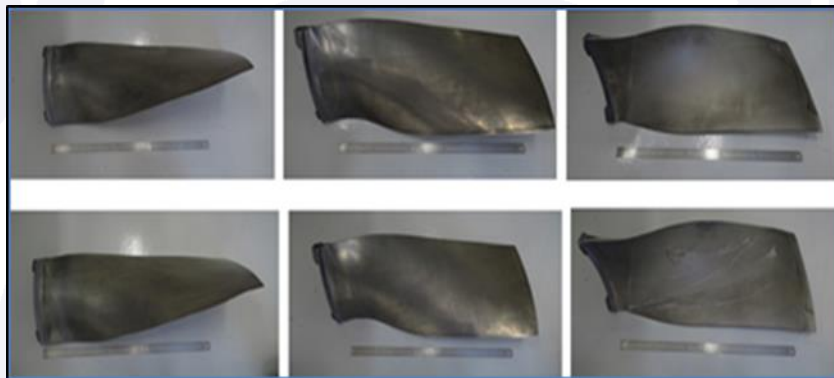
Figure 4 - Set of blades submitted for analysis at the DCTA.

In Figure 4, fan blades removed from the engine, which were sent for preliminary analysis at the DCTA, can be identified.

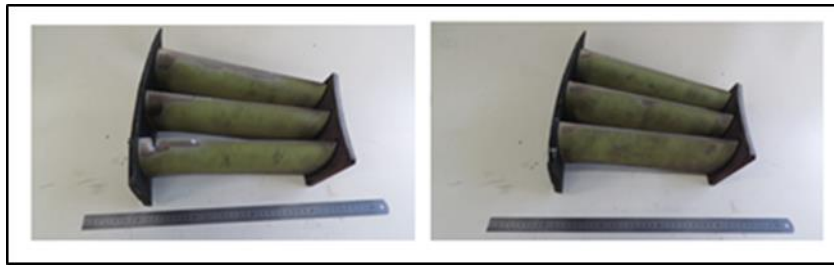
Figure 6 - Segments of fan exit guide vanes sent for analysis.

Figure 6 illustrates the fan exit guide vanes, which were also submitted for analysis at the DCTA.

By means of a visual and stereoscopic analysis, it was observed that the fractures of the annulus fillers, acoustic lining panels and guide vanes occurred from impacts and presented typical characteristics of overload, as shown in Figures 7 to 9.

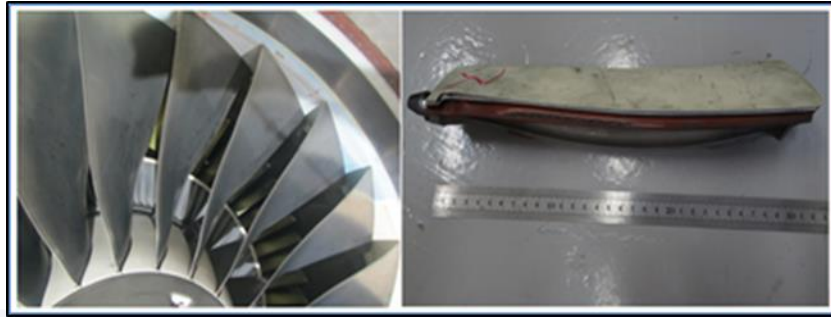
Figure 10 - Annulus fillers installed and a whole unit removed.

For reference and comparison purposes, Figure 10 shows some installed annulus fillers and a whole unit removed.

The risks found in the parts were also due to impacts on the surface of the material, with no evidence of corrosion or fatigue.

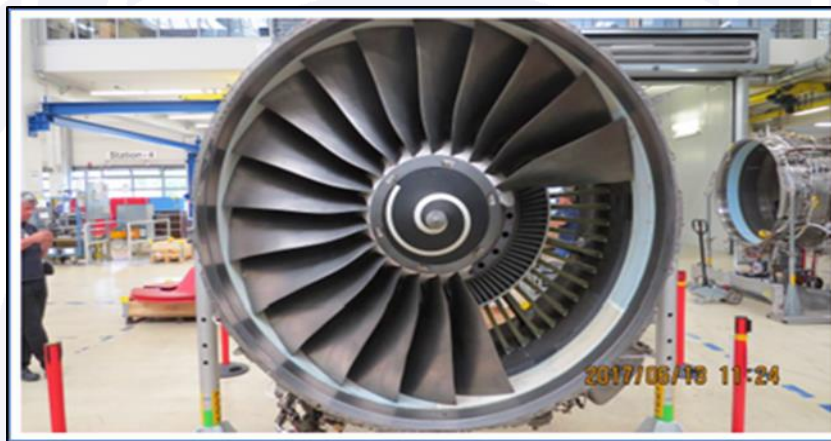
Figure 11 - Engine under analysis at the MTU service center.

Subsequently, the engine was subjected to an analysis in the premises of the manufacturer's service center, in this case MTU Maintenance Ltd. (Figure 11).

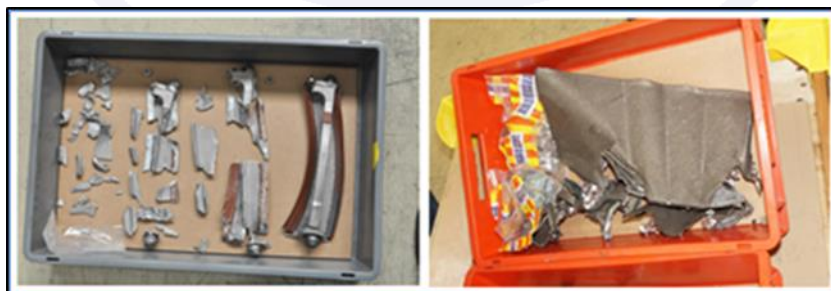
Figure 12 - Parts and fragments of the engine sent separately for analysis.

Due to the impossibility of reinstalling some parts and fragments of the engine, without significantly altering its state after the occurrence, they were sent separately, in order to allow a more reliable analysis (Figure 12).

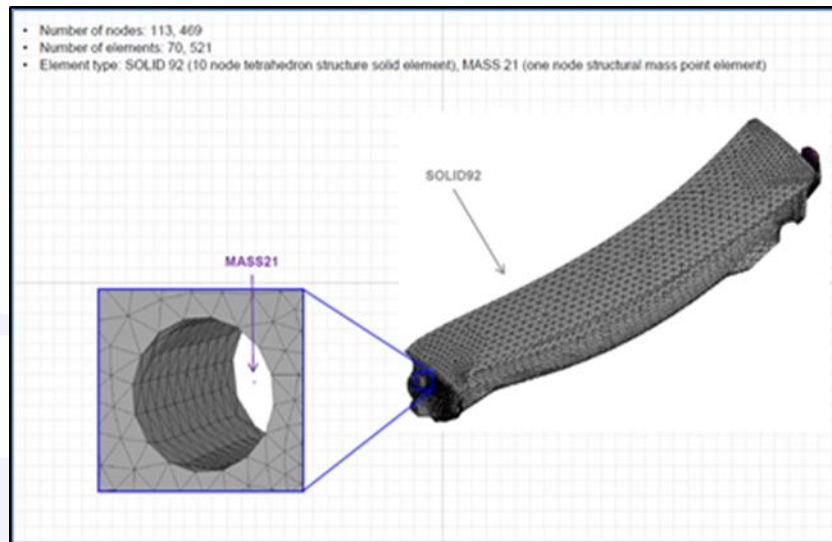
Figure 18 - Solid with the shape of annulus filler used as model for analysis.

Considering the relative positioning of all the engine components and the dynamics of the air flow (compressed air and bypass air), combustion flow and flue gas flow, it was found that the engine damage occurred from a failure in the structure of two annulus fillers.

At a later date, the results of disassembly and engine analysis being known, the tension distribution was simulated from boundary loading conditions in the theoretical structure of a solid identical to one of the annulus fillers (Figure 18).

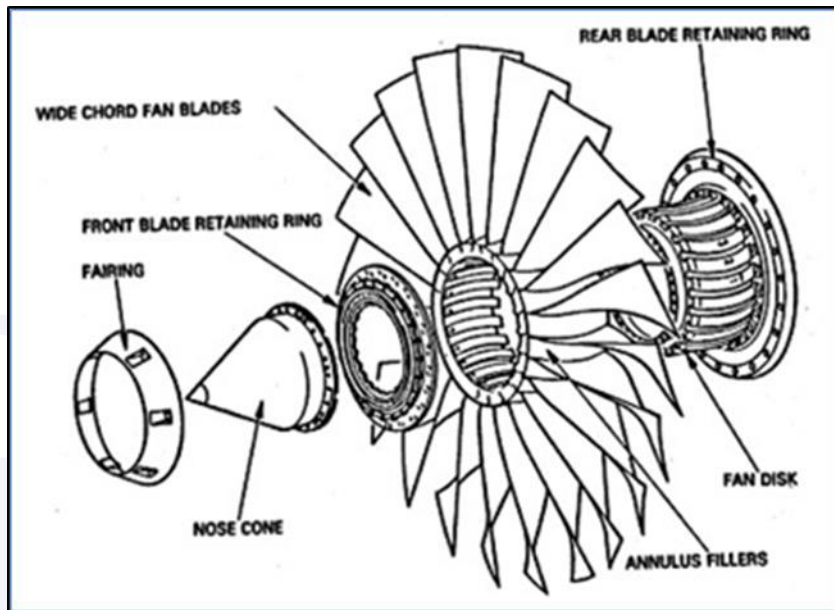
Figure 20 - Overview of the Fan Module components.

In this stage, besides the fragmented annulus fillers, other components of the engine structure connected to them were also analyzed, which are called Fan Module, as shown in Figures 20 and 21.

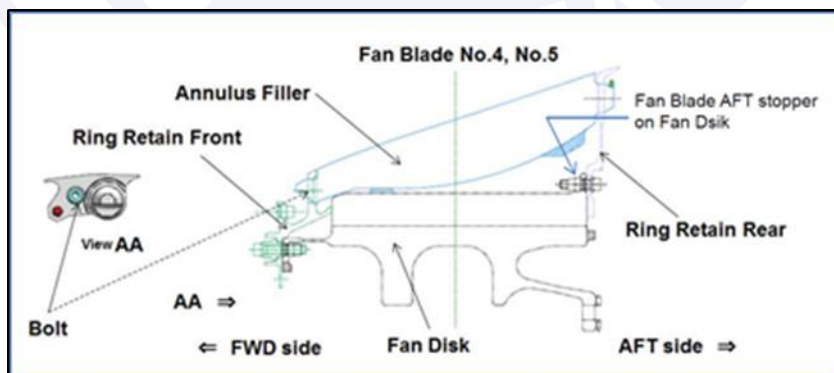
Figure 22 - View in longitudinal section of the parts' set that was analyzed.

Specifically, the analyzed pieces were: the front blade retaining ring, the rear blade retaining ring, the fan disk, twenty non-fragmented annulus fillers, two fan blades and a bolt (the fragment of the head of a screw), as shown in Figure 22.

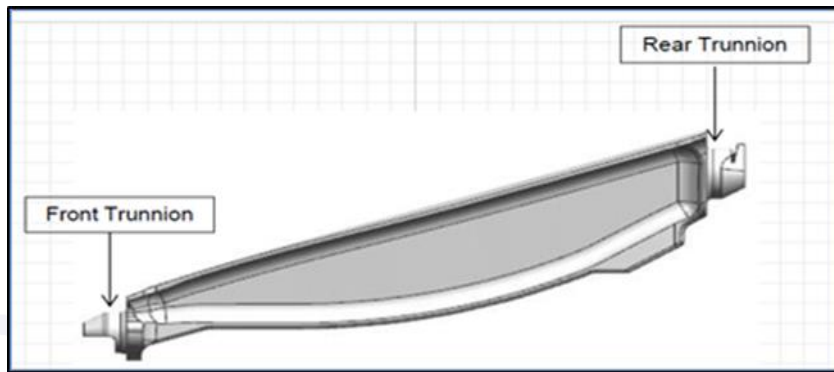
Figure 25 - Side image of an annulus filler for reference.

The annulus fillers #4, 5, 6 and 7 presented contact marks, wear, cracks, fractures and deformations different from those found in other annulus fillers. For purposes of illustration, Figure 25 shows a side view of an annulus filler with its rear trunnion and front trunnion.

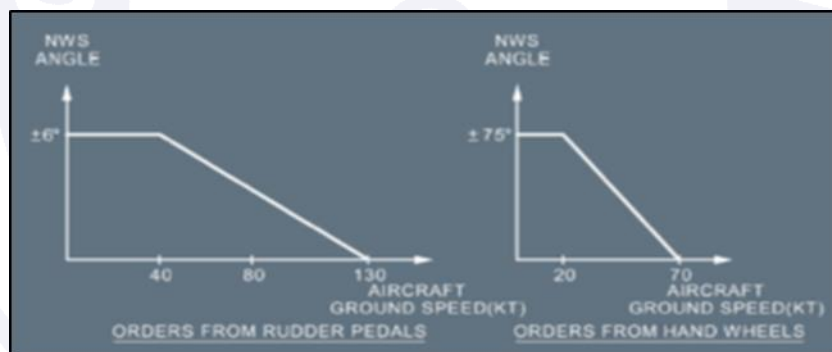
Figure 29 - Graph of the variation of Nose Wheel Steering (NWS) Angle according to the type of command (pedal or hand wheels) by the speed of the aircraft on the ground.

Such a system has been programmed so that the change in the angle of the nose wheel (Nose Wheel Steering Angle) obeys a logic that takes into account the speed of the aircraft, as shown in Figure 29.

Analyzing the graph of Figure 29, it was possible to conclude that the hand wheels command was very ineffective, since the aircraft was little effective, since the aircraft at a speed of 70 kt.
