FINAL REPORT
A - 030/CENIPA/2019

OCCURRENCE:	ACCIDENT
AIRCRAFT:	PT-HPG
MODEL:	206B
DATE:	11FEB2019

This is the Final Report of the 11FEB2019 accident with the 206B aircraft model, registration PT-HPG. The accident was classified as “[SCF-PP] System/Component Failure or Malfunction Powerplant – Engine Failure in Flight”.

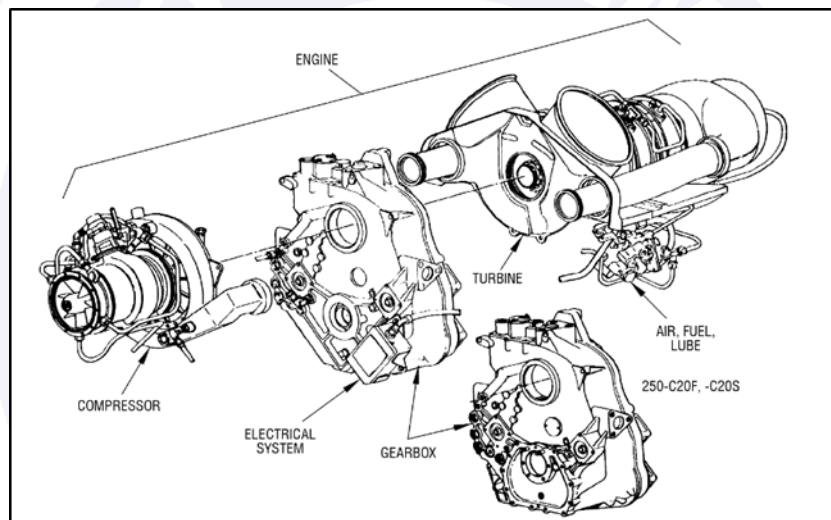
Figure 4 - Overview of the modules.

It was equipped with an M250 engine, which in terms of maintenance, was originally developed to allow modular overhaul. The major components of the engine were the compressor, the Gearbox and the turbine (Figure 4).

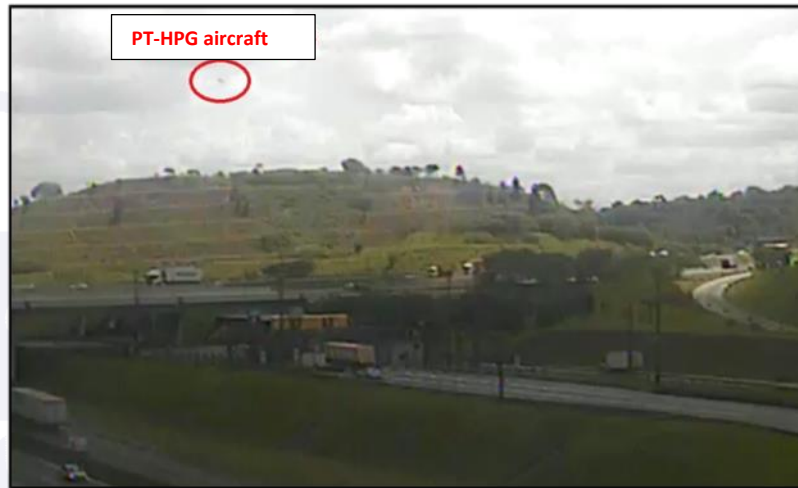
Figure 28 - Image from the security camera just before the accident.

The meteorological conditions at the accident site were favorable for the visual flight, as observed in the security camera of SP-021 Highway (Figure 28).

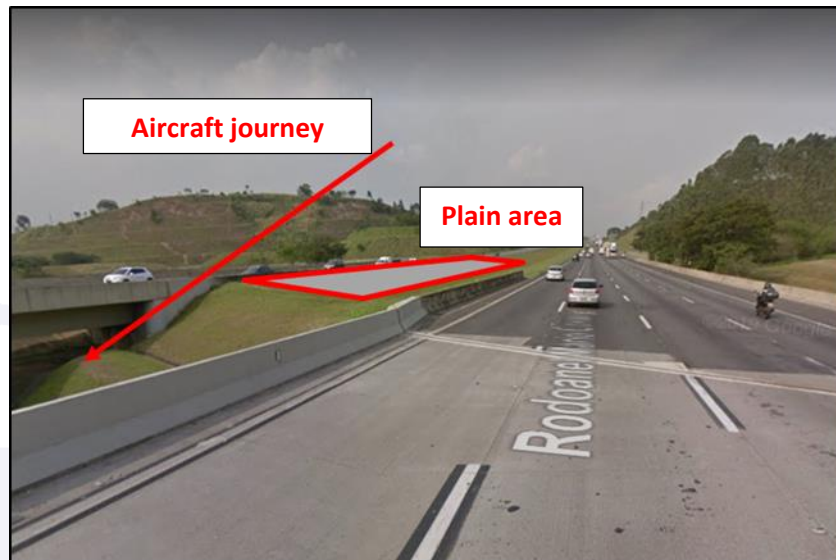
Figure 31 - Aircraft journey and probable area chosen by the pilot for autorotation.

Analyzing the images of the field investigation and the sketch, the Investigation Team inferred that the aircraft approached the grassy space between the two elevated runways of the Rodoanel, and perpendicularly to the marginal lane of the Anhanguera Highway (Figures 31 and 32).

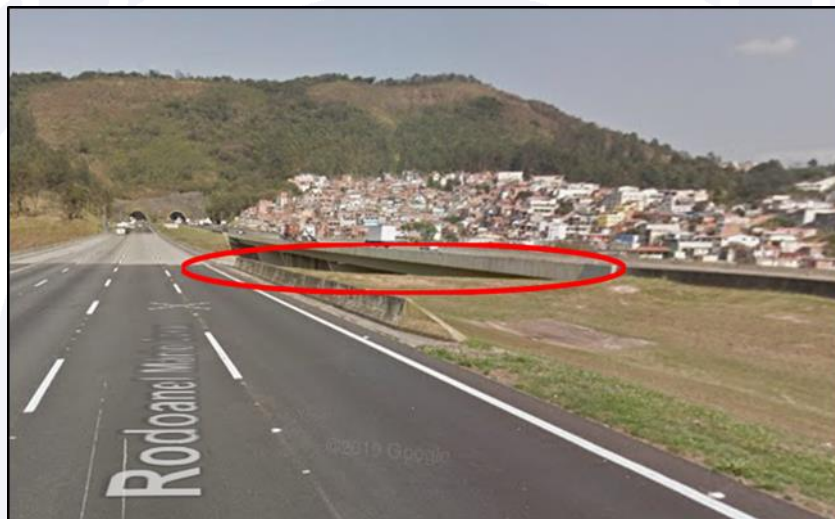
Figure 32 - Place where the aircraft passed (between lanes).

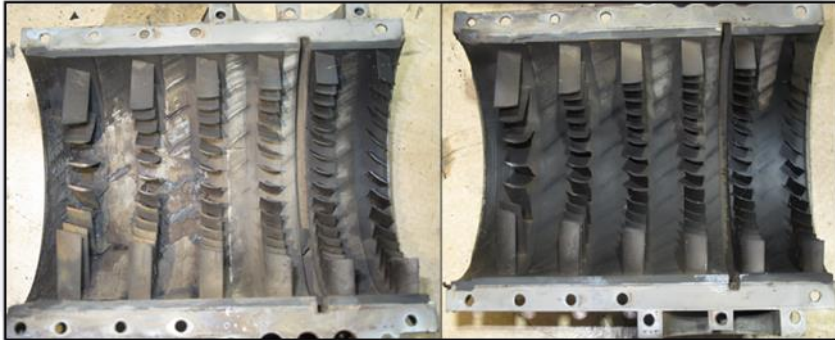
No compromise was observed for the stator and rotor blades (Figures 40 and 41).

Figure 40 - Stator blades intact.

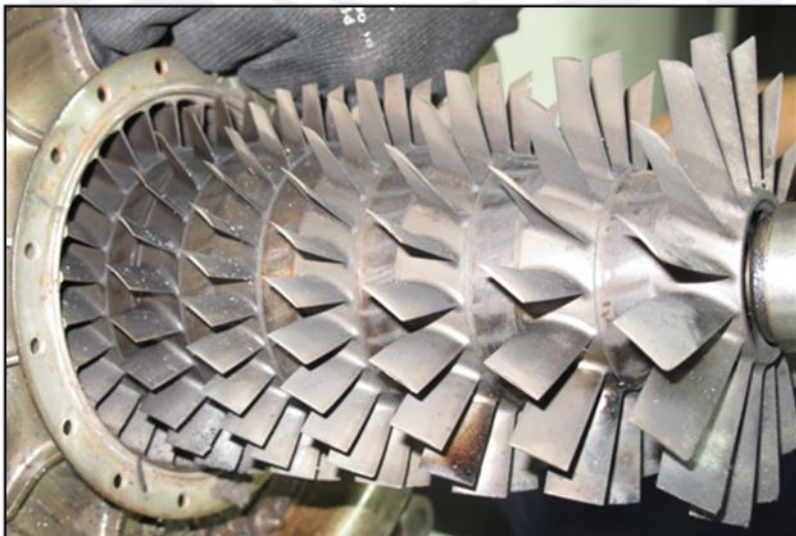
Figure 41 - Rotor blades intact (axial compressor impeller).

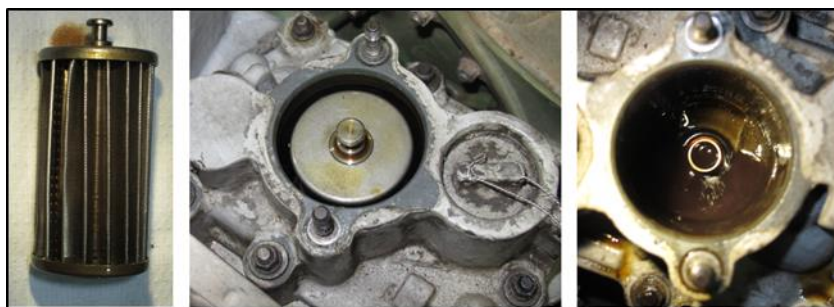
The oil pressure filter was visually inspected and no dirt / wreckage or foreign material was observed. The residual oil contained in the oil pressure filter container was apparently clean, with normal color and smell (Figure 49).

Figure 49 - Oil pressure filter and the filter container.

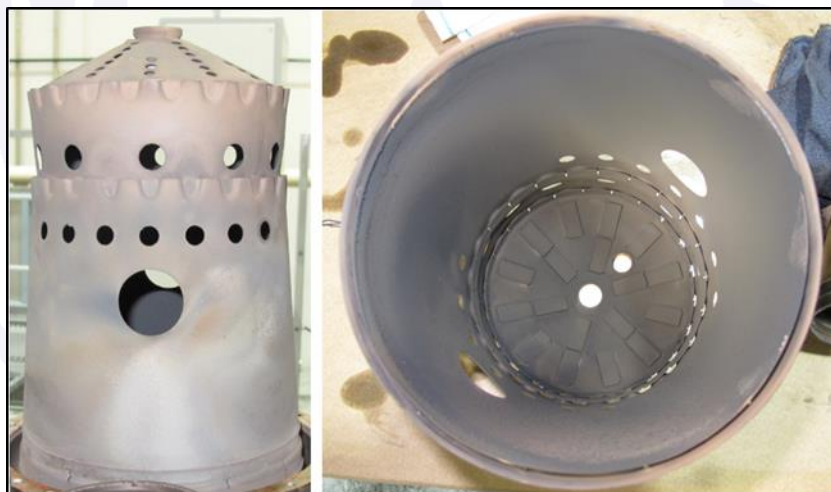
Figure 59 - "Liner" of the combustion chamber.

There was no evidence of irregular burning in the combustion chamber. All components, liner and case, showed a normal and uniform firing pattern, as well, no damage was found in the set of shield and stator blades, although the shield had a rough surface, probably due to material coming from the compressor rubbing (Figures 59 and 60).

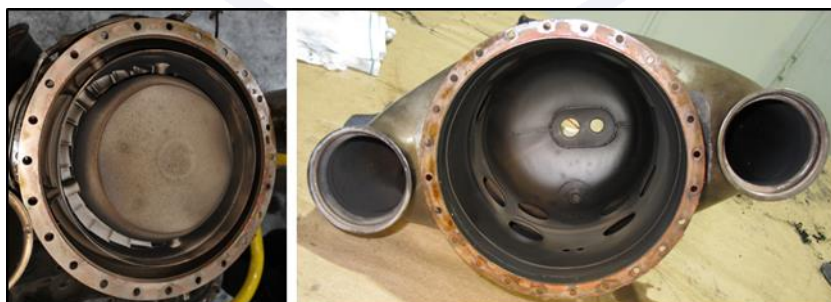
Figure 60 - Shield, stators and combustion chamber case.

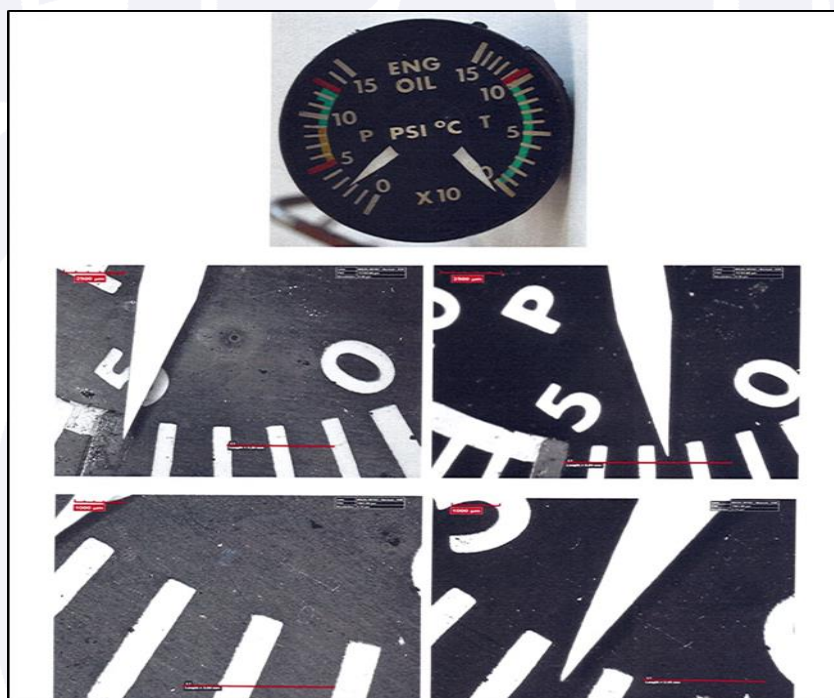
The engine oil pressure and temperature indication instrument did not show signs of impact of the measuring pointers against the reading surface, and not being possible to determine their position at the time of the accident (Figure 61).

Figure 61- There were no marks on the face of the dial indicating the impact of the hand.

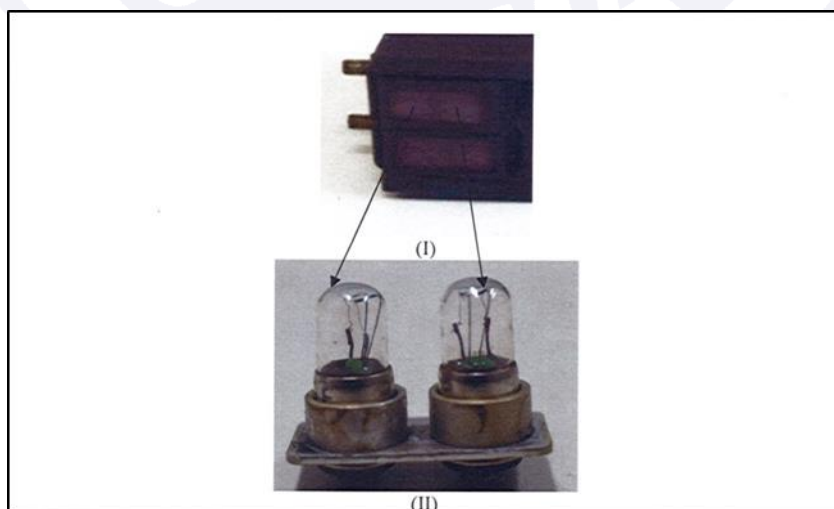
As for the panel of warning lights (Warning and Caution Lights), each lighting space (slot) was composed of two lamps, which were subjected to stereoscopic exams (Figure 62).

Figure 62 - Each slot consisted of two lamps.

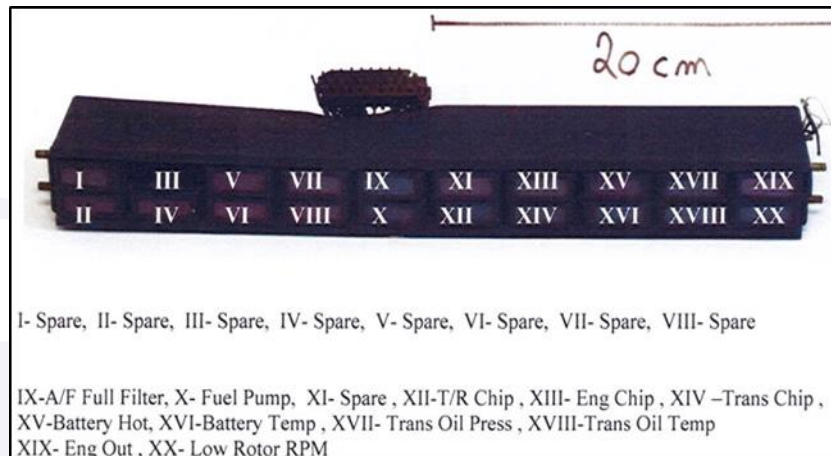
The identified positions from I to VIII and XI did not have a warning function, being called spare (Figure 63).

Figure 63 - Overview of the Warning and Caution Lights panel.

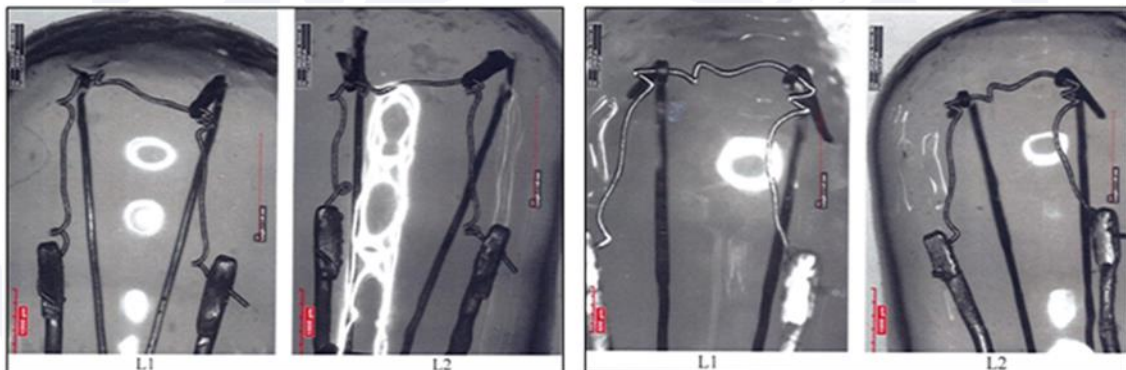
When observing the filaments of the lamps in the Warning and Caution Lights panel, it was found that both lamps in the IX-A / F Full Filter slots, X-Fuel Pump, XII-T / R Chip, XV-Battery Hot, XVIII -Trans Oil Temp and XIX-Eng Out did not show filament rupture and had normal deformation caused by use (Figures 64, 65 and 66).

Figure 64 - Normal deformation caused by the use of lamp filaments in slots IX-A / F Full Filter and X-Fuel Pump.

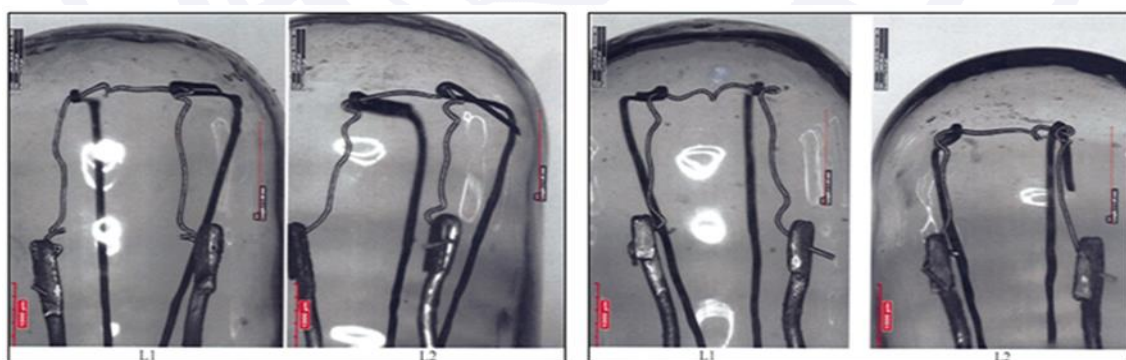
Figure 65 - Normal deformation caused by the use of lamp filaments in slots XII-T / R Chip and XV-Battery Hot.

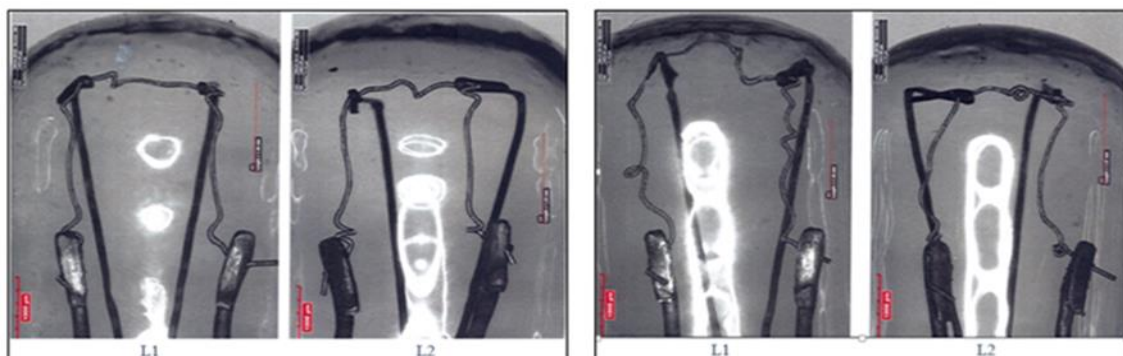
Figure 66 - Normal deformation caused by the use of lamp filaments in slots XVIII-Trans Oil Temp and XIX-Eng Out.

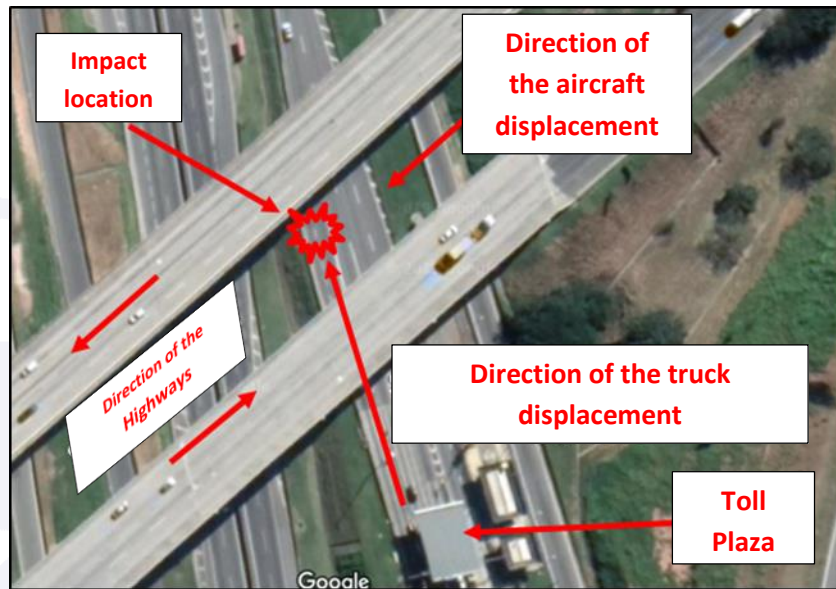
Figure 75 - Sketch of the occurrence site.

Near the landing, making a profile compatible with the autorotation profile, the aircraft collided with a truck moving perpendicularly (Figure 75).
