**FINAL REPORT**  
**A - 060/CENIPA/2017**

| <b>OCCURRENCE:</b> | <b>ACCIDENT</b> |
| <b>AIRCRAFT:</b> | <b>PT-YZM</b> |
| <b>MODEL:</b> | <b>AS 350 B2</b> |

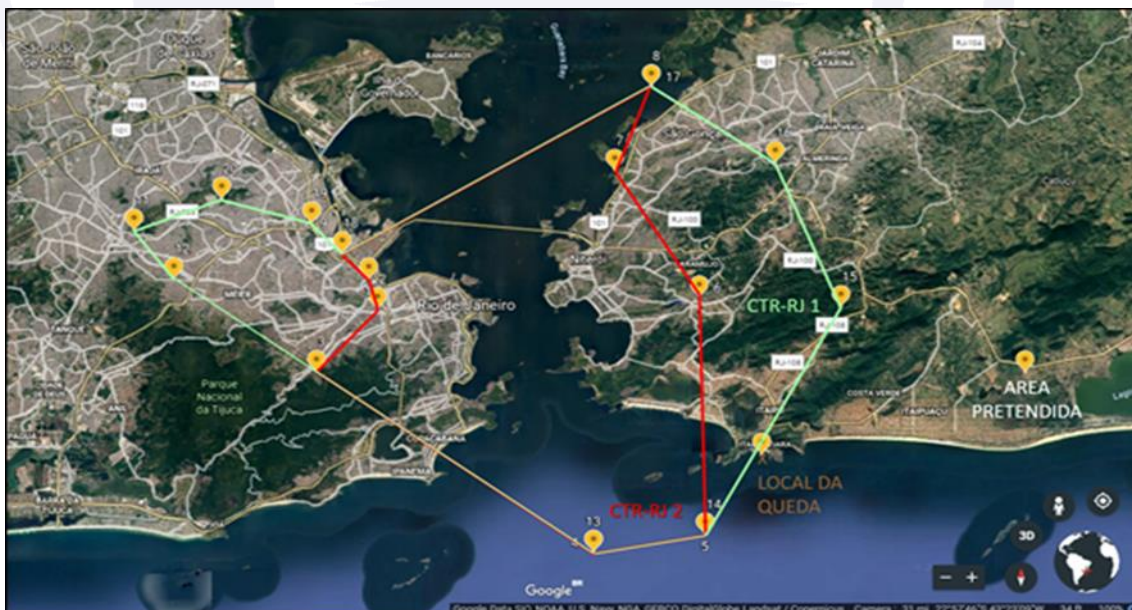
Figure 5 - Illustration of the lateral limits of the CTR-RJ 1 and the CTR-RJ 2.

The intended flight included a night leg and aimed at landing in an area outside the lateral limits of the CTR-RJ 1 and 2 (Figure 5).

Therefore, the requirements established in item 3.4.3 of the ICA 100-4 were not being met, since its performance, under those conditions, required a pilot with IFRH Rating and an aircraft approved for IFR flight.
