COMANDO DA AERONÁUTICA
CENTRO DE INVESTIGAÇÃO E PREVENÇÃO DE
ACIDENTES AERONÁUTICOS

FINAL REPORT
A-009/CENIPA/2014

OCCURRENCE:	ACCIDENT
AIRCRAFT:	PT-YRE
MODEL:	AS 350 BA
DATE:	10 FEB 2010

This is the Final Report of the 10 February 2010 accident with the AS350 aircraft, registration PT-YRE. The accident was classified as “system or component failure”.

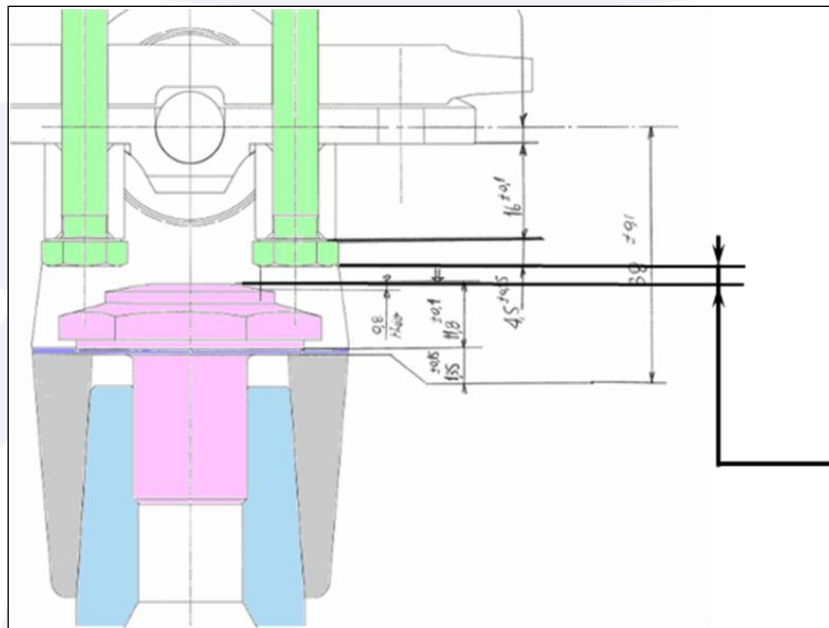
Figure 4 – Scheme of the fastening of the fork (which holds the tail rotor blades) to the conical shaft.

The scheme below (cross-section view) shows how the fork is attached to the conical shaft. The distance between the fork fastening-bolt and the bolts which limit the flapping of the blades is 4mm.

The bolt for fastening the fork to the conical shaft is represented in pink. The bolts which limit the flapping of the blades are shown in green. The fork is gray. The conical shaft is represented in blue. This shaft connects with the blade supporting-fork, ensuring that rotation is transmitted to the tail rotor system. The fork, in turn, has a groove, which the conical shaft ‘tongue’ has to match.

The system is assembled and fixed by means of a fastening bolt (shown in purple in Figure 4). In addition to this bolt, two other bolts (green color in figure 4) limit the flapping of the tail rotor blades.

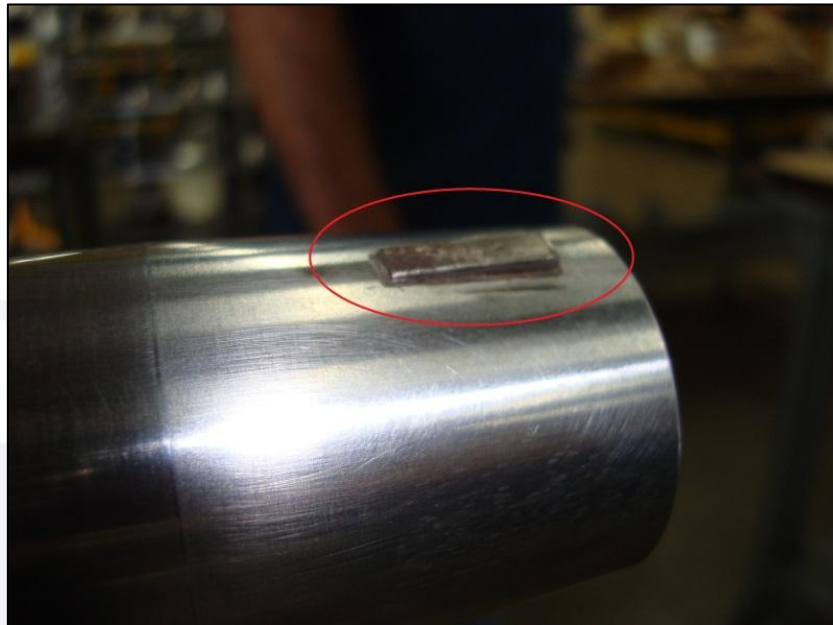
Figure 5 – Transmission shaft ready to be installed. In the highlight, the tongue on the surface of the shaft.

In figure 5, it is possible to observe the 'tongue' (in highlight), which serves two purposes: the first one is to assist in the task of fastening the tail rotor blades support-fork to the conical shaft and prevent relative movement between the conical shaft and the fork; the second one is to be an indicator in case of an abrupt stop of the tail rotor. These two purposes can only be accomplished if the 'tongue' is duly placed in the groove.

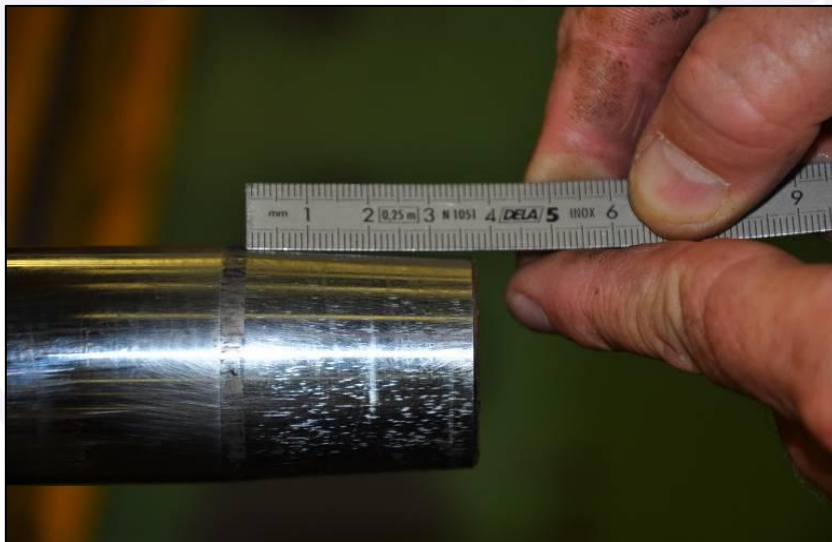
Figure 24 – The section of the conical shaft that remains inserted in the fork corresponds to 37-38 mm, when they are correctly assembled.

When the system is assembled appropriately, approximately 37 to 38 mm of the conical shaft are inserted in the blade support-fork (figure 24), and on the front part, a space of 3 mm is left between the ends of the conical shaft and fork (figure 25).

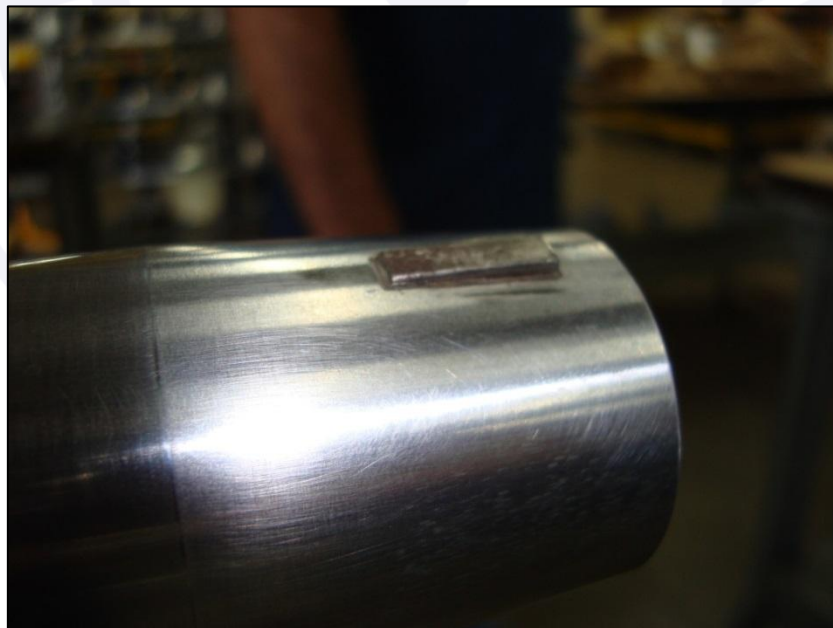
Figure 28 – 'Tongue' installed before the application of torque simulating turn.

During the simulation, a considerable loss of material was observed as a result of friction between the parts. The figures below illustrate the result of the grinding.

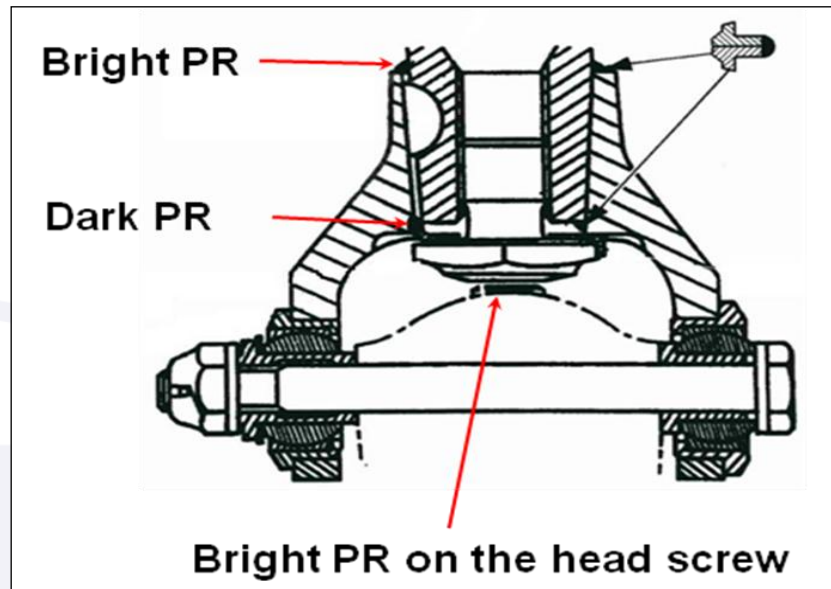
Figure 33 – Representation of the place in which the polymers were applied and how they were found.

The presence of residues from different polymers indicates that the polymers had been placed on different dates. The work at the laboratory with a spectrometer also suggests that there were two polymers on the conical shaft and fork, placed on different dates.

The figures above are evidence that failures occurred during the last assembly and during the application of the polymer. With the assistance of Eurocopter, the following aspects were considered:

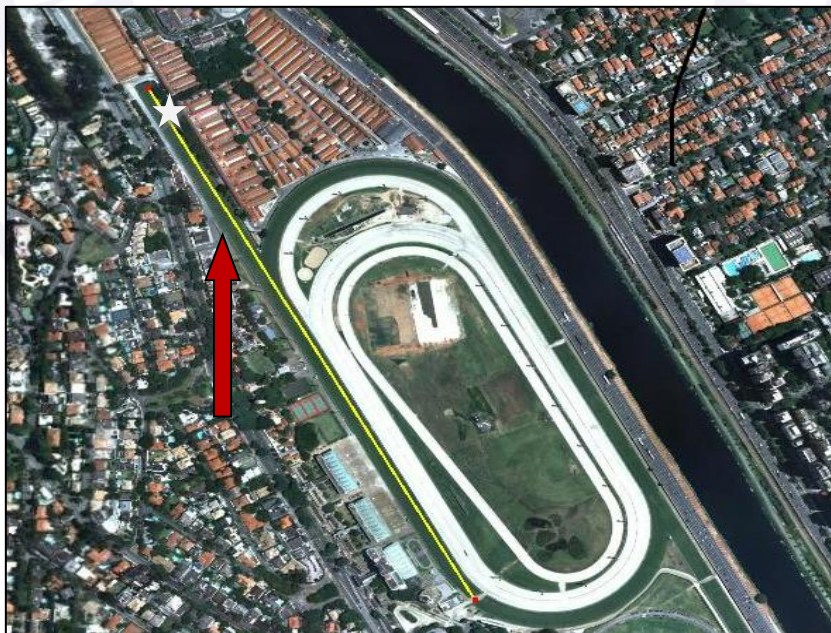
Figure 37 – Landing area.

The collision with the ground occurred in the grass race-track of the São Paulo Jockey Club.

It was an area appropriate for run-on landings: flat terrain with no holes or obstacles, with a length of 1,070 meters.

In the figure above, the yellow line represents the area chosen for landing. The white star shows the location where the aircraft crashed. The red arrow indicates the direction of the wind, with an estimated strength between 4 and 8kt.
