FINAL REPORT
A-028/CENIPA/2014

OCCURRENCE:	ACCIDENT
AIRCRAFT:	PT-OMX
MODEL:	210N
DATE:	09FEB2014

This is the final report of the 09 February 2014 accident with the 210N aircraft, registration PT-OMX. The accident was classified as “loss of control in flight”.

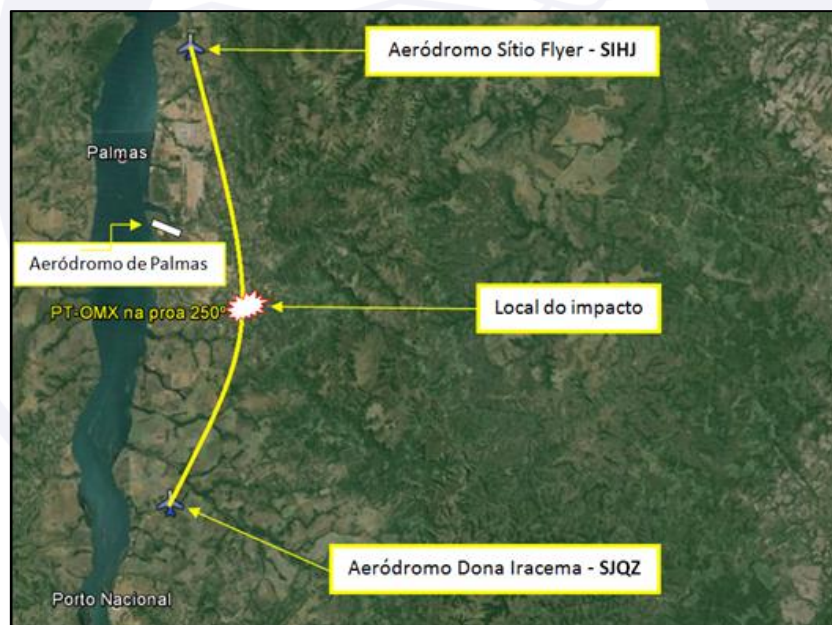
Figure 4 – Croquis with the trajectory intended and point of impact.

According to reports made by third parties, the aircraft, after taking off from SJQZ, did not fly direct to SDNB, but circled the departure aerodrome five times before proceeding to the destination.

An eyewitness who observed the aircraft en route said that it was approaching with an intermittent noise “as if the aircraft was about to stop”. The witness reported that on two occasions there was a perception that the engine had stopped functioning.
