COMANDO DA AERONÁUTICA
CENTRO DE INVESTIGAÇÃO E PREVENÇÃO DE
ACIDENTES AERONÁUTICOS

FINAL REPORT
A - 061/CENIPA/2013

OCCURRENCE:	ACCIDENT
AIRCRAFT:	PP-CGO
MODEL:	AW119 MKII
DATE:	8 MAY 2012

This is the Final Report of the 8 May 2012 accident involving the AW119 MKII aircraft, registration PP-CGO. The accident was classified as inflight engine failure.

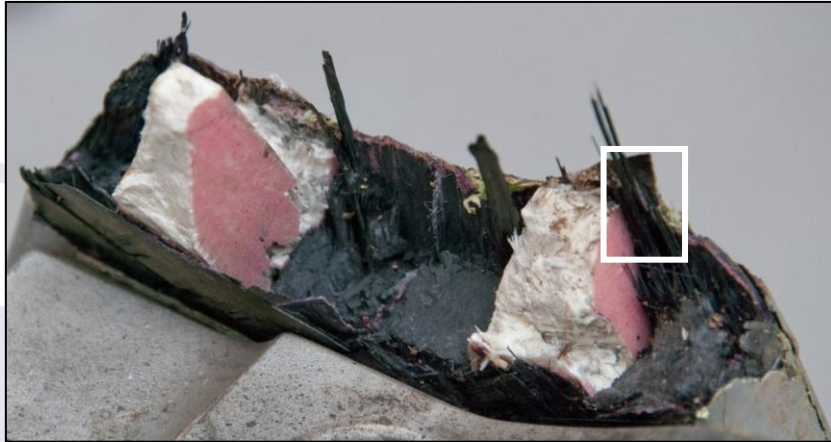
After the macroscopic analysis, examinations by means of electron microscopy were performed in the fracture of the blue-marking blade. In Figure 35, the region appears as seen with the naked eye. In Figure 36, it is seen by means of electrophotography.

Figure 35 – The area marked with a white rectangle was utilized for Scanning Electron Microscopy.

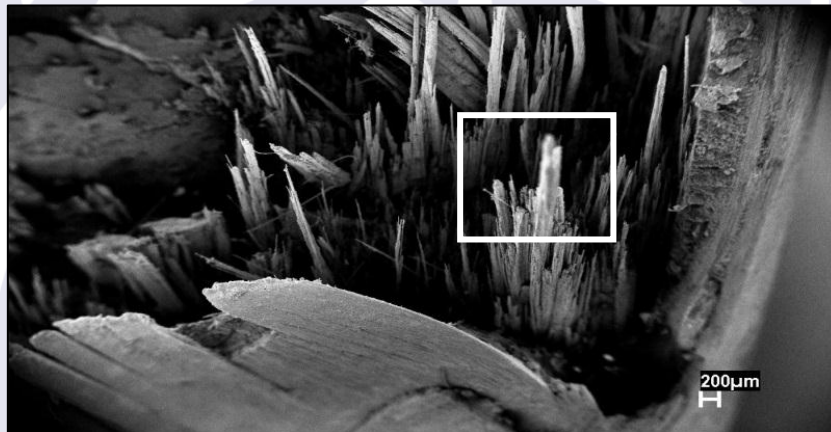
Figure 36 – The area marked with a white square was analyzed with higher magnification from the scanning electron microscopy.

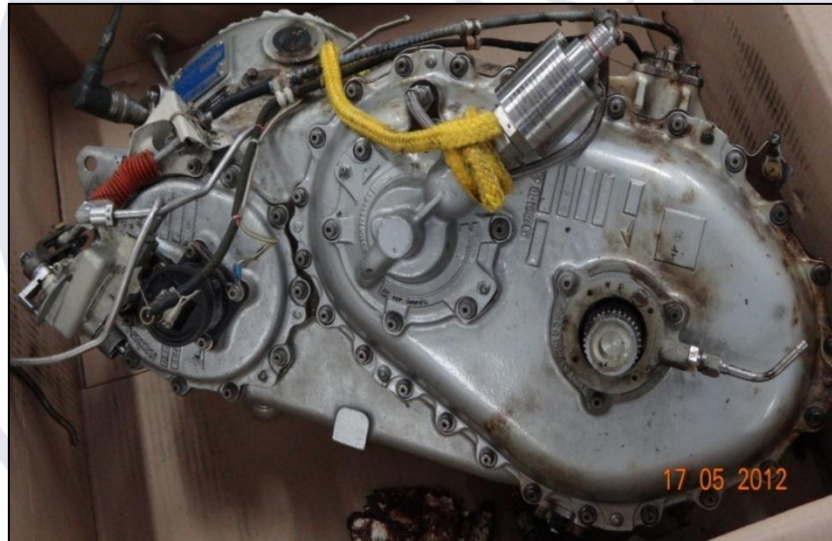
Figure 45 – Engine reduction gear box (RGB).

In the beginning of the work, the engine was embroiled in the structure of the nacelle, which exhibited significant damage from impact and severe fire (Figures 41, 42, 43 and 44). The reduction gearbox was fractured at the junction with the power section of the engine (at flange "B") and had no damage caused by heat (Figure 45).

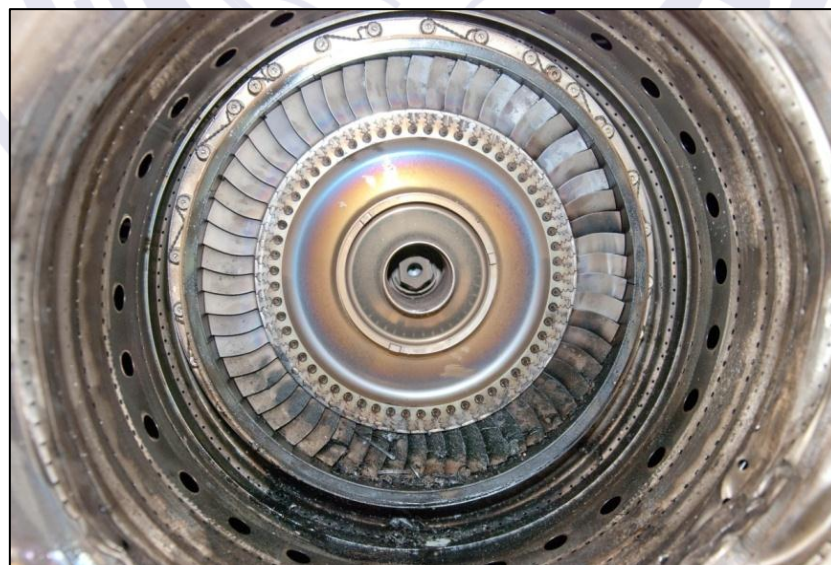
Figure 49 – Compressor Turbine Rotor

The compressor turbine rotor, at its front (Figures 49 and 50), had mild rubbing marks on the root of the blades.

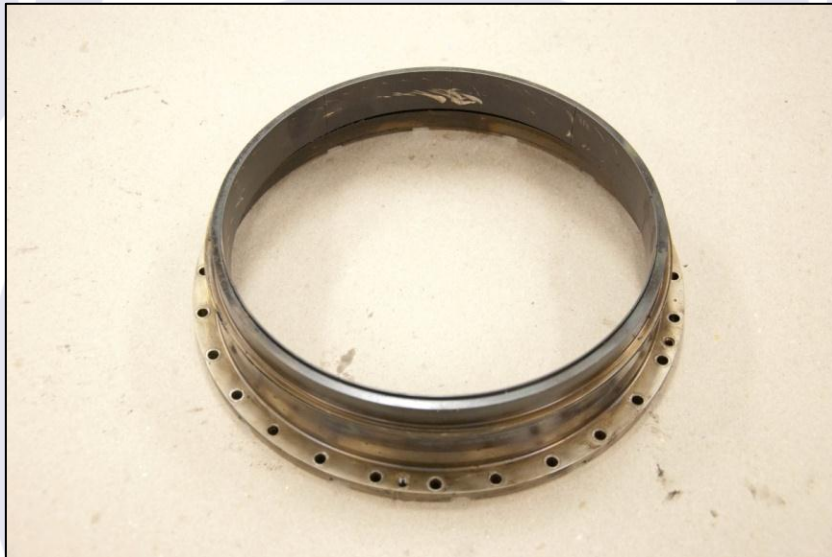
Figure 51 – Segmented ring of the compressor turbine.

The compressor turbine segmented ring showed several marks of impact left by the blades of the compressor turbine rotor in the segments, as can be seen in Figures 50, 51 and 52.

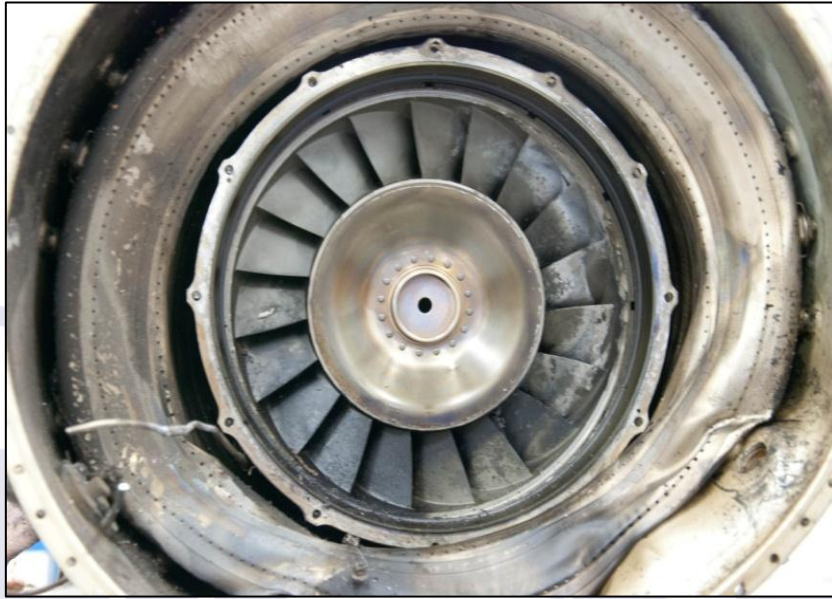
Figure 54 – Back view of the stator of the power turbine with the diaphragm.

The diaphragm showed signs of mild rubbing. The power turbine stator of the engine was in good condition, showing no damage from high rotation or impact. The rear side of the diaphragm (Figures 53 and 54) also had signs of mild rubbing left by the roots of the power turbine rotor blades.

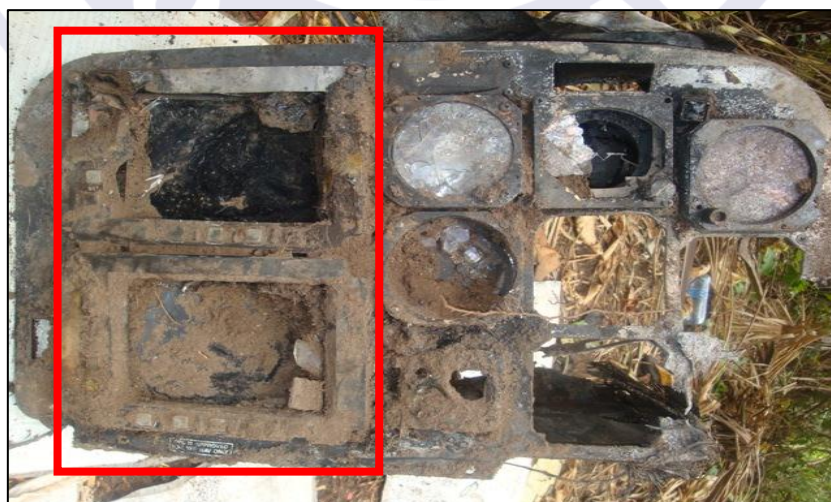
Despite presenting a high level of destruction and not possessing resistance requirements against impact, temperature and pressure, like the ones of the flight recorders, the two Electronic Display Units (EDUs) installed in the PP-CGO panel were removed from aircraft wreckage (Figure 61, highlighted) and taken for analysis in the laboratories of the Astronautics Corporation - manufacturer of the component - in Milwaukee, USA, in an attempt to recover the data stored in its Non-Volatile Memories (NVM).

Figure 61 – Panel removed from the wreckage of the PP-CGO. In highlight, the two EDUs taken for analysis in the USA.

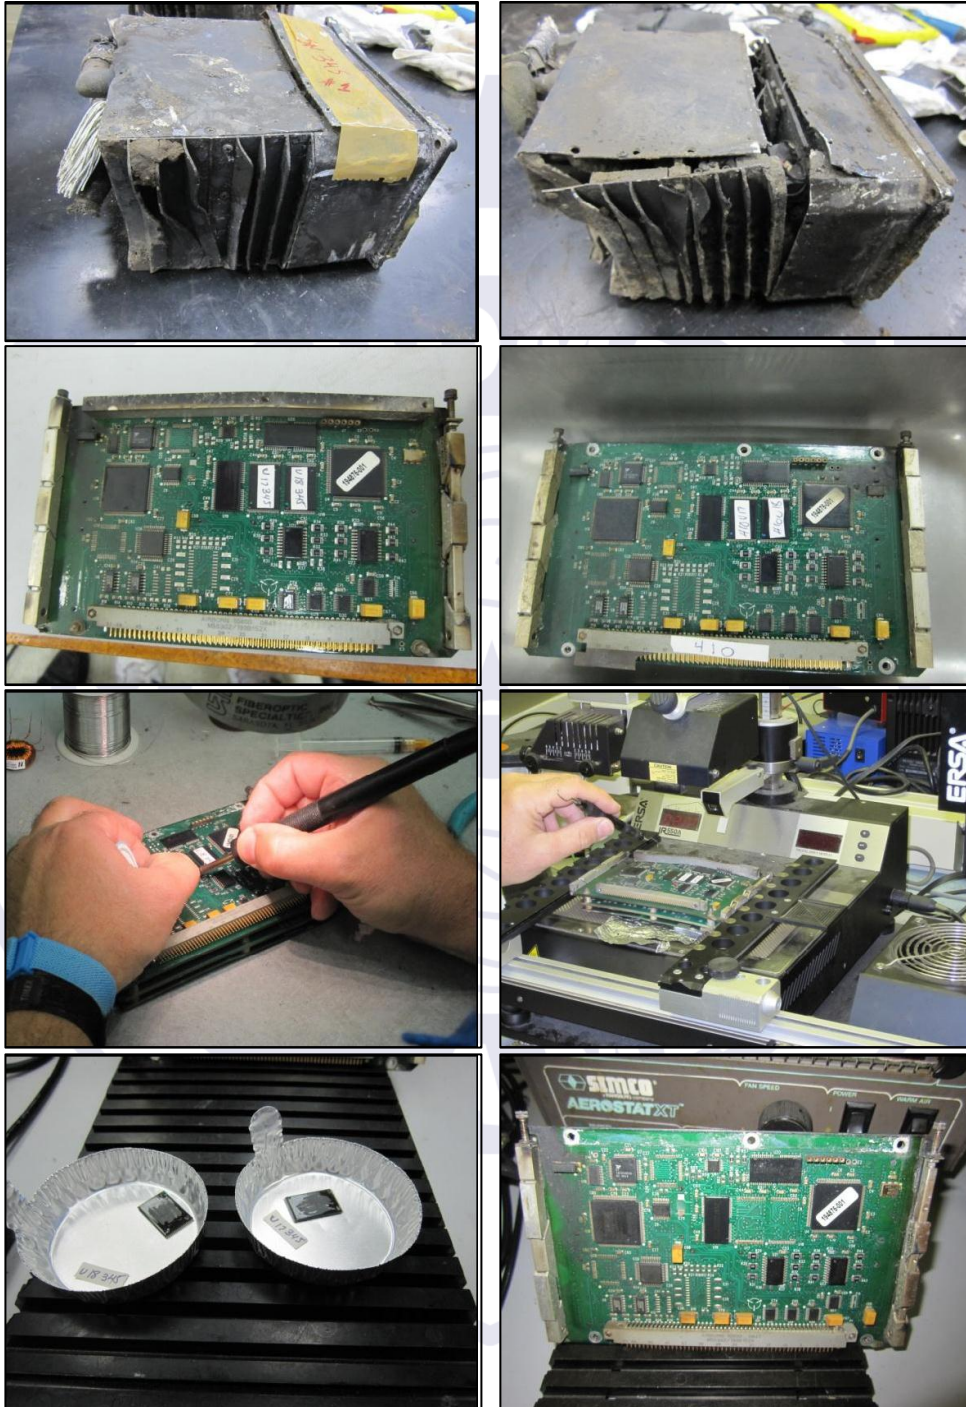
After an initial analysis, the decision made (on account of the damage sustained by the components) was to remove the non-volatile memory chips of the two electronic units and reinstall them on the test bench of the company (Figures 62, 63, 64, 65, 66 and 67).

Figures 62, 63, 64, 65, 66 and 67 – Sequence of pictures showing the removal of the non-volatile memory from the EDU's installed in the PP-CGO, and its later installation in the protoboard of the *Astronautics Corporation*.

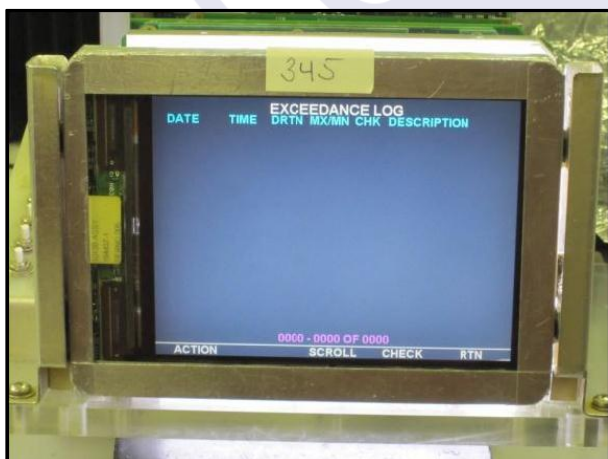
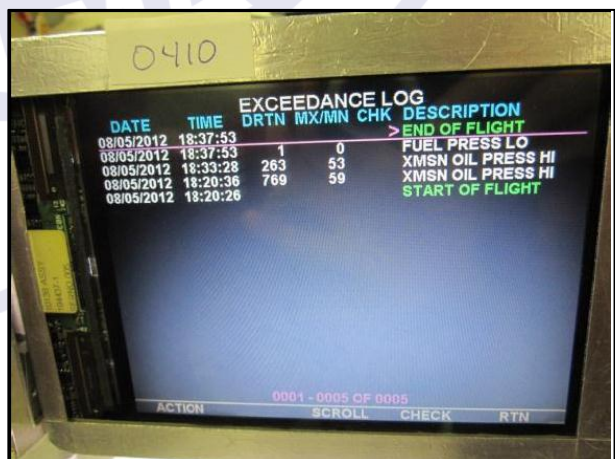
In relation to the Exceedance Logs, the results were different. As can be seen in Figures 70, 71, and in Table 7, the EDU SN 345 did not record any information; however, the EDU SN 410 presented the extrapolation of the maximum oil pressure limit (XMSN OIL PRESS HI) for 769 seconds (at 18:20:36), and for 263 seconds (at 18:33:28), and of the minimum fuel pressure limit (FUEL PRESS LO) approximately 0.8 seconds before the termination of the flight (END OF FLIGHT).

Figures 70 and 71 – Exceedance Log Messages of the accident flight stored in the EDUs of the PP-CGO.

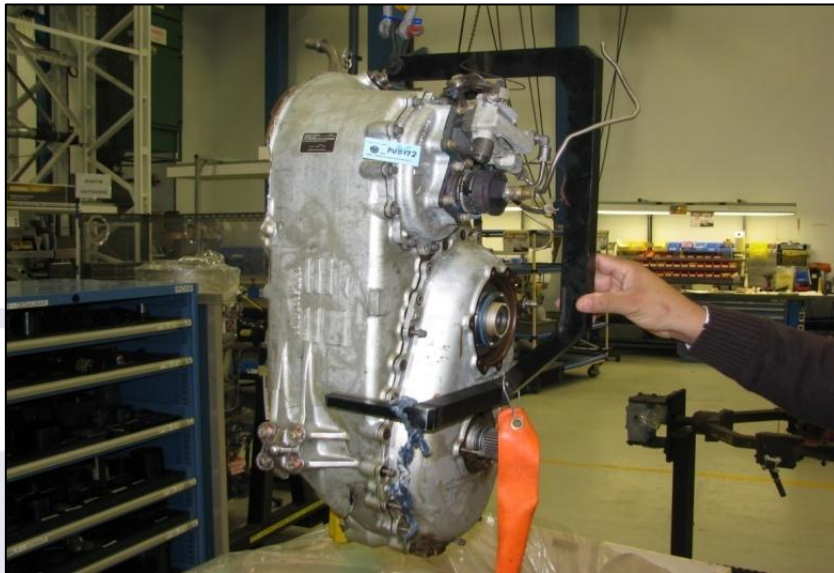
Figure 72 – View of the reduction gear box in the laboratory of analysis of PW Canada.

The RI APA Report 03/2013, signed by engineers of the Aeronautical Propulsion Division of the Aeronautics and Space Institute (IAE), concluded that no evidence of malfunction or abnormalities was found in the reduction gearbox box that could have compromised the operability of the engine.

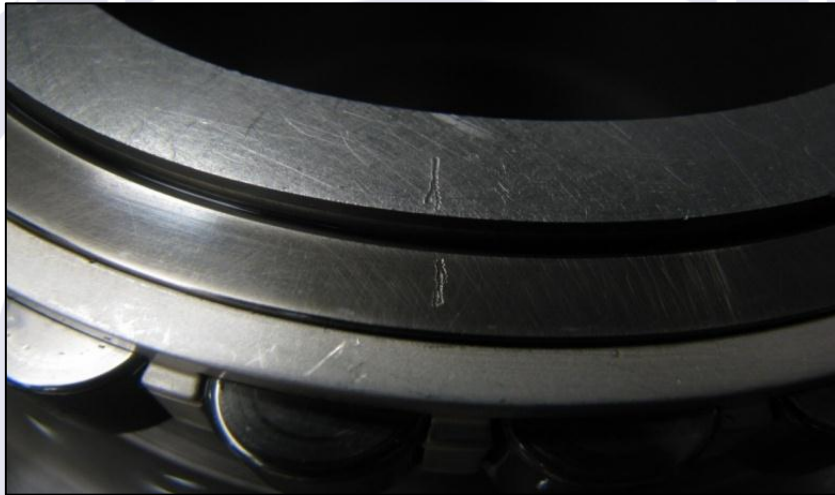
Figure76 – Marks of alignment made after the application of torque in the nut.

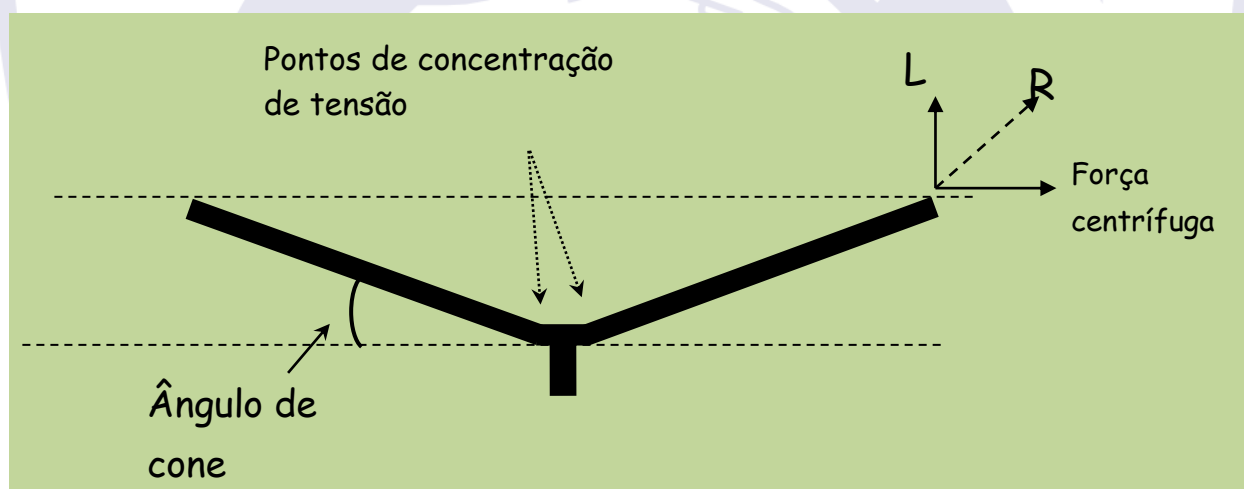
Figure 88 – Cone effect. Source: NIKOLSKY and SECKEL (1949).

In the event of loss of rotation, in addition to losing directional control to correct the tendency of fuselage roll, one also loses the centrifugal force that keeps the rotor blades forming a disk. The result is what is called a "Cone Effect", in which the blades fold up and, in situations that are more critical, they may end up breaking at the point of attachment.

Figure 88 - The "Cone Effect" has the following characteristics:

- Tends to be bigger in pitch-down attitudes and heavy weight/G load conditions;
- tends to decrease with increasing speed of blade rotation speed and with the consequent increase of the centrifugal force;
- tends to increase when the helicopter is operated at rotations below the minimum specified by the manufacturer;
- Results in overload to the blades, decreased amplitude (area) of the rotor disc, and loss of lift.

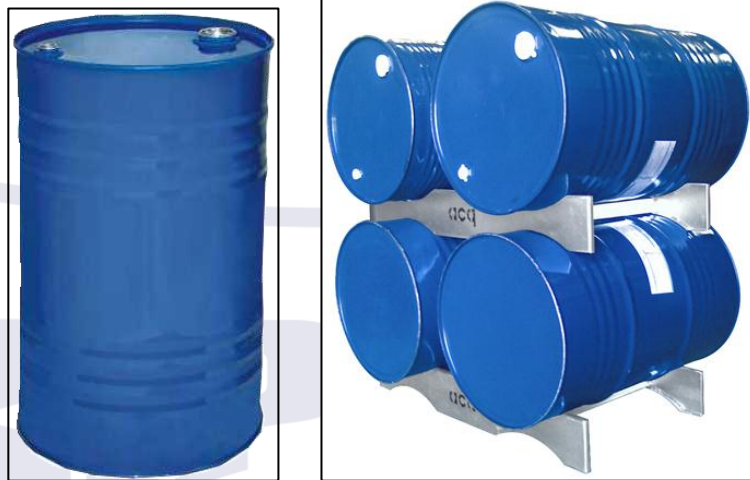
Figure 92 – Stainless steel and carbon steel barrels in accordance with the NBR 15216.

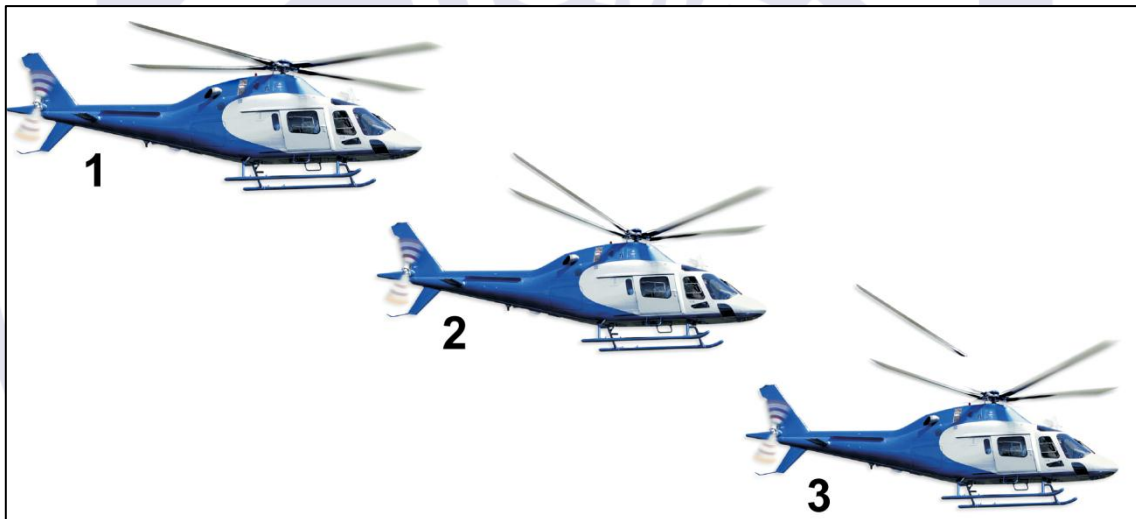
Figure 94 – Dynamics of the accident (Phases 1, 2, and 3).

Cruise flight: The aircraft took off from *Fazenda Nossa Senhora Aparecida* at 18:20 UTC, with eight persons on board, destined for a refueling point established in the municipality of Piranhas, State of Goiás. 17 minutes into the flight, after flying over an elevation of 2,150 feet located in the southern sector of *Fazenda Rancho Alegre*, the aircraft engine flamed out. According to information obtained through the testimony of witnesses, the helicopter was at an altitude of approximately 1,000 feet above the ground.

Cone Effect: the engine loss of traction associated with the high torque applied, with the aircraft weight near the maximum for operation, and with the low momentum of inertia provided by the composite material blades of the AW119 MKII Koala aircraft caused a quick drop of the main rotor RPM. As a result, the combined action generated by the loss of lift centrifugal force and by the weight of the helicopter on the main rotor disc caused the blades to bend up (Cone Effect)

Breakage of the blade: at a third moment, the bending up of the blades continuously intensified up to the occurrence of a static failure of the main rotor blade marked in blue color.

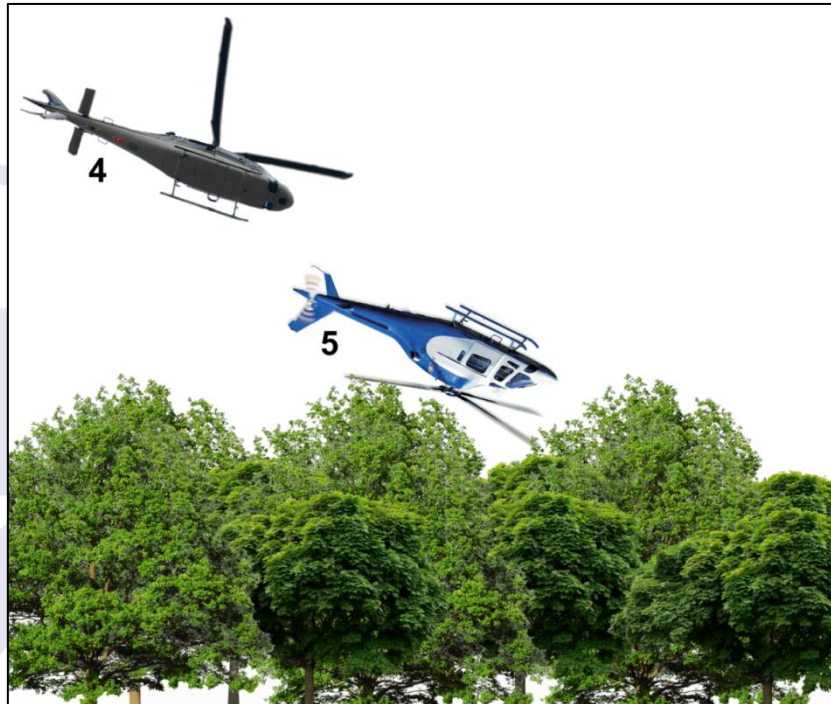
Figure 95 – Accident dynamics (Phases 4 and 5).

Roll around the longitudinal axis: the tendency of the fuselage to roll after the quick drop of rotation (RPM), associated with the momentum provided by the loss of one of the main rotor blades caused the aircraft to initiate a roll around the longitudinal axis in a counterclockwise direction.

Collision with the ground: it was not possible to determine how many rolls were performed by the aircraft around its longitudinal axis; however, on account of the conditions found by the investigators at the Initial Action, it is likely that the PP-CGO collided with the ground in a nearly upside down position.

Although it was not possible to identify the angle and speed at which the helicopter hit the ground (see section "1.16 Relative to the ASI"), the conditions found at the crash site indicated that the collision occurred at a high angle of attack and great speed.
