COMMAND OF AERONAUTICS
AERONAUTICAL ACCIDENT INVESTIGATION AND
PREVENTION CENTER

FINAL REPORT
A-103/CENIPA/2014

OCCURRENCE:	ACCIDENT
AIRCRAFT:	PT-YJJ
MODEL:	AS 350 BA
DATE:	07 JUNE 2014

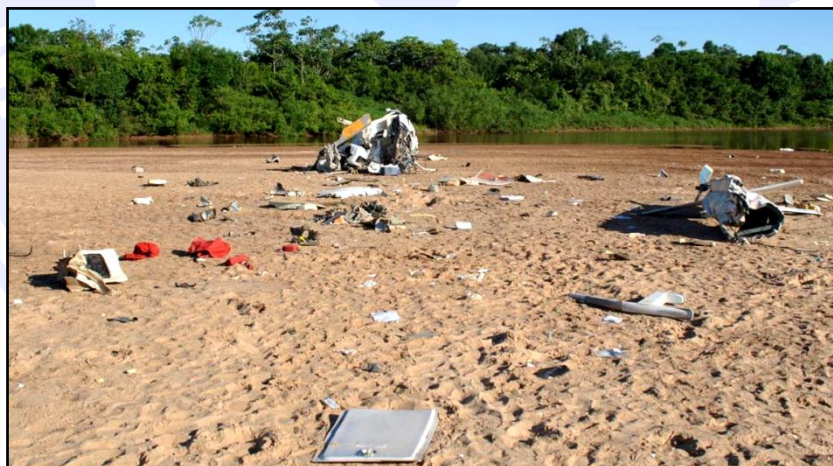
Figure 1 – Distribution of the PT-YJJ aircraft wreckage.

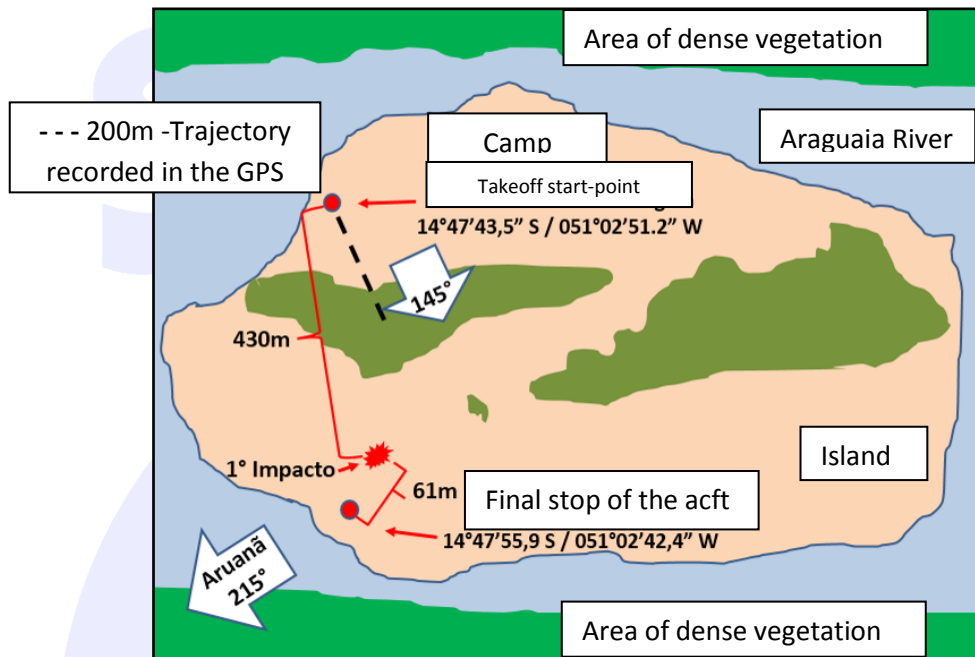
The point of first impact was at a distance of 430 meters from the point where the takeoff began (figure 2).

The aircraft wreckage was spread for 61 meters between the point of first impact to the point where the aircraft came to a stop (figure 2), on a magnetic bearing of approximately 190°.

Figure 2 – Sketch of the departure site, with the point of first impact and the point of final stop. The dotted line represents the 200 meters of trajectory of the initial phase of departure, on the magnetic heading 145°, recorded in the GPS memory.

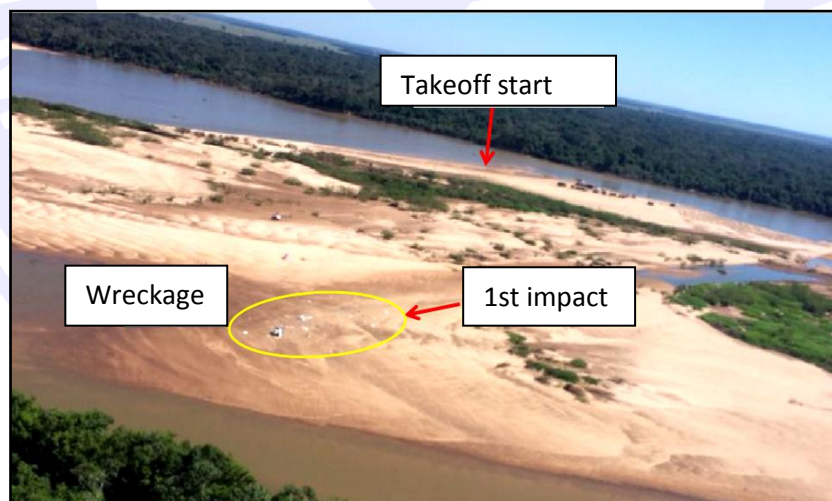
Between the point where the takeoff began and the point of first impact, there was a vegetation-covered area, in which the ground was located at a height of about four meters above the point of departure of the aircraft, with bushes of up to two meters (Figures 2 and 3).

Figure 3 – Aerial photograph of the departure site, with the point of first impact and distribution of wreckage.

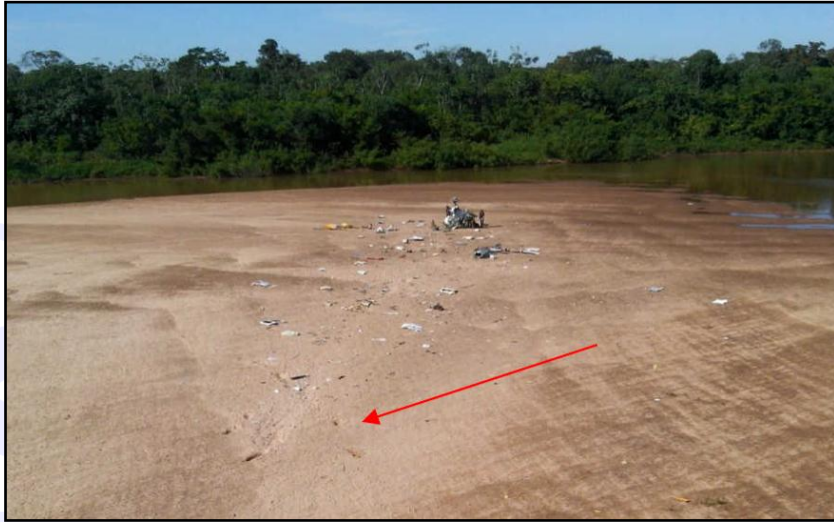
Figure 4 – Air view of the crash site. The red arrow indicates the initial points of impact.

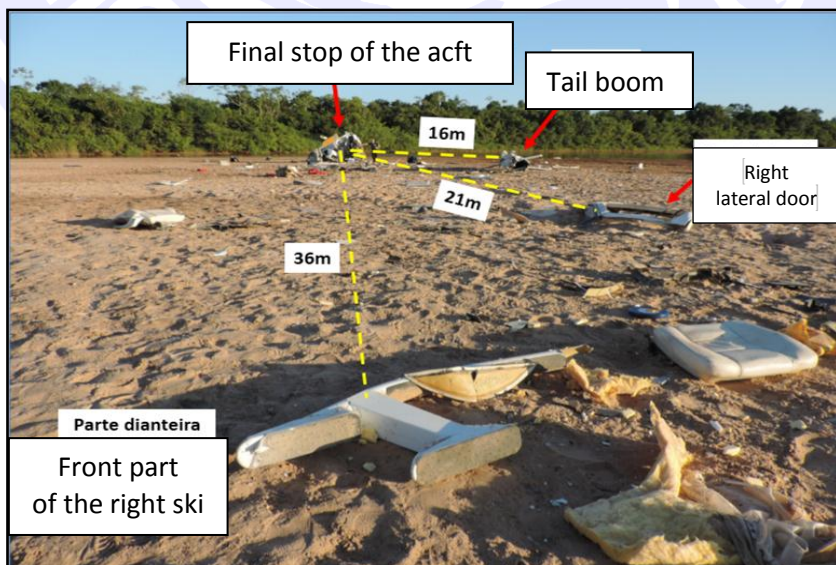
Figure 12 – Positions of the front part of the right ski, right hand side door and tail boom, at the final stop of the aircraft.

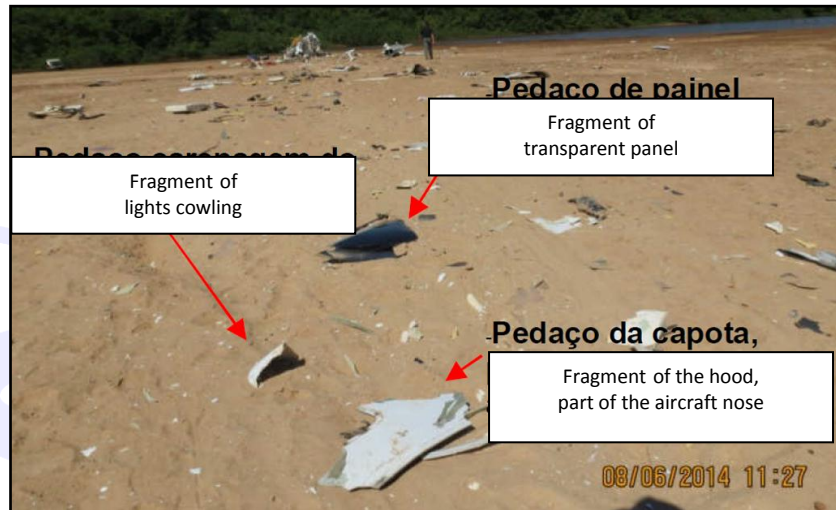
Along the line of wreckage, the first parts found belonged to the cabin structure (several fragments of the cowling, metal fragments of the lower part of the cabin, windshield, and part of the central column of the windshield).

Figure 15 – First fragments of the aircraft found ahead of the point of first impact.

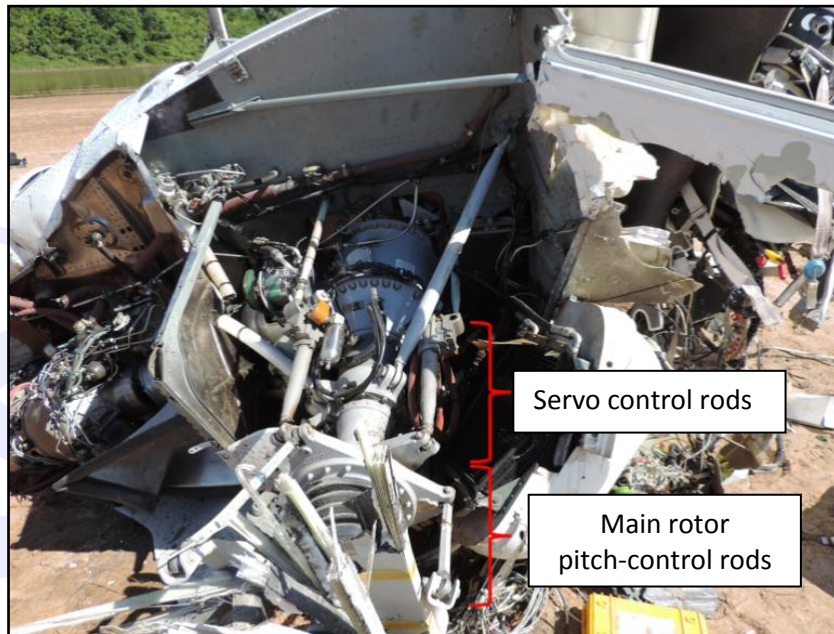
The main rotor pitch control rods and the hydraulic servos' rods were duly connected and cotter-pinned.

The chains of command of the lateral cyclic, longitudinal cyclic, and collective were examined, and the anomalies found resulted of torsions, tractions and rupture of the structure on account of the impact of the aircraft with the ground.

Figure 19 – Rods of the main rotor pitch control and of the servo controls.

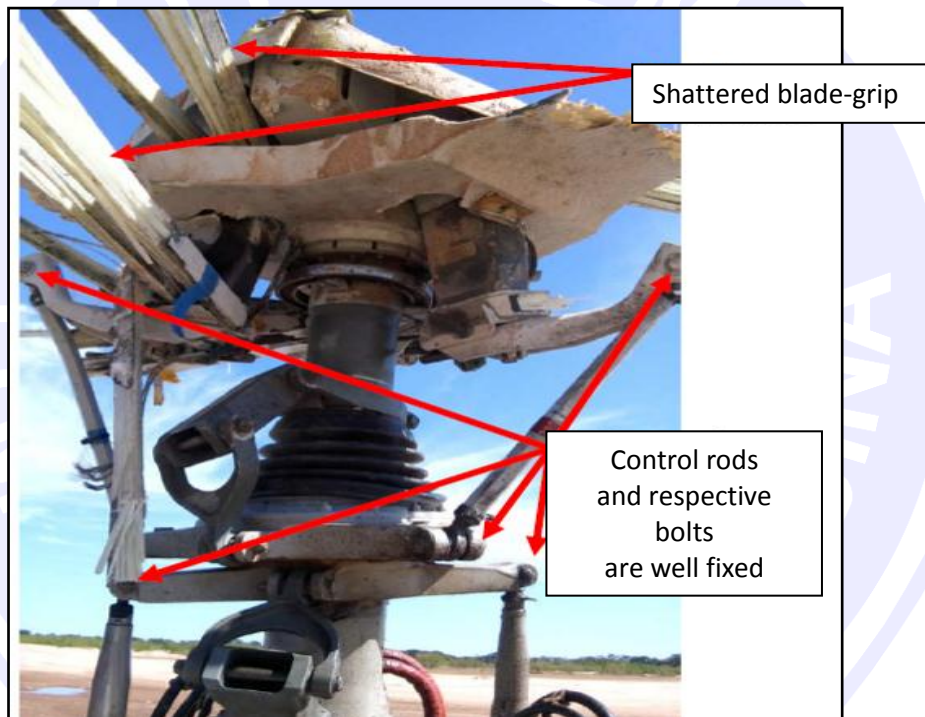
Figure 20 – Control rod and respective bolts with normal fastening.

The shattered blade grips shown in the previous figure resulted from the high energy rotation at the impact.

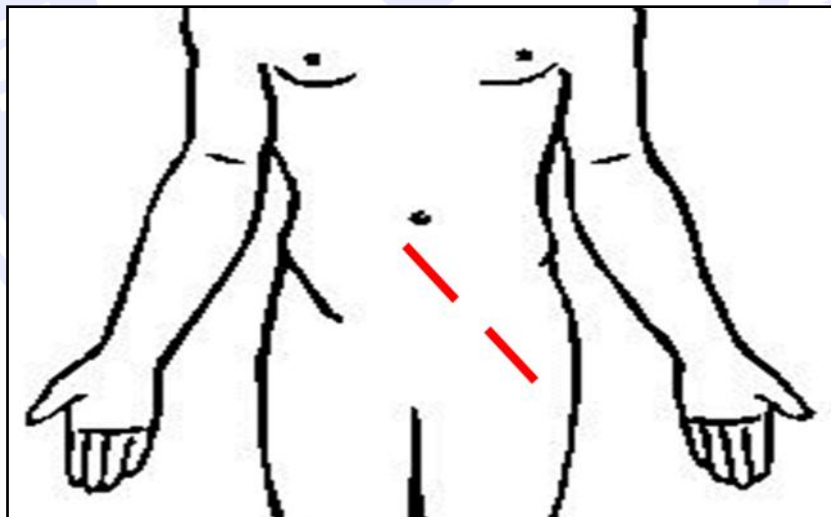
In the photos taken by the Goiás State forensic police, it was possible to observe excoriations on the left part of the pilot's chest and abdomen, one next to the left iliac crest, and another one in the same direction but in the epigastric region.

Figure 24 – Drawing representative of the excoriations in the abdominal region, as found in the pilot's body.

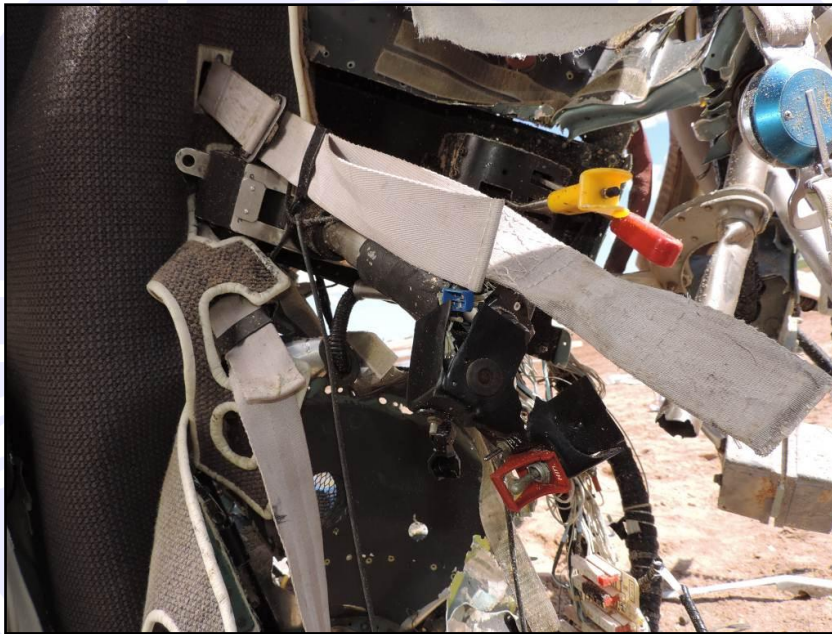
The abdominal belts of the front seats sustained rupture of the stitch sewing (figure 26). These belts remained connected to the points of attachment in the aircraft (figure 27).

Figure 29 – Abdominal seat belts of the front seats.

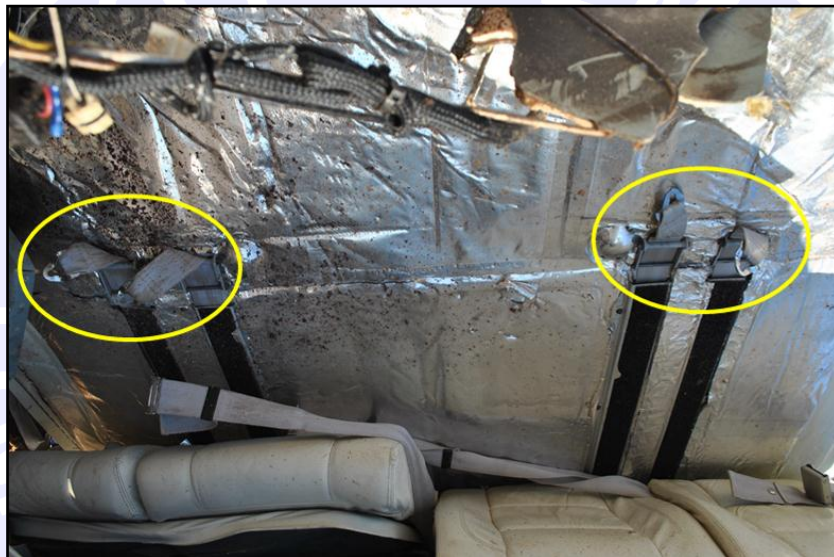
The belts and suspenders of the rear seats were intact, without marks or damage that would be typical if the aircraft occupants had been wearing them.

Figure 31 – In highlight, suspenders of the rear seats.

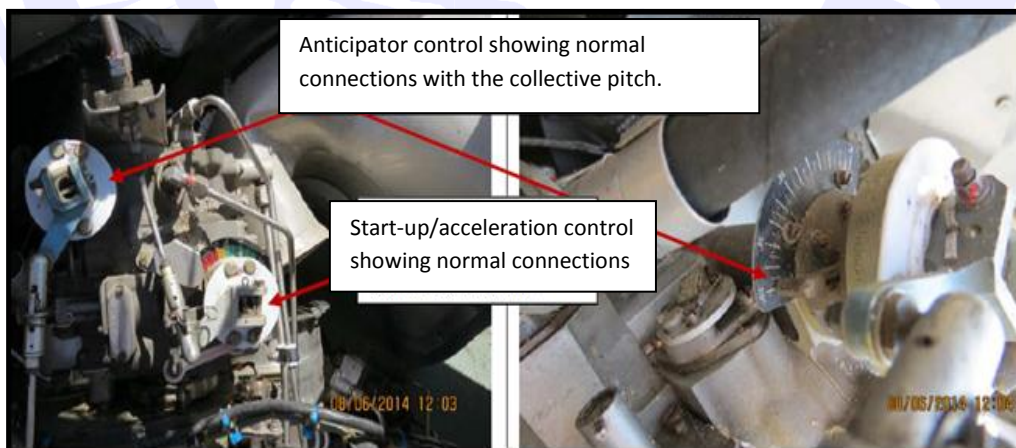
These controls may have moved on account of the structural deformation, and the indication may not correspond exactly to their position prior to the impact of the aircraft with the ground, although they were in a position close to the one during the flight (figure 35).

The anticipator control, a device connected to the collective control, and that regulates the regime of the engine according to the pitch that is applied, was in a position of maximum degree, corresponding to a collective pulled all the way up. This control was subject to tension with the deformation of the structure, but it was possible to identify that there was application of the collective control at the moment of impact.

Figure 35 – Flow rate control (engine start-up and acceleration) and anticipator control.

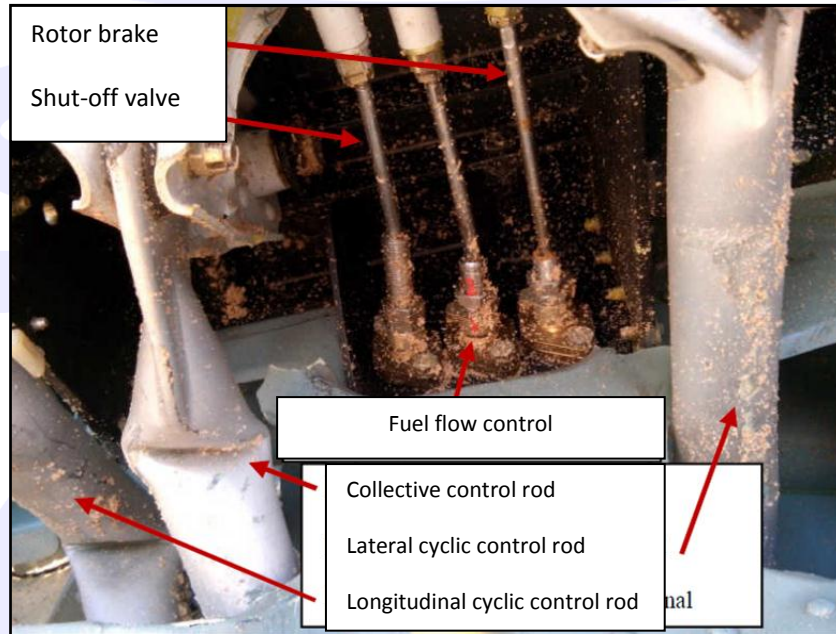
Figure 36 – Control rods, fuel flow rate control, rotor brake and shut-off valve.

The cyclic control rods in the lower part of the cabin, below the box of power-levers, were well fixed and keeping their cotter pins. The control rods of the power-levers were also well connected. The only anomalies found resulted from torsions sustained by the structure due to the impacts with the ground.

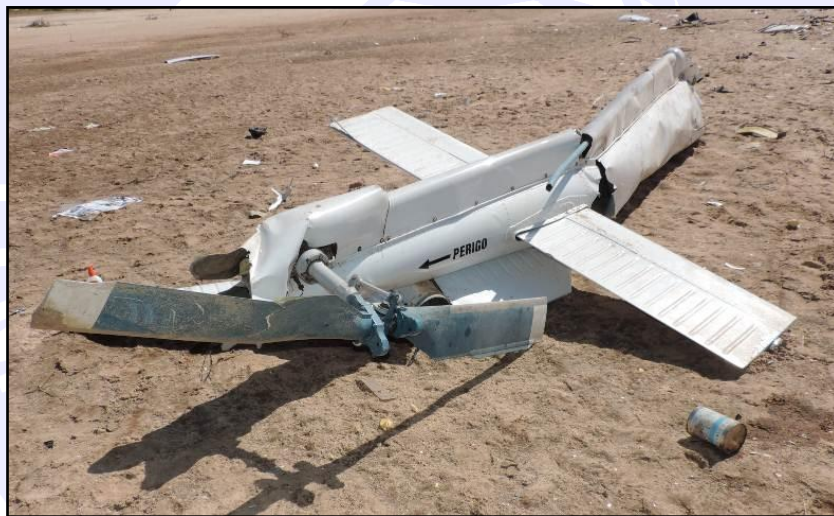
The rear blade (tail ski), an item installed in the lower part of the drift did not present any recent signs of abrasion.

Figure 40 – Tail rotor blades and tail boom.

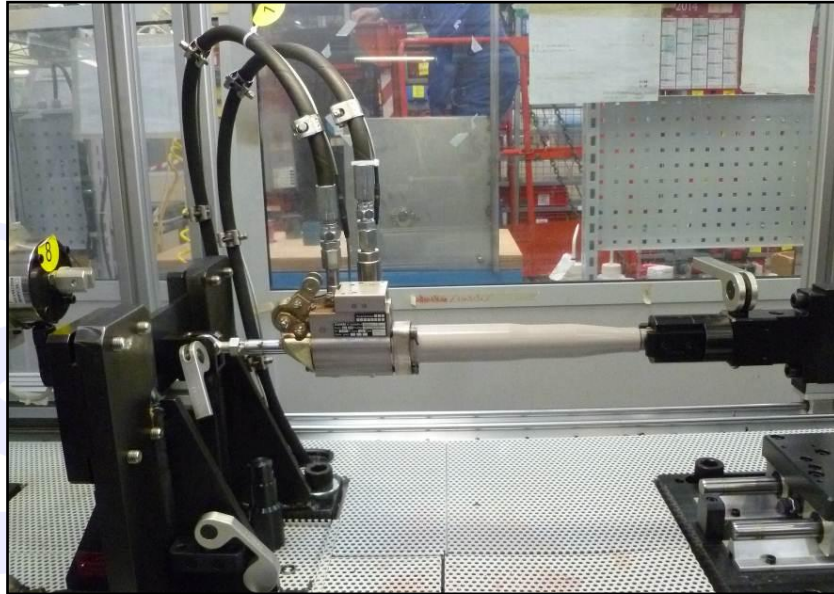
Figure 42 – Bench-test of the front servo control.

The right, front and rear servo controls, together with the hydraulic filter, presented normal performance upon being tested on the bench.

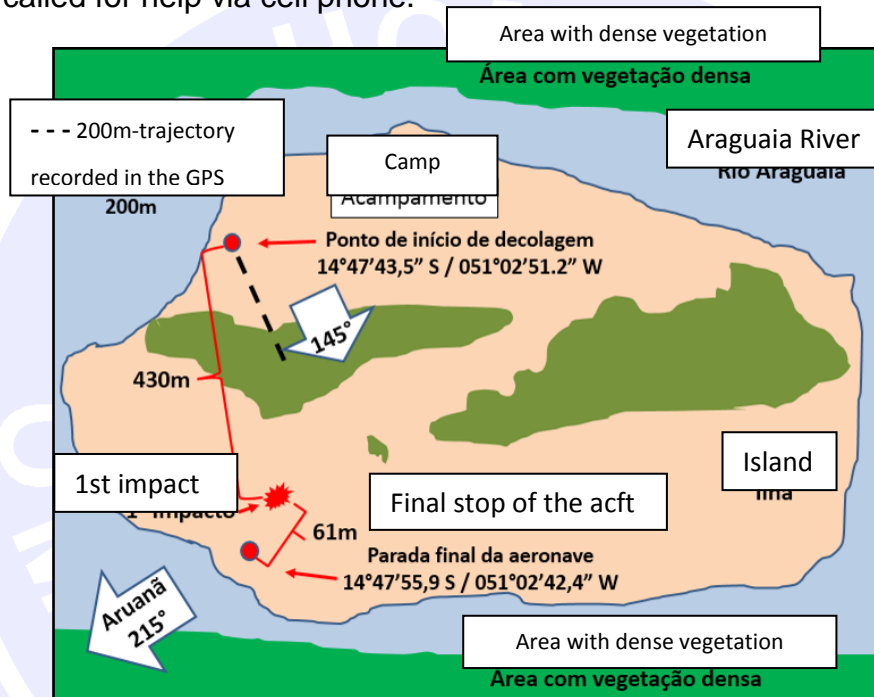
The aircraft started takeoff with a counterclockwise turn, i.e., a nose counterclockwise turn of more than 180°, climbing vertically until reaching a height of 10 meters. Then the aircraft began moving horizontally at heading 145°, leaving the height of 10 meters to reach 30 meters at 57 kt, at a distance of 200 meters from the takeoff start point (figure below). From this position onward, the data were not stored in the GPS memory.

Figure 53 – Sketch of the takeoff site, showing the points of first impact and final stop. The dotted line represents the 200 meters of trajectory of the initial phase of takeoff, at heading 145°, which was recorded by the GPS.

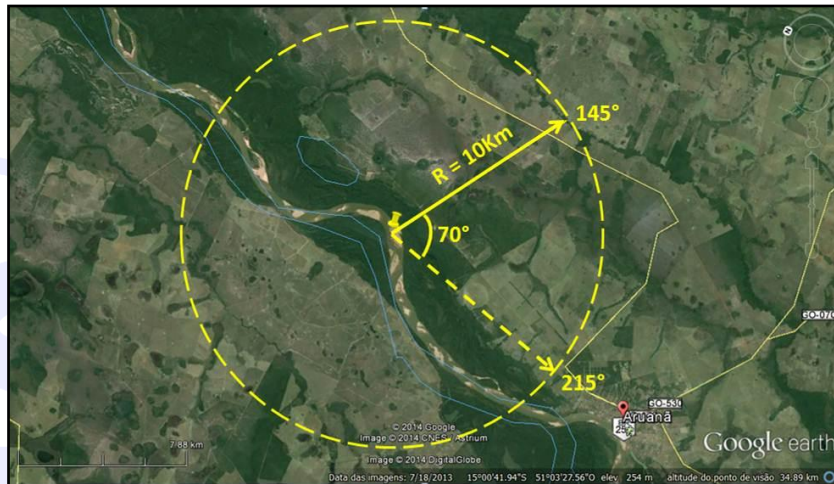
Figure 54 – Air view of the crash-site. Heading 145° was used for takeoff, and heading 215° was the one to be used for a flight to Aruanã.

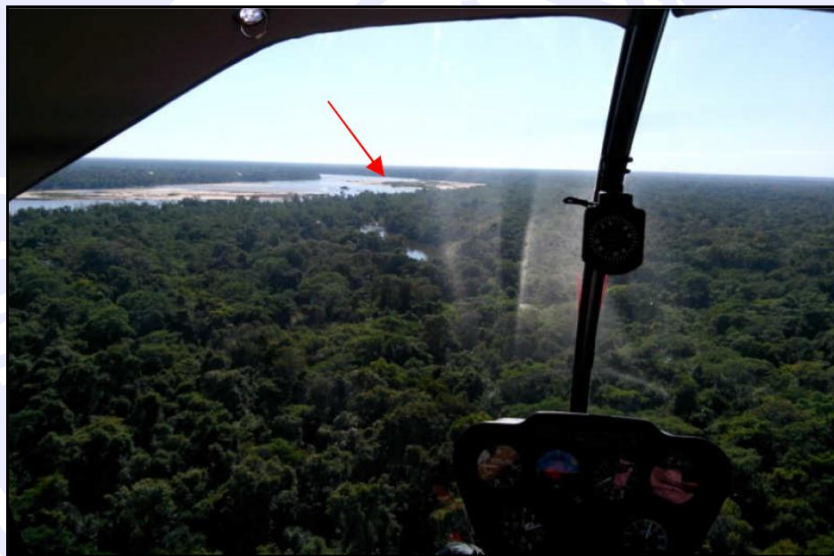
The figure below shows an aircraft flying from the city of Aruanã, bound for the Araguaia River camp, i.e., along a route opposite to the one the pilot of the accident aircraft intended to fly. It is possible to observe the dense vegetation of the region, totally deprived of illuminated references.

Figure 55 – Route from Aruanã to the crash-site (indicated by the arrow).

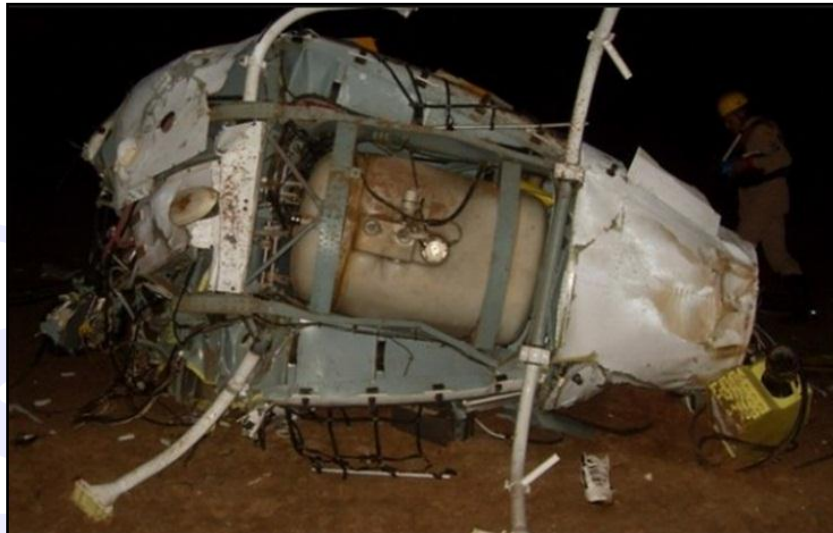
The figure **below** shows the lighting condition of the departure site, approximately one hour after the accident. In the background, at a distance of less than 200 meters, there is dense vegetation (trees) which cannot be seen in the photograph.

Figure 56 – Underside of the aircraft illuminated by the camera *flash*. Behind the position of the aircraft, due to the ineffectiveness of the flash, one cannot see the trees at a distance of less than 200 meters.
