FINAL REPORT A - 188/CENIPA/2013

OCCURRENCE: AIRCRAFT: MODEL: DATE: ACCIDENT PT-NKO EMB-711C 190CT2013

This is the Final Report of the 19 October 2013 accident with the EMB-711C aircraft, registration PT-NKO. The accident was classified as inflight collision with obstacle.

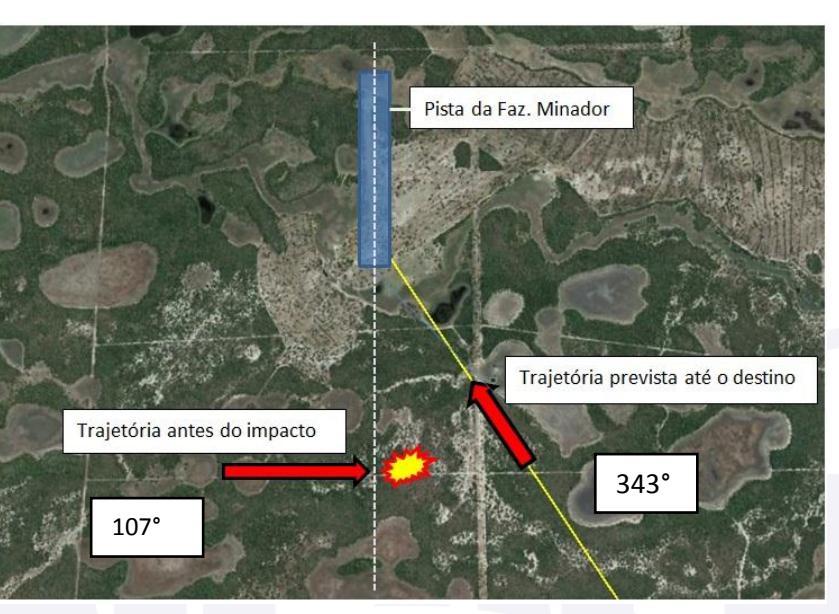
- Considering that the threshold closer to the crash-site had a 013° direction, the ideal heading for a base leg with a turn to the left would be 103°. In this case, there would be a difference of only 4° between the ideal track and the one supposedly flown by the aircraft (107°).

However, the first impact occurred in a position beyond the landing strip extended axis, that is, for some reason the pilot did not turn to the left to join the final leg.
