**COMANDO DA AERONÁUTICA**  
**CENTRO DE INVESTIGAÇÃO E PREVENÇÃO DE**  
**ACIDENTES AERONÁUTICOS**

**FINAL REPORT**  
**A - 207/CENIPA/2013**

<b>OCCURRENCE:</b>	<b>ACCIDENT</b>
<b>AIRCRAFT:</b>	<b>PR-MXM</b>
<b>MODEL:</b>	<b>R66</b>
<b>DATE:</b>	<b>20NOV2013</b>

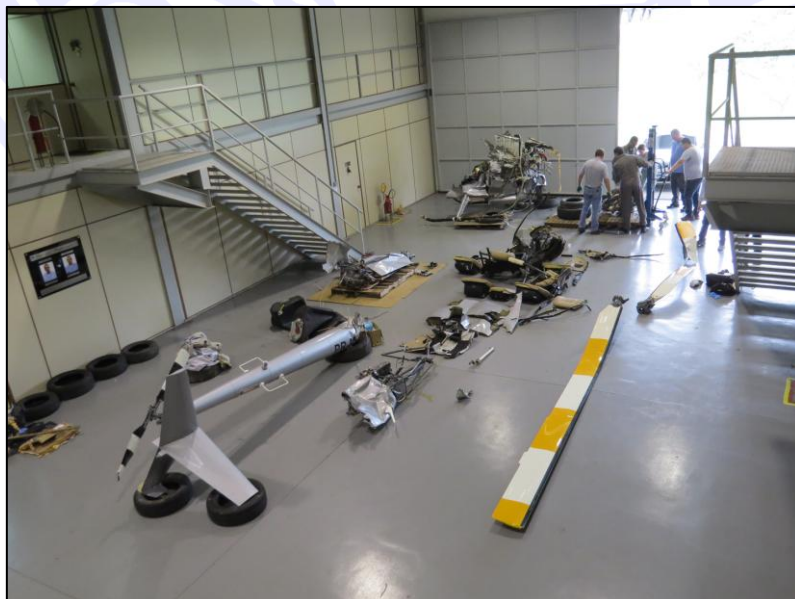
Figure 6 – 2D-reconstruction of the aircraft in the SERIPA III hangar.

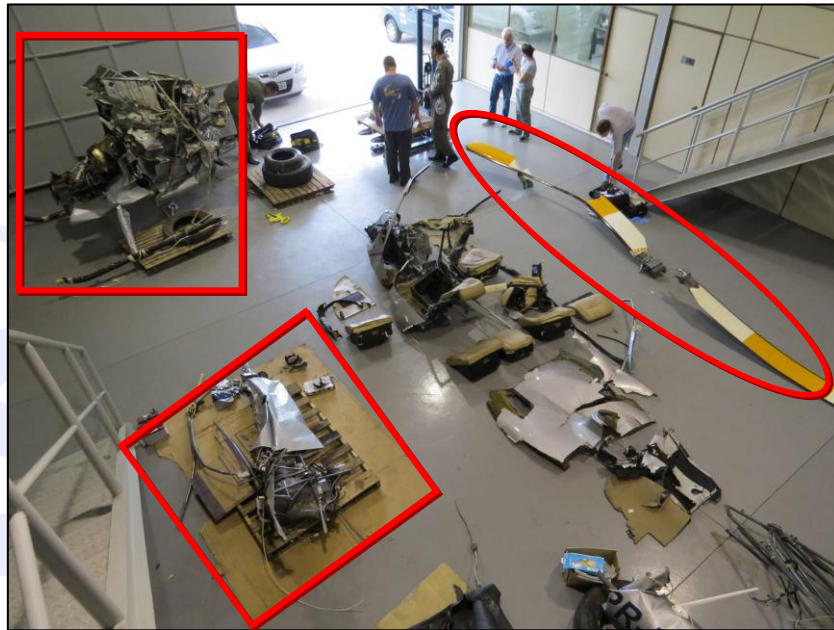
Figure 7 – 2D-reconstruction of the aircraft in the SERIPA III hangar. In highlight, the main transmission box, part of the cabin, and main rotor.

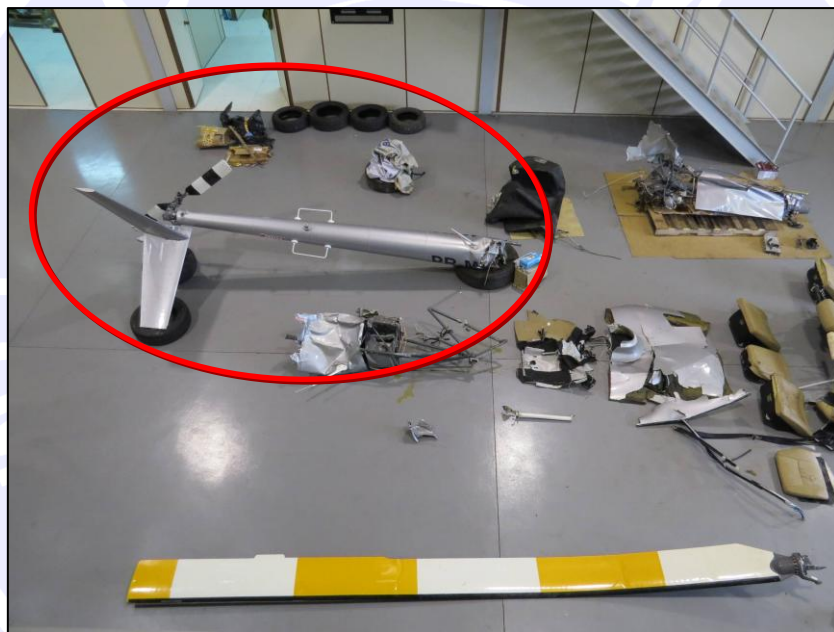
During the descent, the aircraft sustained a sudden loss of control, broke into three parts, and plummeted vertically toward the water.

Figure 8 – Reconstruction of the aircraft in the SERIPA III hangar, with the tail boom in highlight.

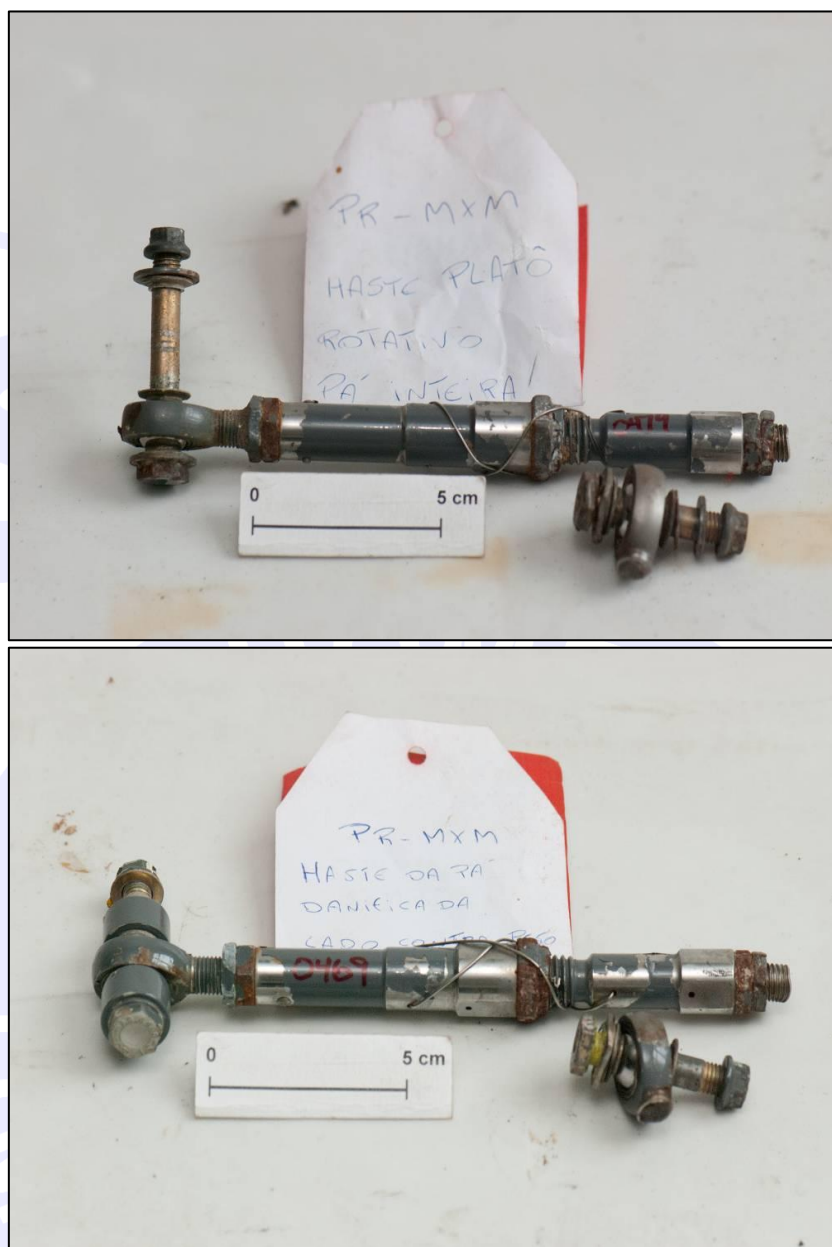
Figure 17 – Pitch links of the aircraft sent to the DCTA for analysis.

The fracture surfaces of the blade spindles and pitch links had dents and an incline of approximately 45 degrees, indicative of overload (Figures 21 and 22).

The collision of the blade with the aircraft structure justifies the breakage (due to overload) of the entire rotary assembly of the main rotor head, including the spindles and pitch links (Figures 17 and 18).

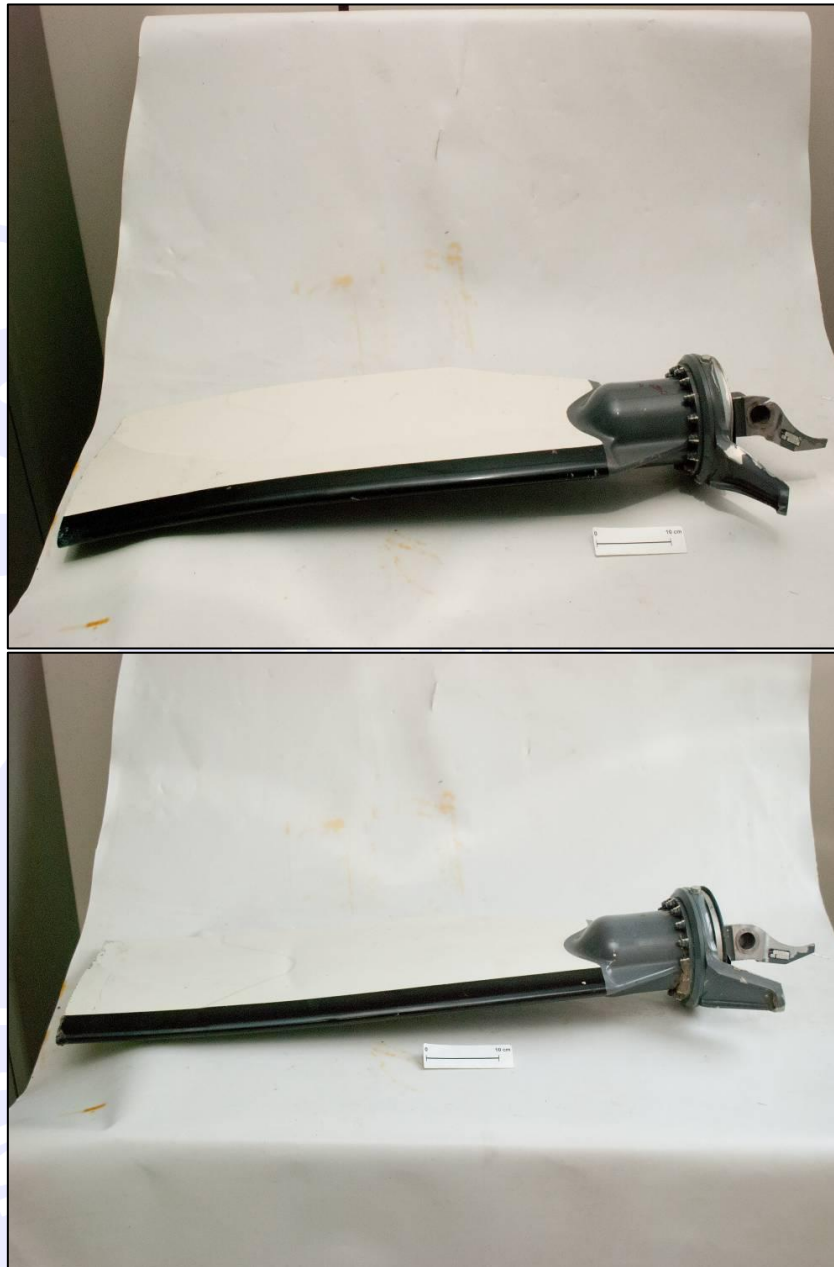
The blades were cut off near the root in order to facilitate their transport. The fact that the blades were cut off did not hamper the analysis of the spindles.

Figure 18 – Spindles of the aircraft sent to the DCTA for analysis.

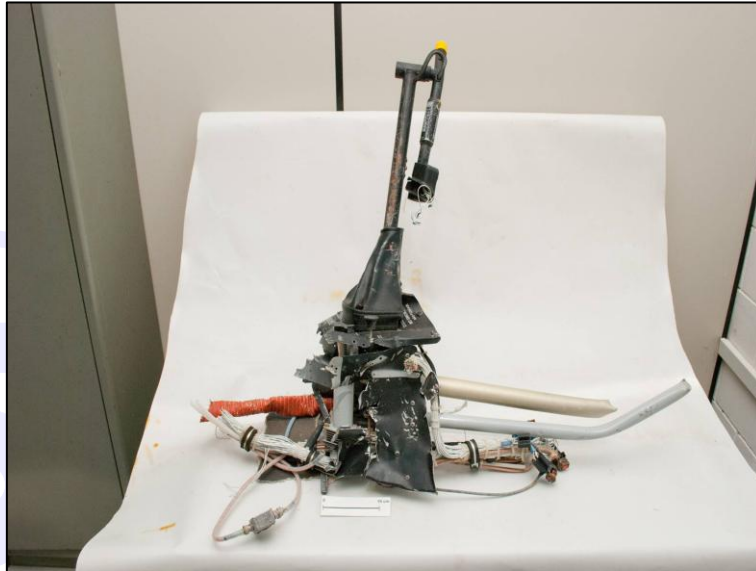
The cyclic control assembly sent to DCTA included the friction adjustment mechanism.

Figure 19 – Cyclic control assembly, including the friction adjustment mechanism, sent to the DCTA.

The moving parts of the cyclic had relatively free movements, in spite of the level of corrosion that the parts had sustained on account of the period it stayed immersed in saline water.

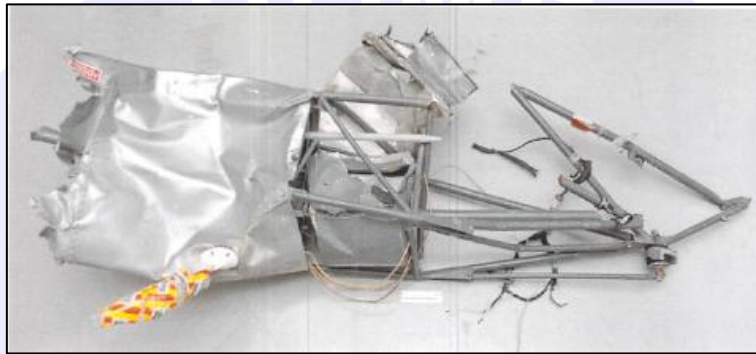
Figure 20 – Aircraft frame sent to the DCTA.

In the analysis of the frame, only signs of fracture due to overload were found. The existing corrosion in the observed parts did not seem to have begun prior to the accident. Aspects, such as the 45°-incline of the fracture surface (Figure 27), and plastic deformations in the flight control tubes (Figure 28), in addition to other aspects such as "fish mouth" in the breakage of the tubes (Figure 29), which are characteristic of failure due to overload, were observed in the fractures of the frame.
