**COMANDO DA AERONÁUTICA**  
**CENTRO DE INVESTIGAÇÃO E PREVENÇÃO DE**  
**ACIDENTES AERONÁUTICOS**

**FINAL REPORT**  
**A - 605/CENIPA/2014**

| <b>AIRCRAFT:</b> | <b>PR-CRR</b> |
| <b>MODEL:</b> | <b>T206H</b> |

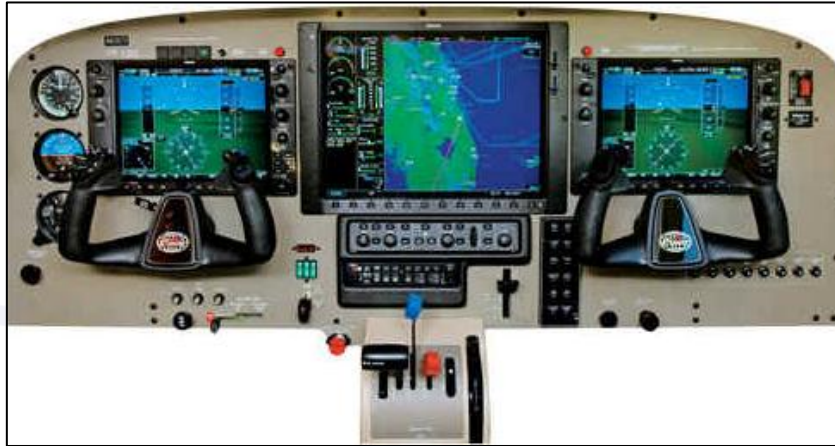
The PR-CRR instrument panel had digital screens, and consisted of the *Primary Flight Display* (PFD), the *Garmin Display Unit* (GDU), relative to the G-1000 (*Garmin*) navigation system, and the *Multifunction Display* (MFD). Such screens provided information of the flight instruments, navigation, and aircraft engine (figure 1).

Figure 1 – Example of a digital panel utilizing the G-1000.
