**COMMAND OF AERONAUTICS**  
**AERONAUTICAL ACCIDENT INVESTIGATION AND**  
**PREVENTION CENTER**

**FINAL REPORT**  
**A - 084/CENIPA/2013**

| <b><u>AIRCRAFT:</u></b> | <b>PR-VAR</b> |
| <b><u>MODEL:</u></b> | <b>AT-502B</b> |

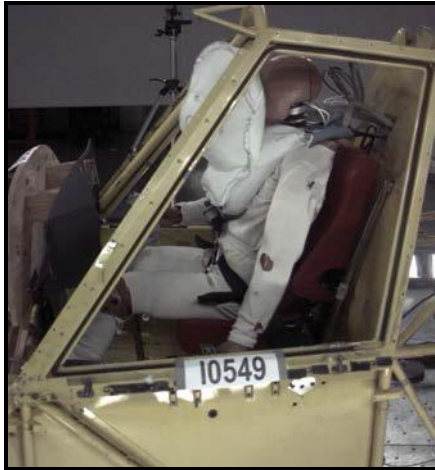
The airbag was activated at the moment of the aircraft impact with the ground, but the pilot received fatal injuries.

Figure 6 – Use of a crash test dummy to show the functionality of the AT-502B aircraft airbag.
