COMMAND OF AERONAUTICS
AERONAUTICAL ACCIDENT
INVESTIGATION AND PREVENTION CENTER

FINAL REPORT
A – N 67/CENIPA/2009

AIRCRAFT **PR - MBK**

MODEL **AIRBUS A-320**

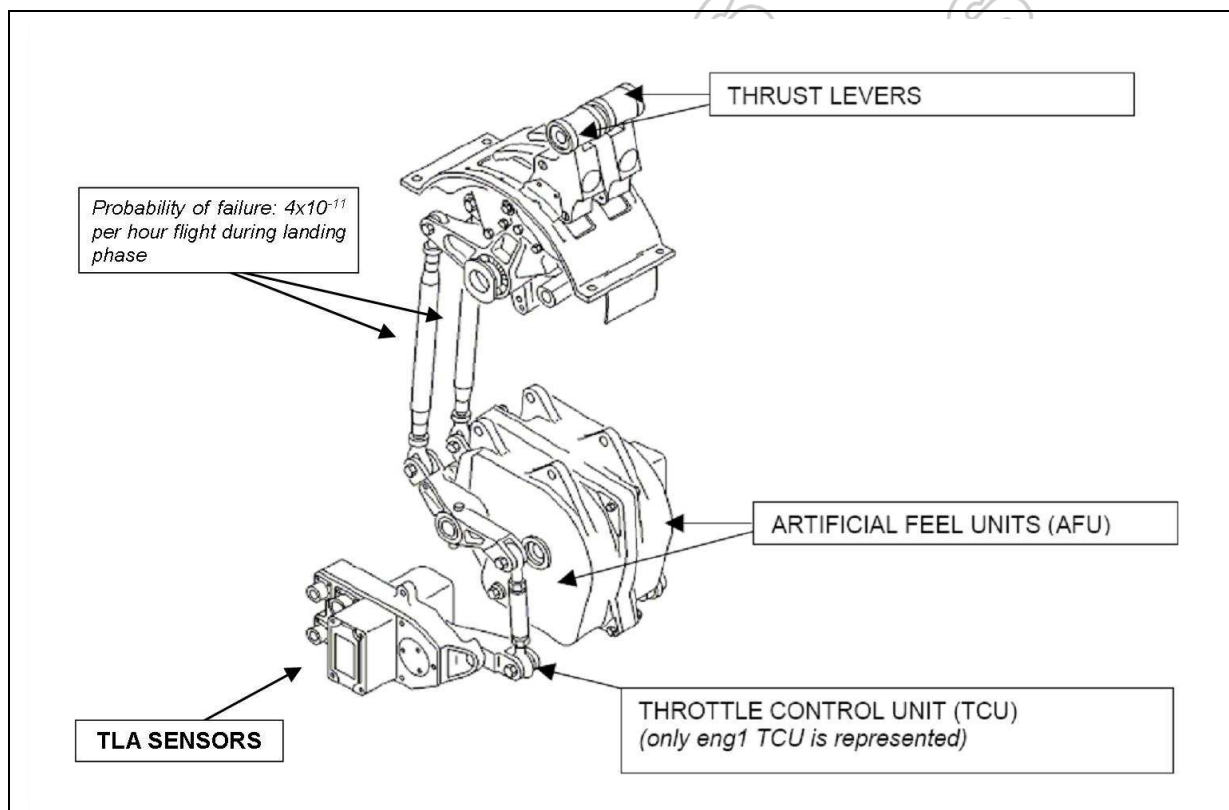
Figure 5 - Scheme of the power control system.

Exams were made in the wreckage of the Artificial Feel Units (AFU) with the purpose of verifying the existence of failures in their quadrants and gears, as well as marks that could confirm the relative position of the thrust levers at the moment of the impact, considering the possibility of a failure of the mechanism that connects the thrust levers to those units.

According to information provided by the aircraft manufacturer, the probability of a failure of the mechanism that connects the thrust levers to the AFUs is 4×10^{-8} per flight hour, and the probability of the failure to occur at the moment of the landing is 4×10^{-11} per flight hour. The sensors that record the position of the thrust levers in the flight data recorder (FDR) are located in the AFUs and not directly in the thrust levers.

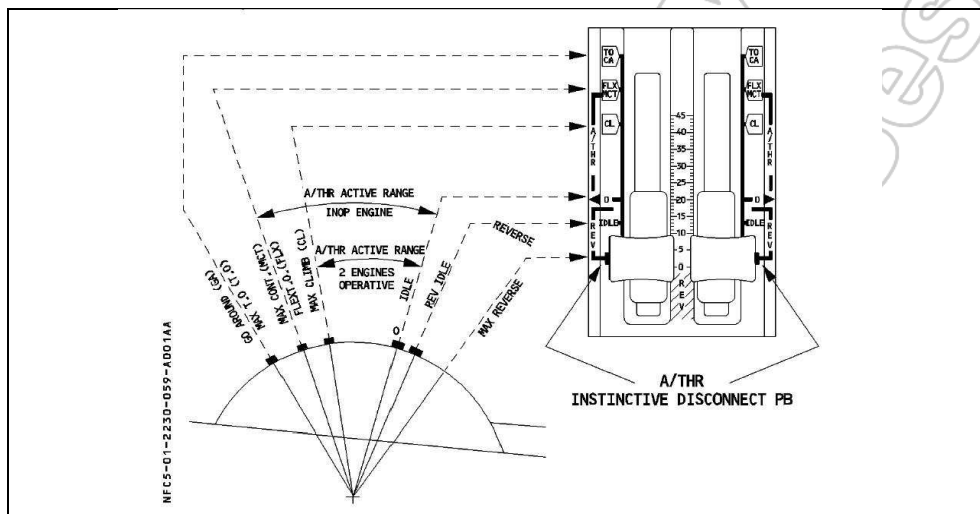
Figure 8 - Positions of the thrust levers.

The power control system of the Airbus A-320, shown in the figure 8, has 5 positions for the levers: "TOGA" (Takeoff/Go-around), "FLX/MCT" (Flex Takeoff/Maximum Continuous Thrust), "CL" (Climb), "IDLE" (Zero Thrust) and "REV" (Reverser). These positions are defined by means of detents, and correspond to the following TLA values:

MAX T.O./GO AROUND (TOGA)	TLA= 45°
FLEX T.O./MAX CONT (FLX/MCT)	TLA= 35°
MAX CLIMB (CL)	TLA= 25°
"IDLE"	TLA= 0°
MAX REVERSE (REV)	TLA= -20°

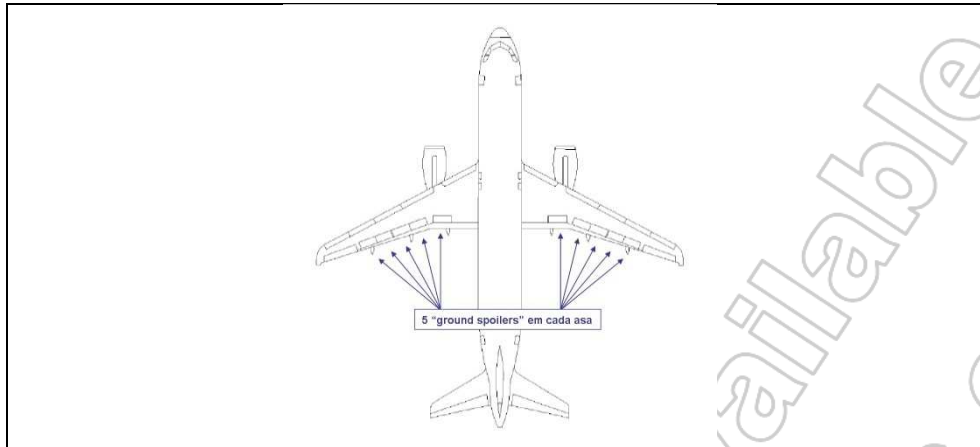
Figure 9 - Ground spoilers: five in each wing.

The A-320 has five spoilers on each wing (figure 9), which open automatically after landing. The spoilers are devices installed on the upper part of the wings whose objective is to reduce lift and increase the aerodynamic drag. During the landing, the device is activated, significantly reducing lift and allowing for a more efficient braking. Consequently, the landing distance of the aircraft is quite reduced.

The automatic ground spoiler function causes the spoilers to open automatically, as soon as the main gears touch the ground, provided the thrust levers are at the "IDLE" position. If one lever stays at the "CL" position during the landing, it deactivates the actuation of the ground spoilers, significantly reducing the aircraft braking capability (between 45% to 50%).
