**COMANDO DA AERONÁUTICA**  
**CENTRO DE INVESTIGAÇÃO E PREVENÇÃO DE**  
**ACIDENTES AERONÁUTICOS**

**FINAL REPORT**  
**A - 503/CENIPA/2021**

| <b>AIRCRAFT:</b> | <b>PP-BRJ</b> |
| <b>MODEL:</b> | <b>AS-350B3</b> |

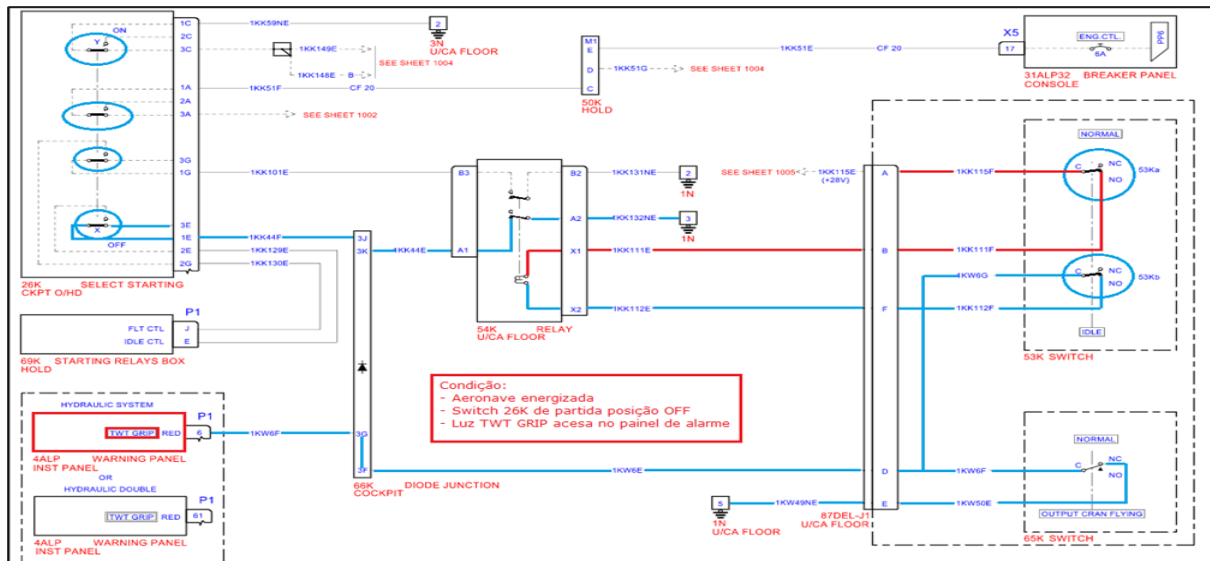
With the aircraft energized, the start selector in the OFF position, and the twist grip in the IDLE position, the 53Ka and 53Kb microswitches would be in the working position, that

is, activated and with their internal contacts closed. As the 65K microswitch or worked with inverted contacts, in this same condition, it would not be activated, but its internal contacts would be closed, allowing grounding and the consequent lighting of the TWT GRIP light on the alarm panel (Figure 1).

Figure 1 - TWIST GRIP electrical circuit in the following configuration: energized aircraft, start selector in OFF position and twist grip in IDLE position.

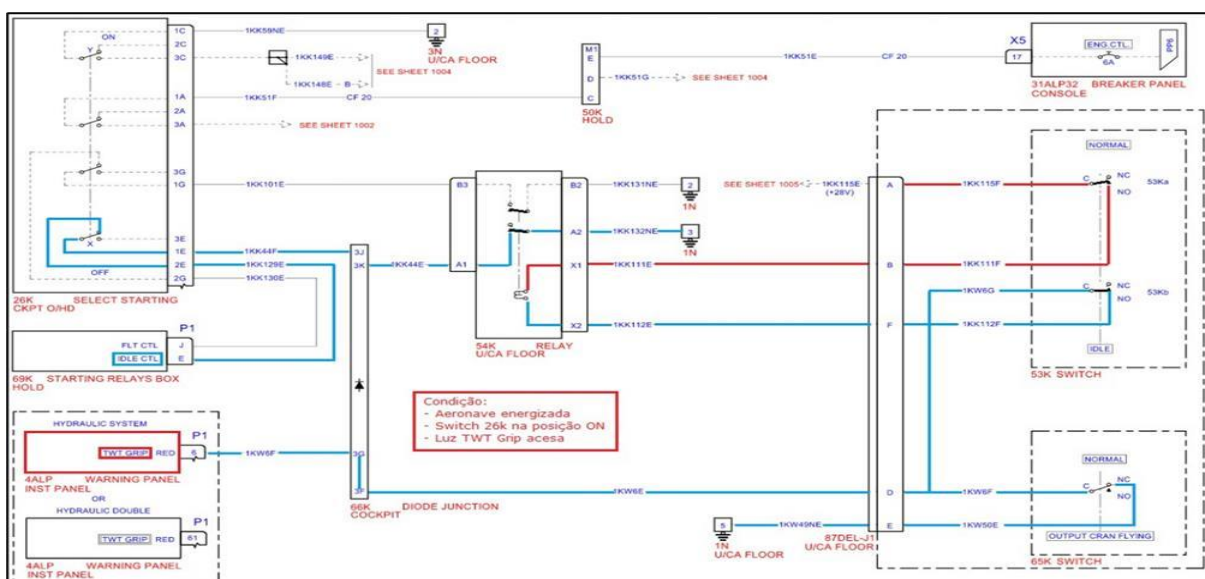
With the aircraft energized, the start selector in the ON position, and the twist grip in the IDLE position, the 53Ka and 53Kb microswitches would be in the working position, that is, activated and with their internal contacts closed. In this condition, the 53Ka microswitch would allow the passage of 28 VDC current to feed the coil at point X1 of the 54K relay while a ground signal would pass through the internal contacts of the 53Kb microswitch, allowing the coil to be grounded at point X2 of the 54K relay.

Only the activation of the two microswitches at the same time would allow powering the 54K relay circuit, giving the system a redundancy characteristic. In this same condition, the 65K microswitch would not be activated, and its internal contacts would remain closed, allowing the grounding signal to be supplied to the 53Kb microswitch and to the alarm panel for the TWT GRIP light to turn on (Figure 2).

Figure 2 - TWIST GRIP electrical circuit in the following configuration: energized aircraft, start selector in ON position and twist grip in IDLE position.

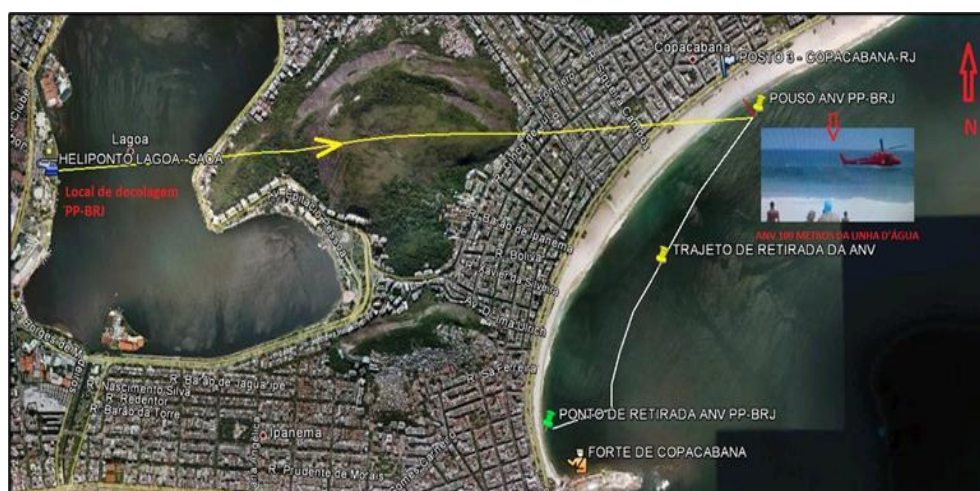
The impact took place at sea, on the Copacabana beach shore, Rio de Janeiro - RJ, and shortly after the landing, the aircraft submerged.

Figure 6 - Aircraft trajectory to the point of impact.

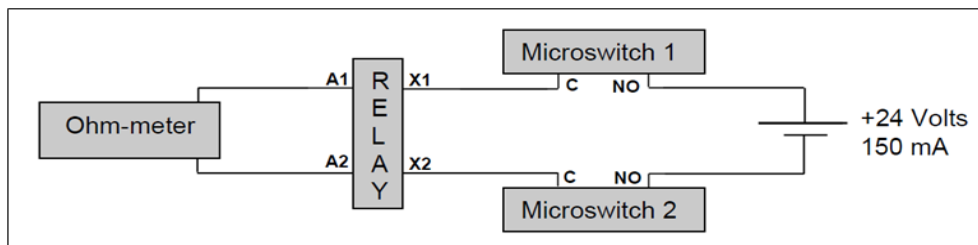
A functional test of the twist grip system was carried out in BEA's laboratories, using the electrical components of the TWIST GRIP. The objective was to expose the microswitches to salt water droplets to simulate the influence of the environment on an aircraft hovering at a low altitude over the sea.

The diagram below (Figure 10) shows the installation that was followed, representative of the installation of the TWIST GRIP set, with the use of new microswitches and relay.

Figure 10 - Diagram of the functional test of the TWIST GRIP system performed by the BEA.

Initially, the system was tested and operated without the addition of salt water to confirm correct operation, which it did.
