FINAL REPORT
A-105/CENIPA/2021

OCCURRENCE:	ACCIDENT
AIRCRAFT:	PP-JCS
MODEL:	210L
DATE:	16SET2021

This is the Final Report of the 16SEPT2021 accident with the Cessna 210L aircraft, registration marks PP-JCS. The accident was typified as “[SCF-PP] Engine failure or malfunction | Engine failure in flight.”

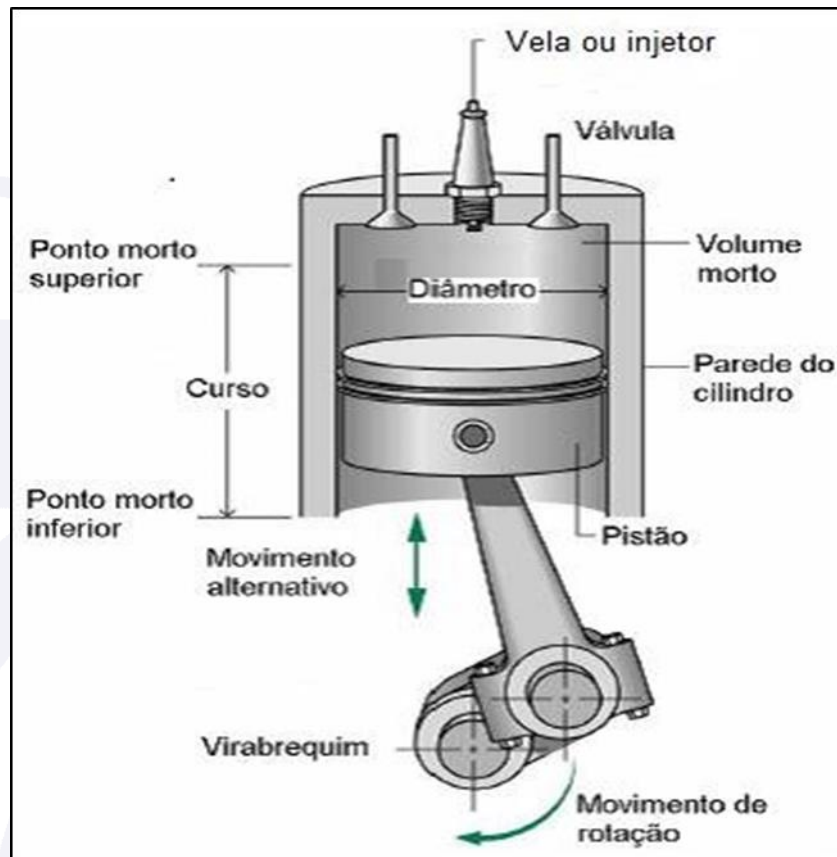
As illustrated in Figure 6, the natural movement of the piston during operation of the engine is to move from Top Dead Center to Bottom Dead Center after the burning of the fuel-air mixture.

Figure 6 - Illustration of the piston, cylinder, rings, connecting rod and crankshaft.
Source: www.researchgate.net
