COMANDO DA AERONÁUTICA
CENTRO DE INVESTIGAÇÃO E PREVENÇÃO DE
ACIDENTES AERONÁUTICOS

FINAL REPORT
A-105/CENIPA/2021

OCCURRENCE:	ACCIDENT
AIRCRAFT:	PP-JCS
MODEL:	210L
DATE:	16SET2021

This is the Final Report of the 16SEPT2021 accident with the Cessna 210L aircraft, registration marks PP-JCS. The accident was typified as “[SCF-PP] Engine failure or malfunction | Engine failure in flight.”

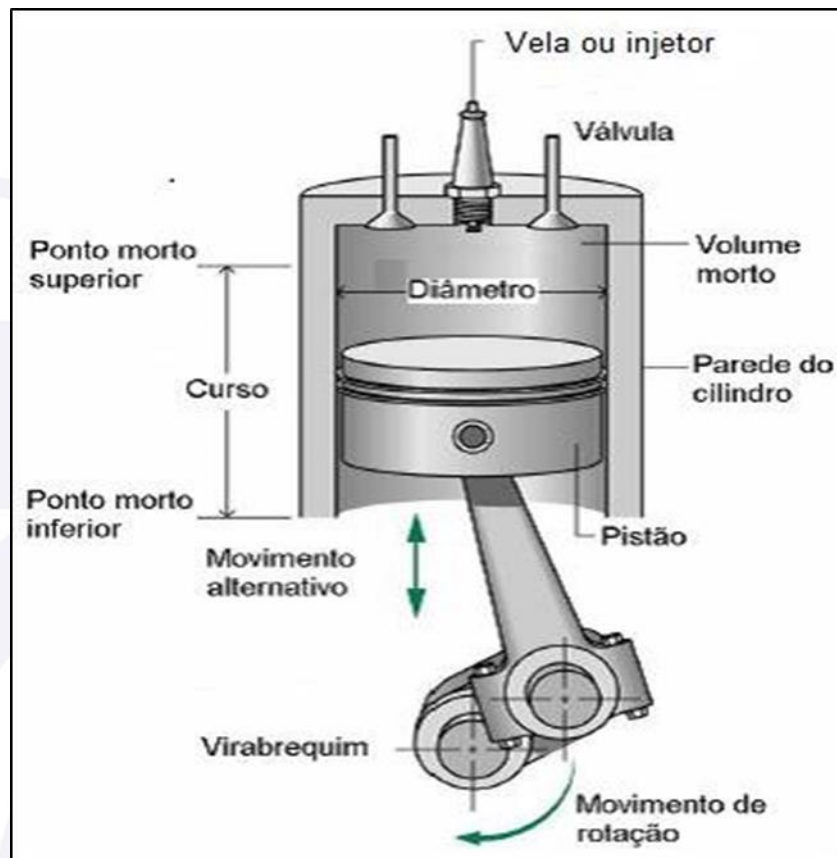
As illustrated in Figure 6, the natural movement of the piston during operation of the engine is to move from Top Dead Center to Bottom Dead Center after the burning of the fuel-air mixture.

Figure 6 - Illustration of the piston, cylinder, rings, connecting rod and crankshaft.
Source: www.researchgate.net
