**COMANDO DA AERONÁUTICA**  
**CENTRO DE INVESTIGAÇÃO E PREVENÇÃO DE**  
**ACIDENTES AERONÁUTICOS**

**FINAL REPORT**  
**A-069/CENIPA/2022**

<b>OCCURRENCE:</b>	<b>ACCIDENT</b>
<b>AIRCRAFT:</b>	<b>PP-MCJ</b>
<b>MODEL:</b>	<b>206B</b>
<b>DATE:</b>	<b>05JUN2022</b>

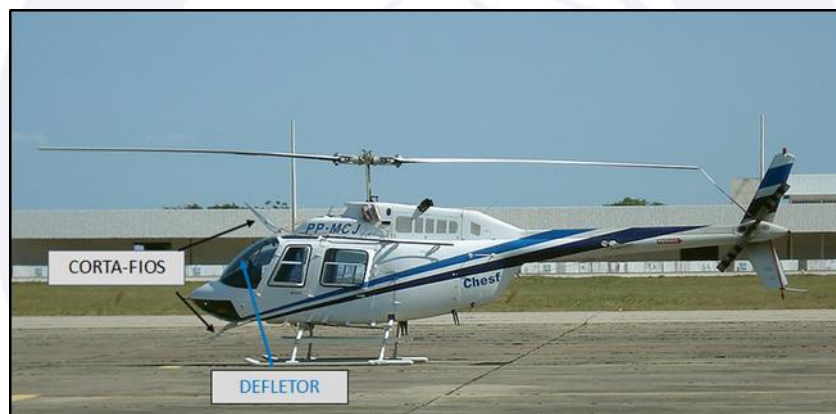
Figure 2 - View of the PP-MCJ aircraft. Source: Jetphotos.net

The aircraft had a Wire-Strike Protection System, consisting of an upper and a lower wire-cutting device. Its windshield had a deflector along its middle section (Figure 2).

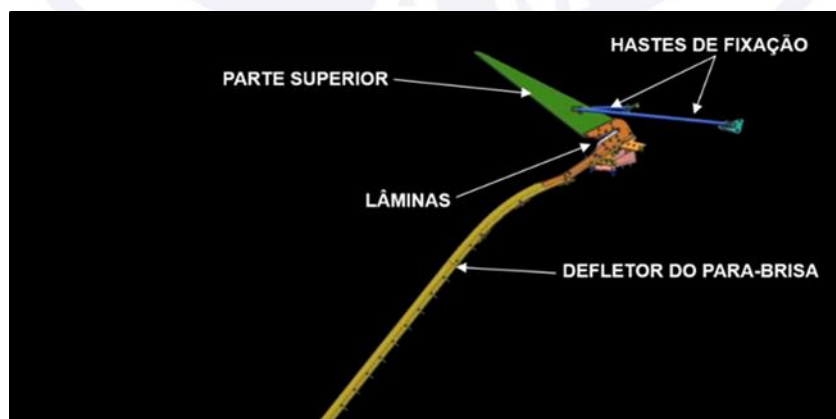
Figure 3 - Detailed view of an upper wire-cutter.

Figure 3 shows a detailed view of the upper wire-cutter.

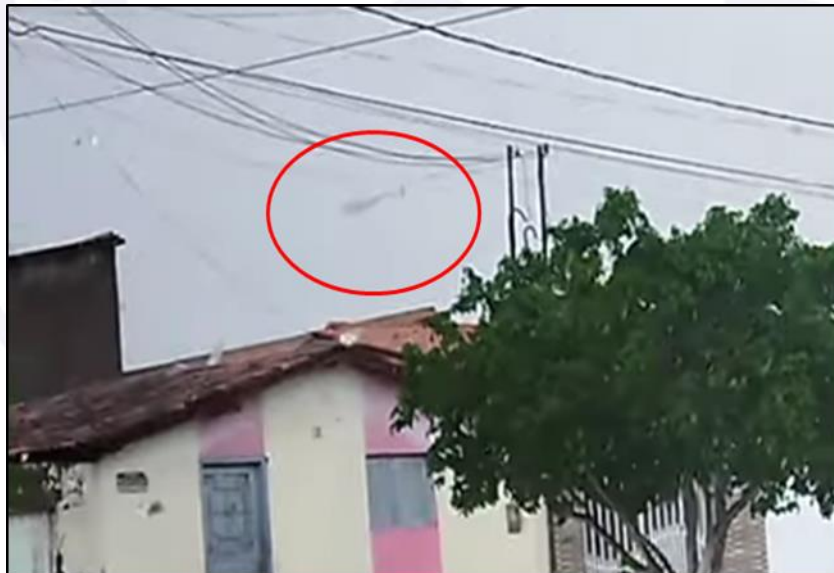
A video, recorded moments before the accident, shows the helicopter in flight moments before the accident under the limited visibility conditions present in that region (Figure 7).

Figure 7 - Image of the PP-MCJ flying over the locality of Currais Novos.

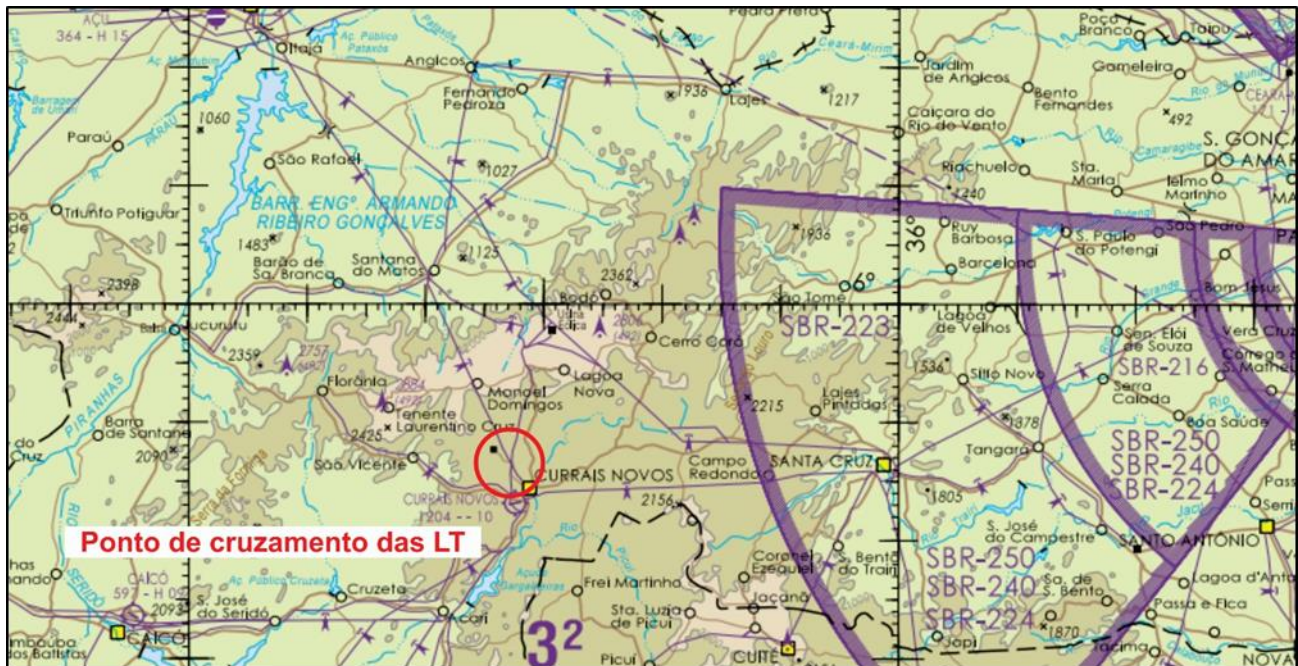
At the time of the accident, the Chart WAC 3018, sixth edition, was the one in force (since 05 November 2020), with topographic data updated as of April 2020. In this publication, the 230-kV LT and its respective intersection with the 138-kV LT were mapped (Figure 9).

Figure 9 – Chart WAC 3018 - 6th Edition, 2020, in force on the date of the accident.

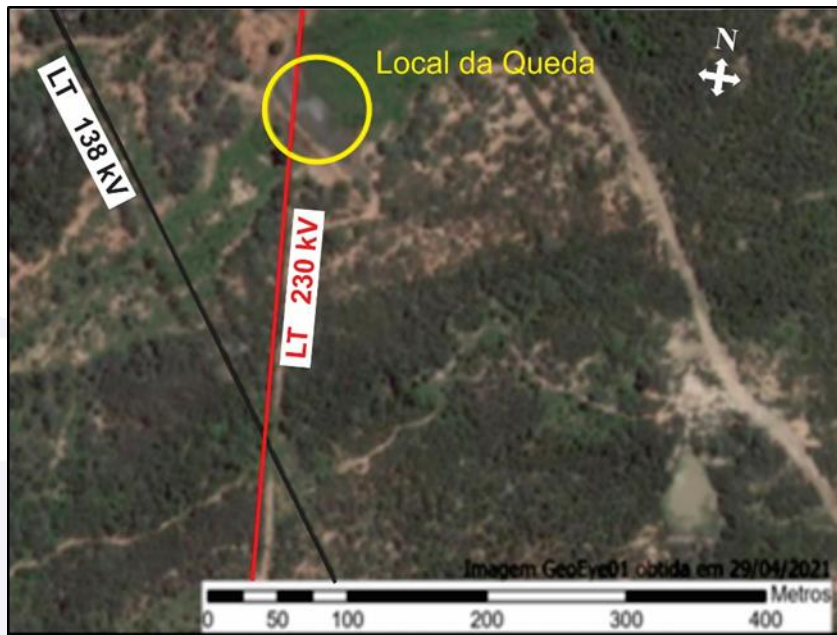
The PP-MCJ was flying parallel to the CHESF's 138-kV LT at a height of approximately 30 m, when it encountered the oblique intersection with the TAESA's 230-kV LT against which it collided.

Figure 10 - Top view of the intersection of the 138-kV LT with the 230- kV LT. In highlight, the dam where the PP-MCJ was found. Source: CHESF.

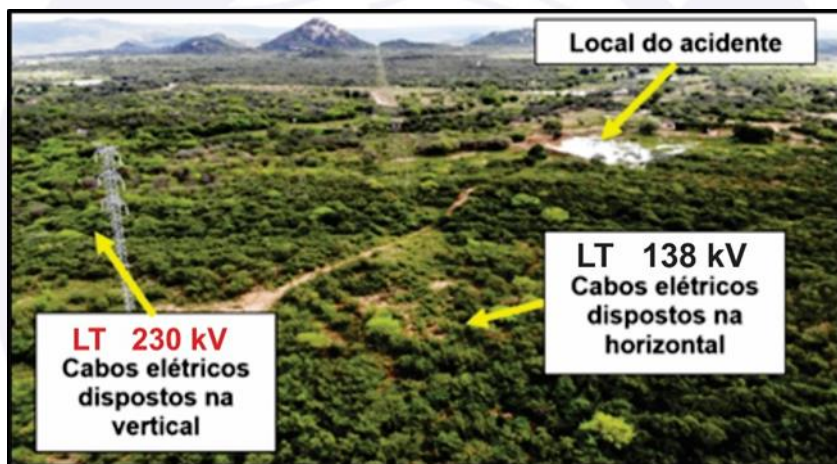
While the 138-kV LT had an average height of 30 m, and its electric cables were separated horizontally, the 230-kV LT cables had a height of approximately 40 m. (Figure 11).

Figure 11 - Intersection of the 138-kV LT with the 230-kV LT.

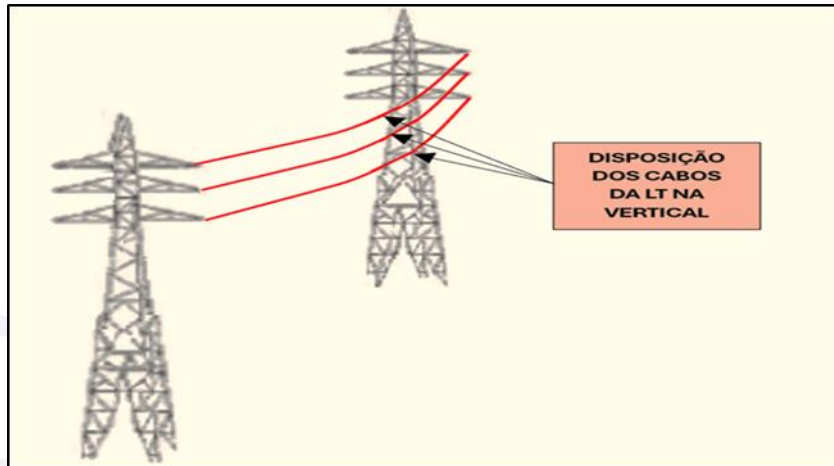
Figure 12 - Vertical arrangement of LT cables.

The helicopter collided with a lightning-rod cable in the upper part of the 230-kV LT at a height of 41.66 meters. The transmission line cables were arranged vertically, as shown in the illustrative image in Figures 12 and 13.

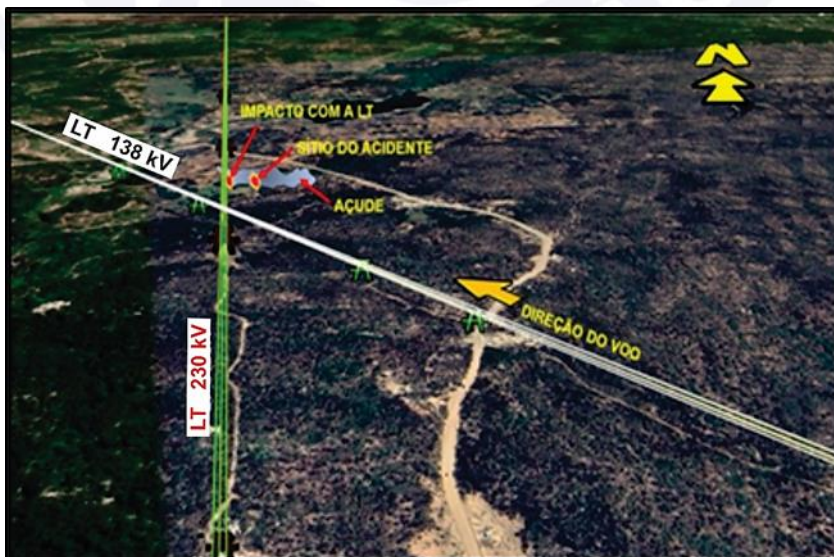
The aircraft fell into a dam, at a distance of approximately 30 m from the point of collision, as shown in Figure 14.

Figure 14 – Croquis of the accident.

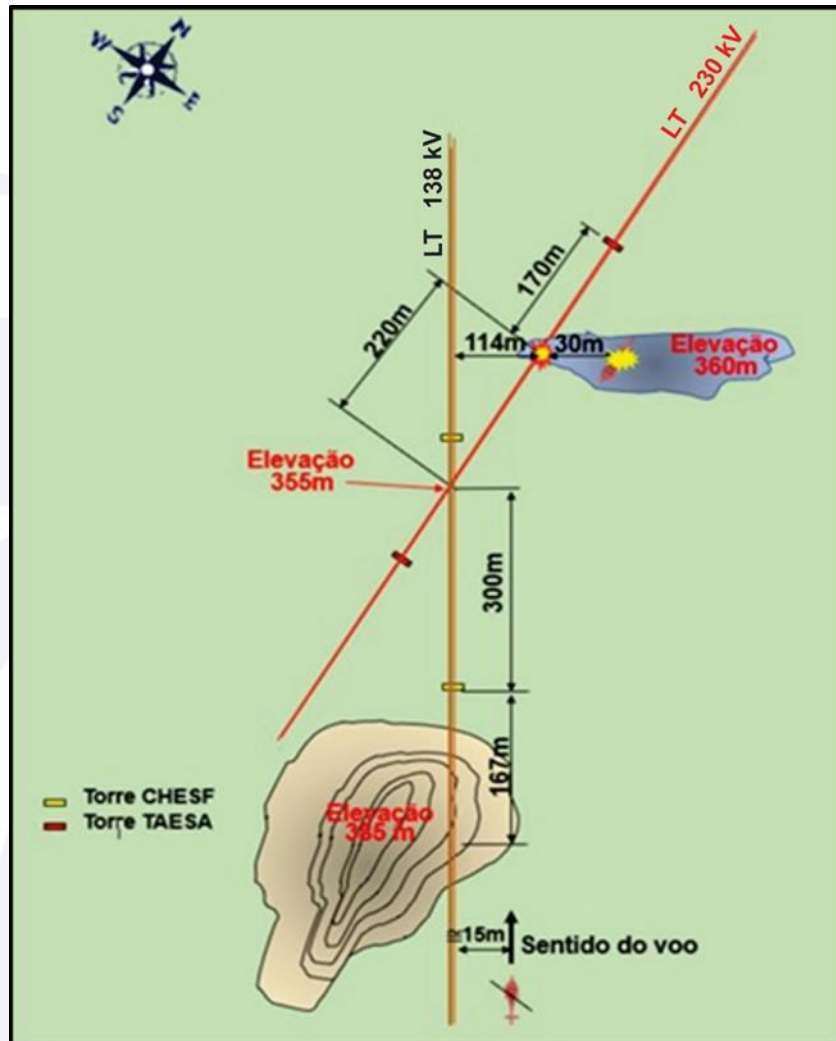
Figure 15 shows an overview of the distances in the region where the accident occurred, illustrating the location of the helicopter collision against the 230-kV LT, and the respective elevations in relation to sea level.

Figure 15 – Croquis with the dimensions of the LT and terrain elevations.

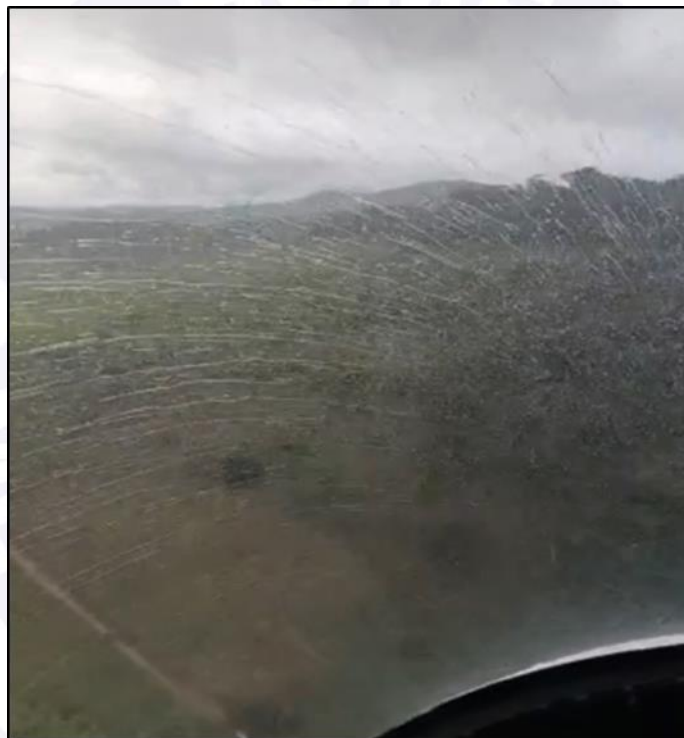
A photo published on the *Piloto Policial* website corroborates the article, showing the effect of rain droplets on the windshield of a helicopter (Figure 30).

Figure 30 - Influence of rain droplets on the windshield of a helicopter, compromising the pilot's visibility. Source: *Piloto Policial* website.

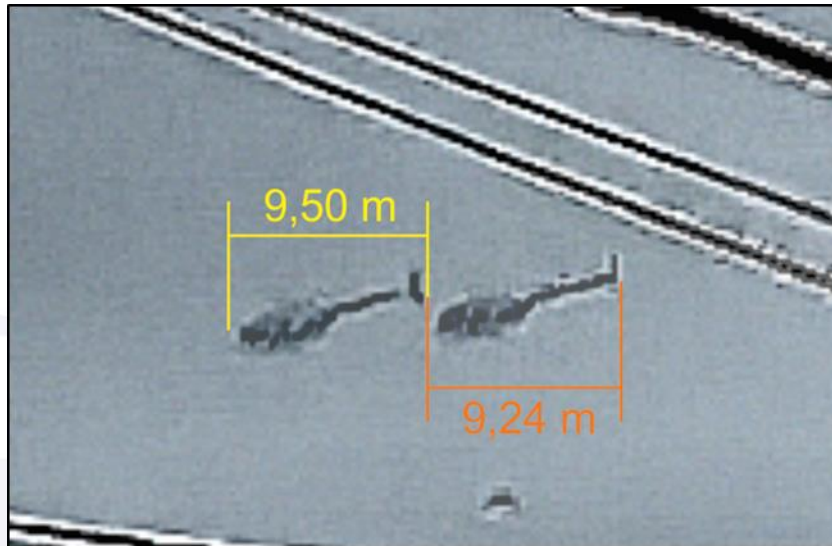
With the aim of calculating the speed of the PP-MCJ from a video recorded by an observer, the Investigation Committee measured the aircraft's displacement in relation to its length (9.50 m) in the interval of five consecutive frames.

Figure 31 - Measurement of displacement (9.24 m) calculated in comparison with the length of the aircraft (9.50 m).

Considering the interval of five frames for the video, at a rate of 20 frames per second, one determined that the aircraft was moving 9.24 m in 5/20 s.

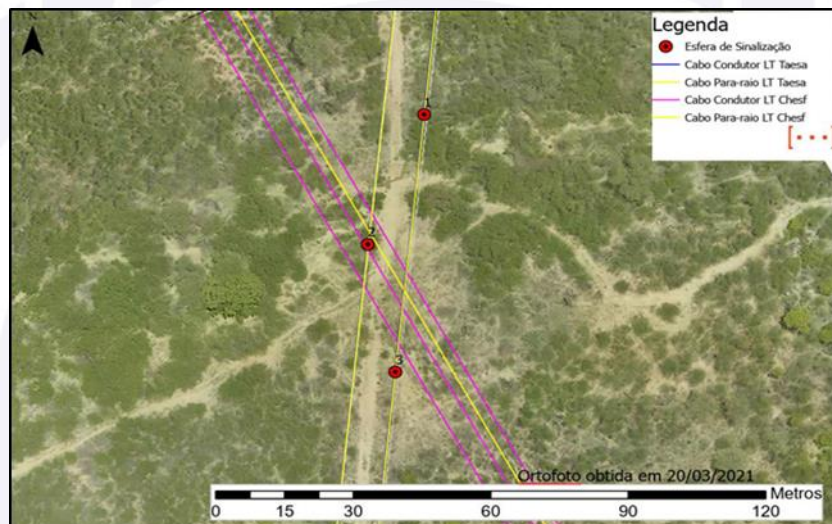
The 230-kV LT cables had orange warning spheres (Figure 33).

Figure 33 - Location of the warning spheres existing before the accident.  
Source: CHESF.

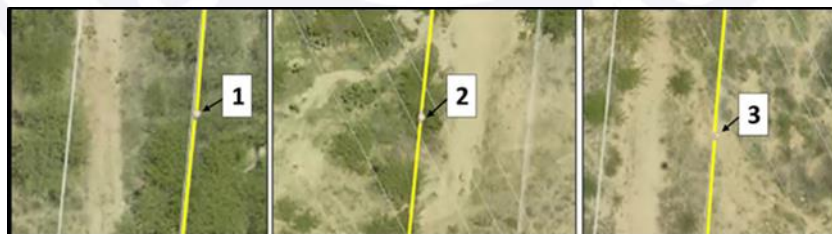
Figure 34 indicates the location of the warning spheres of the electrical cables 1, 2, and 3, respectively, of the 230-kV LT.

Figure 34 - Identification of the warning spheres of the electrical cables 1, 2, and 3, respectively, of the 230-kV LT.

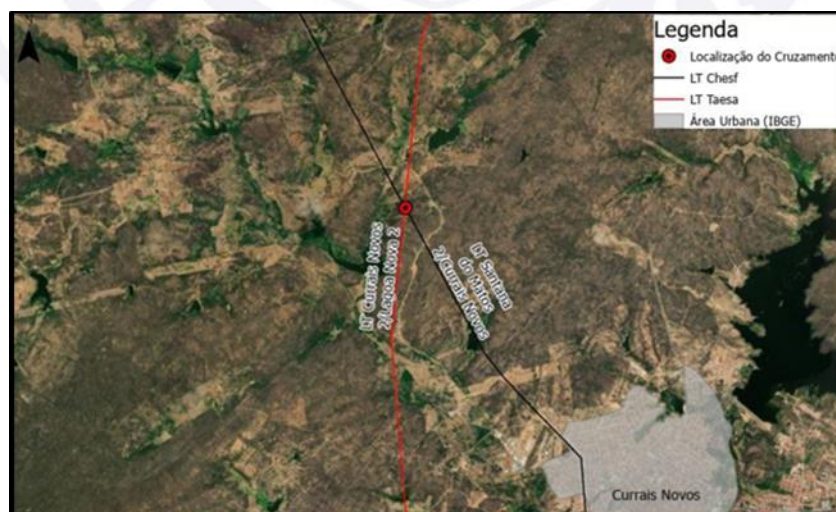
The accident occurred in the afternoon period, at the point of the oblique intersection of the 138-kV LT with the 230-kV LT (Figure 37).

Figure 37 - Geographic location of the intersection of the 138-kV LT with the 230-kV LT, having the town of *Currais Novos* as a reference.

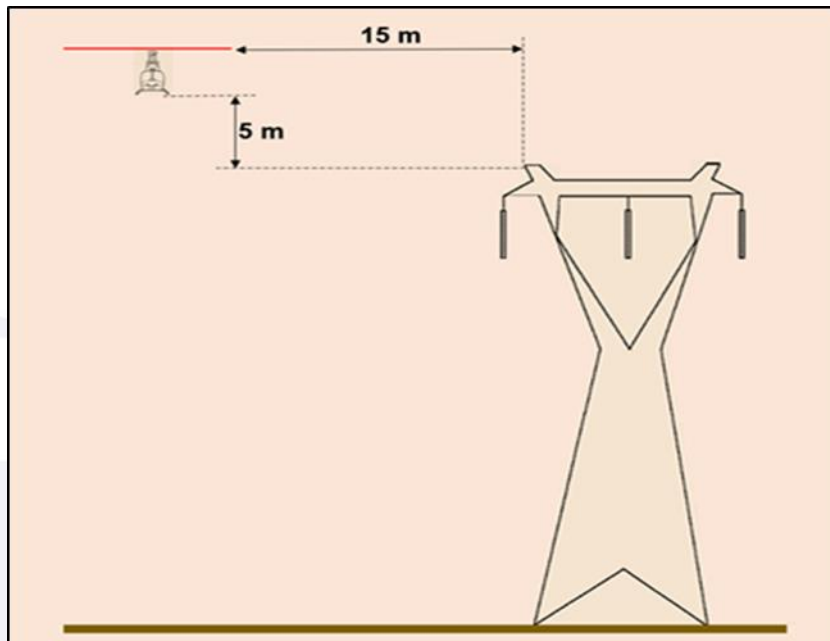
According to a report from the operator's pilots, the PIC used to adopt an inspection-flight profile which would lead him to remain approximately 5 m above, using the skid (landing gear) as a reference, and 15 m laterally away from the inspected cables, using the edge of the main rotor as a reference (Figure 38).

Figure 38 - Flight profile adopted by the PIC in relation to the inspected LT.
